Technical information

TI No.: 46.40U10716A

Model: MC400; CC500; TC500; Tourismo; Travego; Integro; Intouro
 MODEL SERIES: 410120; 410130; 410140; 410200; 410210; 410230; 410240;
 410250; 410260; 410270; 410280; 410540; 410545; 410550;
 410555; 410560; 410565; 410570; 410575; 410585; 629540;
 629557; 632036; 632245; 632285; 632400; 632410; 632420;
 632430; 632431; 632440; 632450; 632451; 632460; 632470;
 633051; 633300; 633310; 633320; 633330; 633340; 633350;
 633360; 633381; 633382; 633383; 633620; 633640; 633660;
 633720; 633723; 633743

TITLE: Checking the drop arm and replacing if necessary

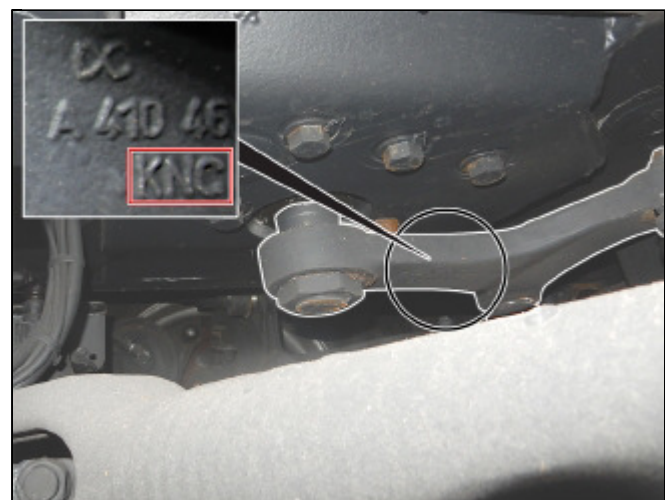
M46.40-0033-71

The drop arm does not conform to prescribed specifications.

Error in production.

1. Identify the manufacturer of the drop arm

The drop arm bears the manufacturer abbreviation '**KNC - A 410 463 04 01**'.

The drop arm does not bear the manufacturer abbreviation 'KNC - A 410 463 04 01'.

Check the drop arm and replace it with a new one if necessary.

- Replace the drop arm with a new one.

- ▶ No further work necessary, conclude the order.
