RECALL 18V-336: REPLACE BELT DRIVE IDLER PULLEY BOLT

E70 (X5 xDrive35d)

RE: Recall 18V-336: Idler Pulley Bolt (B12 19 18)

**Engine Idler Pulley Bolt
Safety Recall 18V-336
Model Year 2009-2013
BMW X5 xDrive35d (Diesel) SAV
*Last updated January 28, 2019***

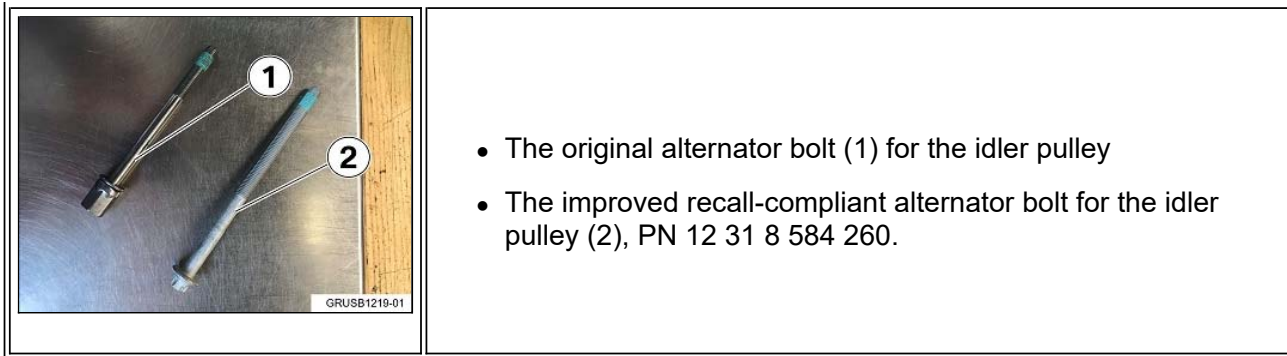
- The original alternator bolt (1) for the idler pulley
- The improved recall-compliant alternator bolt for the idler pulley (2), PN 12 31 8 584 260.

Replace the mounting bolt and idler pulley ("final remedy").

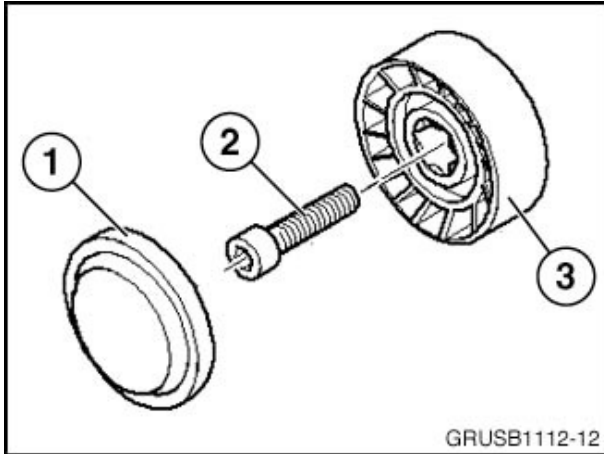
- Exploded view of cover (1) pulley bolt (2) and pulley (3). These parts are not to be reused.
