Safety Recall

Code: 74D5

Subject Passenger Occupant Detection System (PODS)

Release Date November 20, 2018

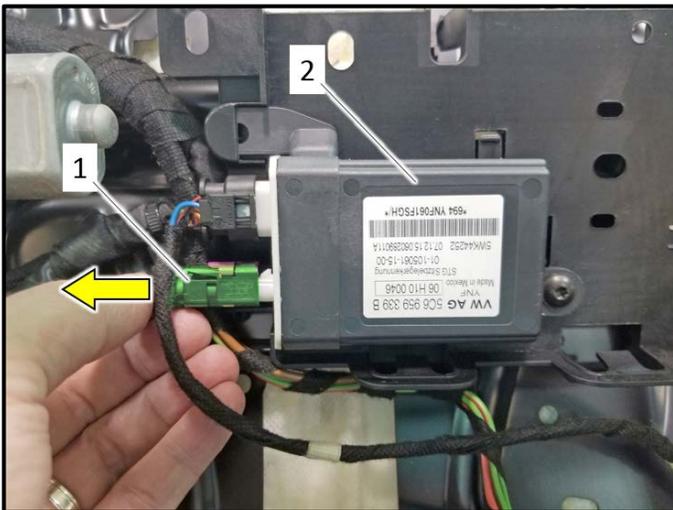
The connector must be removed exactly parallel with the PODS ECU. The center pin in the PODS ECU is fragile and must not be bent during removal. A damaged center pin will cause PODS faults. Damage to PODS ECU is not covered under this action.

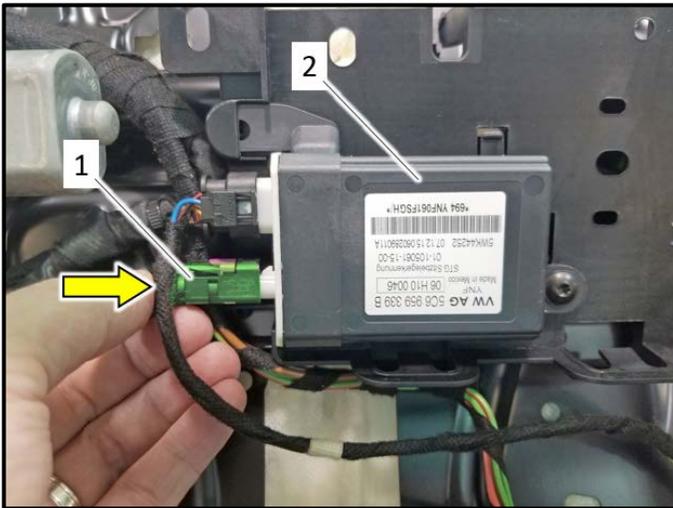
The connector must be installed exactly parallel with the PODS ECU. The center pin in the PODS ECU and connector is fragile and must not be bent during installation. A damaged center pin will cause PODS faults. Damage to the PODS ECU is not covered under this action.

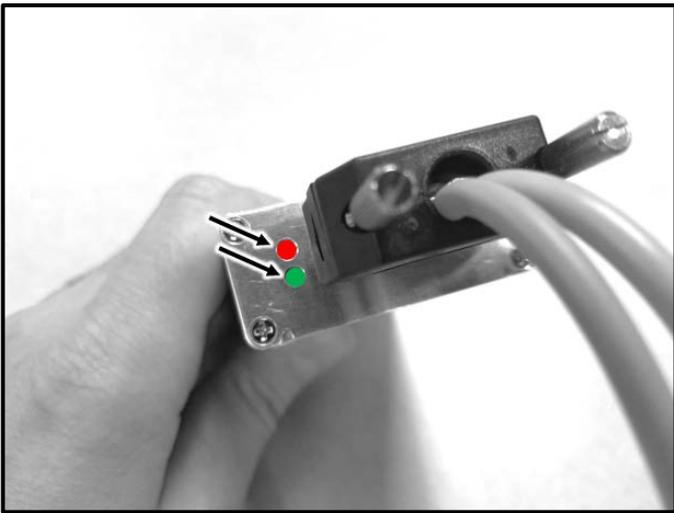
- If the start-up procedure fails, the red and green lights will flash simultaneously.
- This means the maximum number of stored records has been reached.
- If this situation is encountered, contact Audi Technical Assistance for further direction.

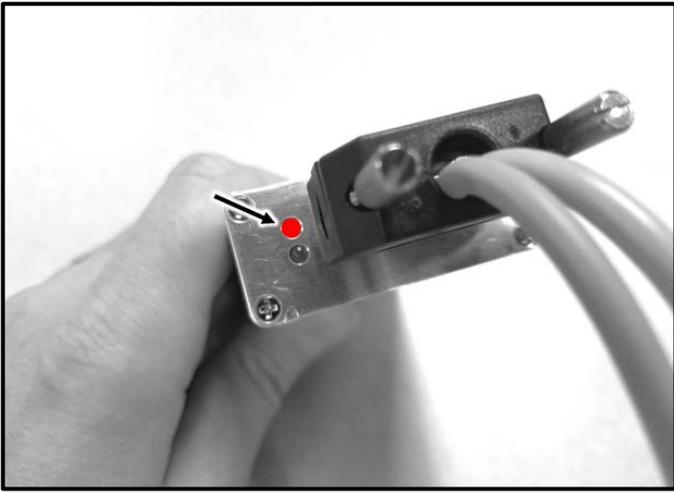
- If the programming has failed the red light will flash and one of the following may have occurred:
 - Battery voltage is too low.
 - Seat was not empty.
 - Sensor not connected to the ECU.
 - Programmer not connected to PODS seat harness.
 - Wrong PODS kit was installed.
- Once a problem is corrected, repeat the programming.
- If the above issues are all addressed and the programming still fails, contact Audi Technical Assistance for further direction and attach the following to the ATA case:
 - Photo of the Programmer lights.
 - Photo showing the battery voltage is above 12.5 volts.
 - Photo showing an EMPTY seat fully installed.
 - Photo showing the PODS sensor wiring fully connected to the PODS ECU.
 - Photo showing the Programmer fully connected to the seat harness.
 - Photo of the part number of the PODS kit (from the box the part came in).
