RECALL 18V-374: CHECK AND REPLACE STEERING WHEEL

This Service Information bulletin replaces SI B32 06 18 **dated June 2018**.

G01 (X3 SAV)

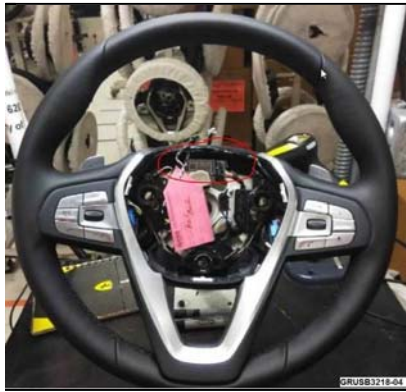
A bar code label for the steering wheel can be found in the circled area as shown on left.

Check the serial number on the bar code label as shown and compare it to the list below.

Only the middle series of numbers in the serial number will change between vehicles.

If the serial number matches the list to the left, then the steering wheel should be replaced as described in repair manual 32 33 015.

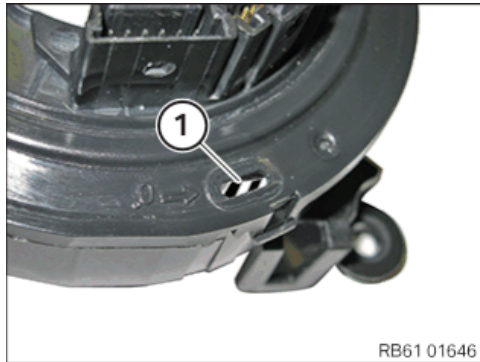
- Check the mark (1) in the inspection glass.

- » The mark (1) is not visible

- Turn the coil spring cassette until the mark (1) becomes visible in the field of view.
