# Safety Recall Code: 69W8 / 69W9

**Passenger Frontal Airbag**

August 17, 2018

USA & Canada: Certain 2018 MY Tiguan

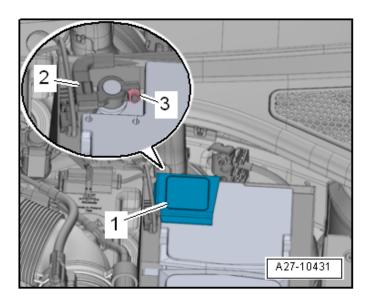
- Open the cover <1> over the battery ground terminal post.
- Loosen the nut <3>.
- Remove and isolate the battery ground cable
   <2> from the battery terminal.

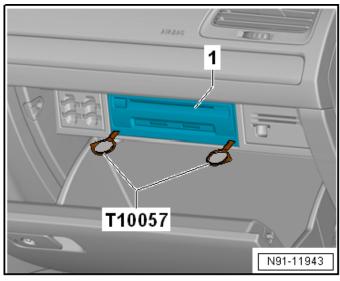
- Remove the Information Electronics Control Module -J794-:
  - Open the glove compartment.
  - Insert the two -T10057- into the slits in the -J794- <1> until they lock into place.

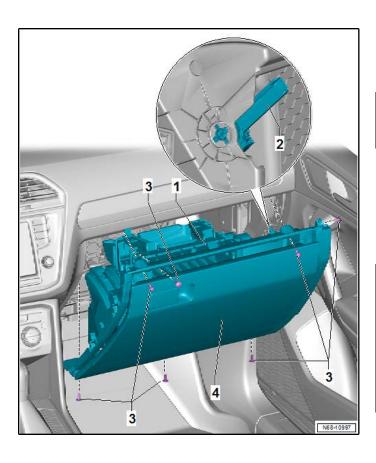
- Remove the front passenger side instrument panel side cover.
- Remove the glove compartment <1>:

Pay attention to dampening mechanism <2> when removing glove compartment. It and its attachment point on the glove compartment are fragile and can be easily broken if care is not taken when removing the glove compartment. Damage to the dampening mechanism or the glove compartment will not be covered under this action.

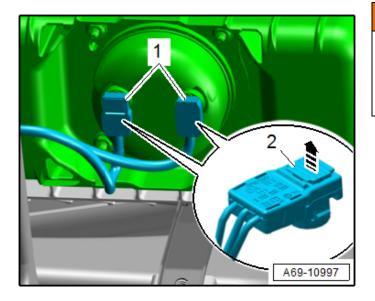
- Release the connector locks <2> with a small screwdriver in direction of <arrow>.
- Disconnect the connector <1> on the Front Passenger Airbag Igniter 1 -N131- and Front Passenger Airbag Igniter 2 -N132-.

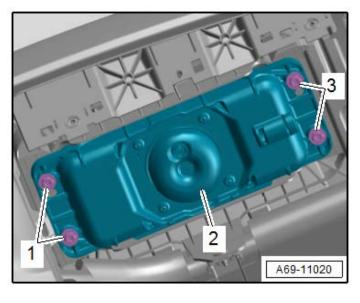
Support the Front Passenger Airbag Unit <2> to prevent it from falling out.

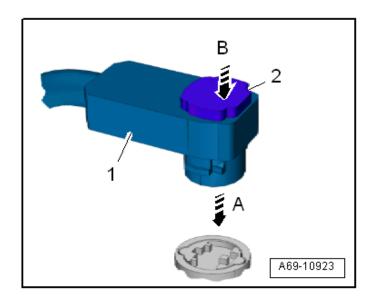
- Connect airbag igniter connectors:
  - Connect the connector <1> to the airbag igniter in direction of <arrow A>.
  - Press in the connector lock <2> in direction of <arrow B>. While doing this, the connector is pushed into the airbag igniter and locks into place.

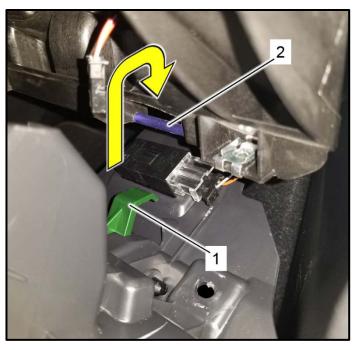
- There are two assembly aid hooks on the bottom of the glove compartment.
- Lift the hooks <1> on the glove compartment over the bar <2> on the instrument panel.

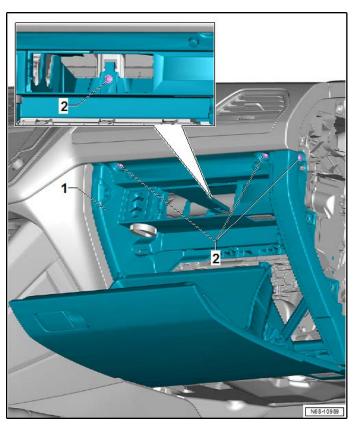
- Reconnect the glove compartment cooling hose and any other connectors.
- Secure the Information Electronics Control Module -J794- wiring harness to the glove compartment.
- Install the glove compartment and torque fasteners to 1.5 Nm.

Pay attention to dampening mechanism when installing glove compartment. It and its attachment point on the glove compartment are fragile and can be easily broken if care is not taken when installing the glove compartment. Damage to the dampening mechanism or the glove compartment will not be covered under this action.
