Safety Recall Code: 69X1

Subject	Second Row Bench Seat Safety Belt Buckles	
Release Date	June 21, 2018	
Affected Vehicles	U.S.A. & CANADA: Certain 2018 MY Volkswagen Atlas with second row bench seat	
	Check Campaigns/Actions screen in Elsa on the day of repair to verify that a VIN qualifies for repair under this action. Elsa is the <u>only</u> valid campaign inquiry & verification source.	
	✓ Campaign status must show "open."	
	✓ If Elsa shows other open action(s), inform your customer so that the work can also be completed at the same time the vehicle is in the workshop for this campaign.	
Problem Description	If a child restraint with a larger than recommended base is installed in the center position of the second row bench seat, it may damage both the center and adjacent outboard safety belt buckles. A damaged safety belt buckle can release unexpectedly, increasing the risk of injury to vehicle occupants in a crash.

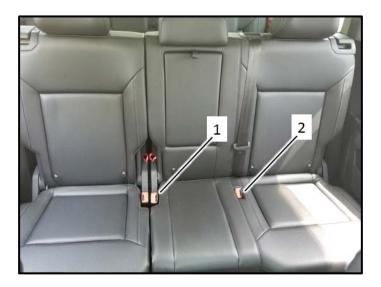
- Inspect center passenger <1> and left passenger <2> seat belt buckles on the bench seat.
- A flashlight should be used to aid in the inspection.
- If the buckle is damaged, it must be replaced.

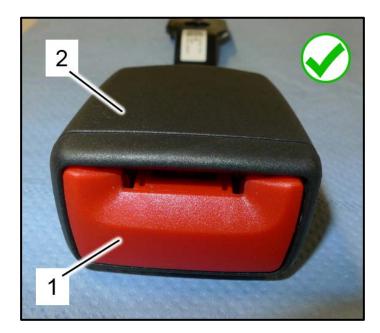
Examples of acceptable seat belt buckles:

- The release button <1> is flush with the buckle housing <2>.
- The housing <2> is not deformed or separated.

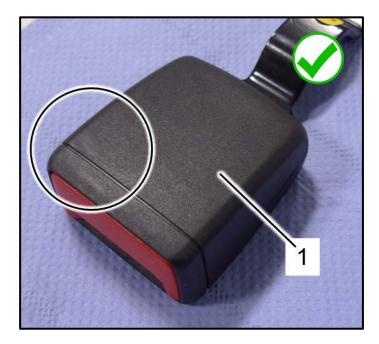
- The housing <1> may show scuff marks or other indications of normal usage (surface scratches, for example).
- These marks are not an indication of damage and the buckle will not require replacement.
- If no damage to the buckle is found, place owner's manual supplement in glove compartment and Proceed to Section E.

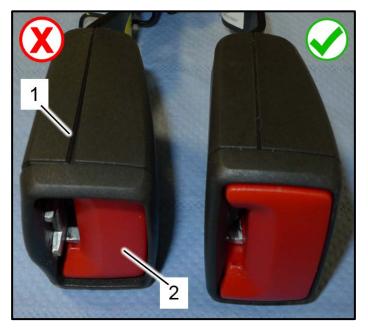
The housing is deformed on the top in the area of the release button.

The housing is broken or split <1>. •

AND/OR

The button no longer returns to the released • position <2>.

- If any of the following scenarios are found:
 - The affected seat belt buckle must be replaced.
 - The vehicle should be grounded until parts arrive.
 - A <u>VTA Web ticket</u> must be created to order a new seat belt buckle.
- See Section C and/or Section D for seat belt buckle replacement instructions.

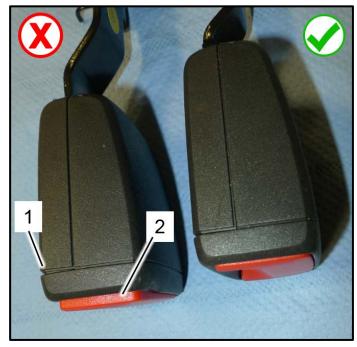
The housing is broken or split <1>. •

AND/OR

The button protrudes outside of the housing • <2>.
