L73X-R.02.18

Engine SW Update

Aventador

**To: Official After Sales Network**  
**Subject: Engine SW Update**  
**Date: 05 October 2018**  
**Pages 10**

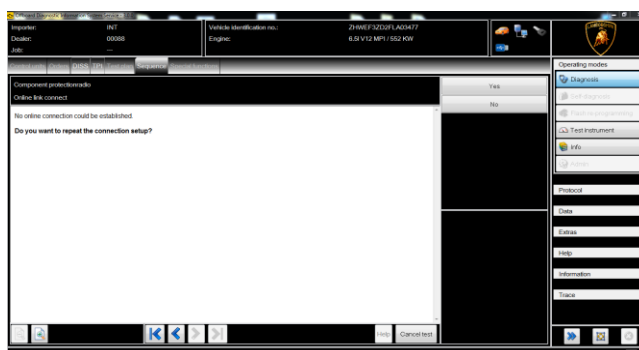
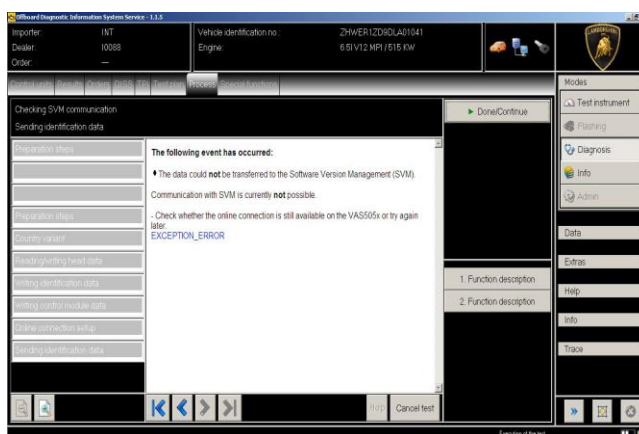
C. If one of the connection error screens is shown as in the pictures below:

- It is not possible to establish a connection with the central server. Please check carefully that the diagnosis laptop is properly connected to the internet network and retry clicking “Yes” or “Done/Continue”.

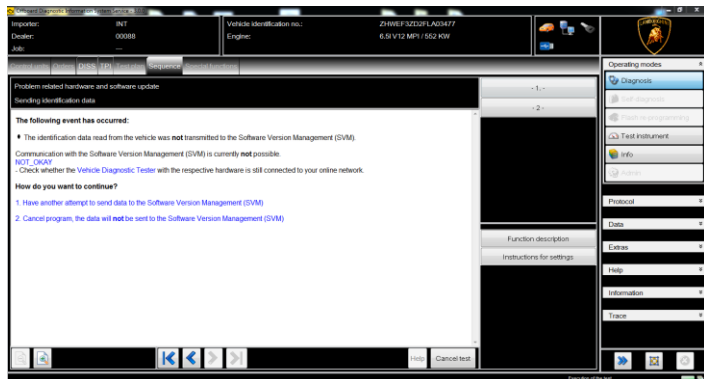
D. If the loss of connection happens during the target/actual comparison during SVM procedure:

- It is not possible to connect to central server, check the working connection of internet and retry by clicking “1”.

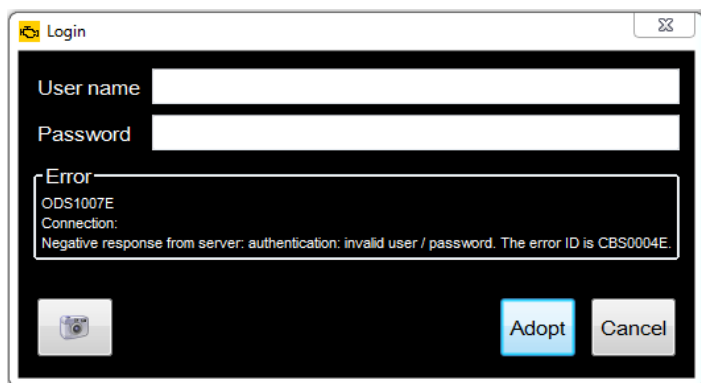
E. If the incorrect identification message is shown as in the picture below (error code: ODS1007E):

- Check that your Geko account is valid;
- Check that the label “Geko” is written on the token that you are using for the authentication;
- Check if the Password inserted is correct;
- Click on Cancel and perform the application test (see document “ODIS\_Checking\_ConnectionServer\_SVM\_2.0” (\*)).

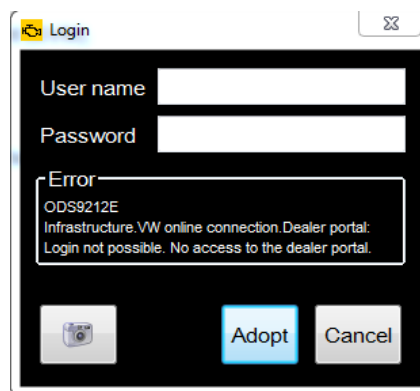
F. If the infrastructure error message is shown as in the picture below (error code: ODS9212E):

- Check that your Geko account is valid;
- Check that the label “Geko” is written on the token that you are using for the authentication;

- Check if in ODIS settings you have “Internet” instead of “CPN” (see document “ODIS\_Initial\_Setup\_2.0” (\*));
- Click on Cancel and perform the application test (see document “ODIS\_Checking\_ConnectionServer\_SVM\_2.0” (\*)).
