SAFETY RECALL 18V-408 Retrofitting Bearing Support for Side Stand

SI 46 002 18R2

**G 310 R (K03, 0G11),
G 310 GS (K02, 0G12)**

Service Information No. SI 46 002 18R2

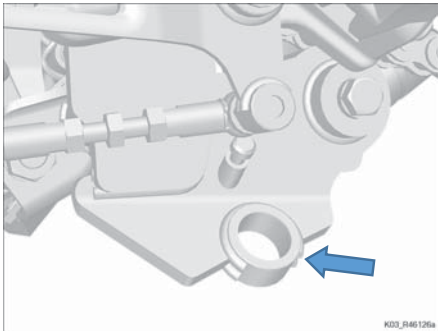
In the course of quality analysis BMW Motorrad has determined that the side stand bearing support can bend, or in an extreme case even break. The side stand bearing support is to be checked for damage and an additional reinforcement will be installed.

The frame that is to be repaired can be identified by a welded on bearing support for the side stand. The new frame has a continuous steel plate with a ring on it. See pictures on pg.3

Figure 1: G 310 R old bearing support for the side stand (arrow).
(Part number: 46 51 8 554 145)

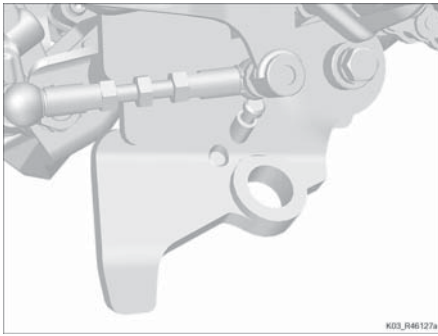
Figure 2: G 310 R new bearing support for the side stand.
(Part number: 46 51 8 414 455)

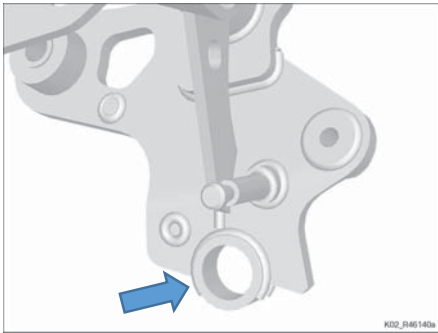
Figure 3: G 310 GS old bearing support for the side stand (arrow).
(Part number: 46 51 8 562 028)

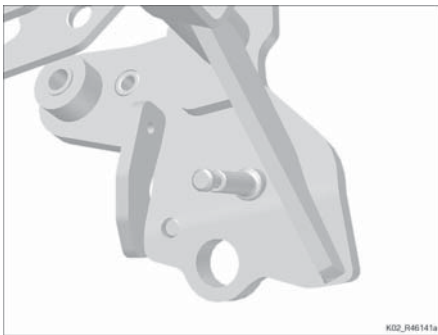
Figure 4: G 310 GS new bearing support for the side stand.
(Part number: 46 51 9 480 423)

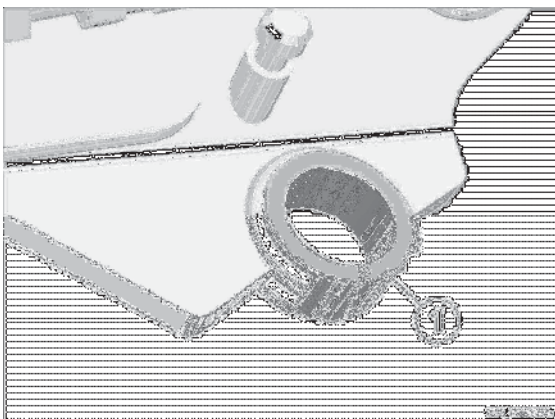
6

- ◆ Check the bearing bush **(1)** for cracks and deformation.

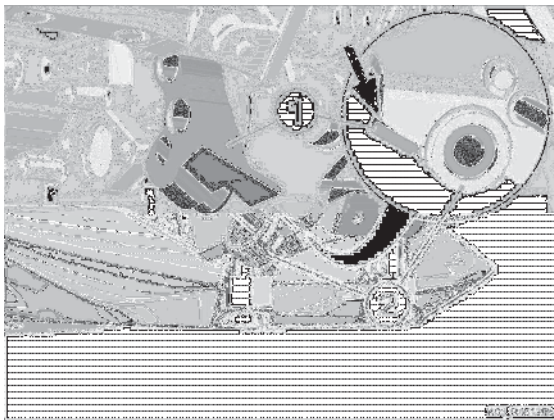
- ◆ Insert drilling template **(1)** in bearing bush **(2)**.
- » Drilling template must rest against the frame stop **(arrow)**.

Bearing bush has cracks or is deformed/drilling template does not fit.

- ◆ Create a Puma case, do not carry out any repairs.

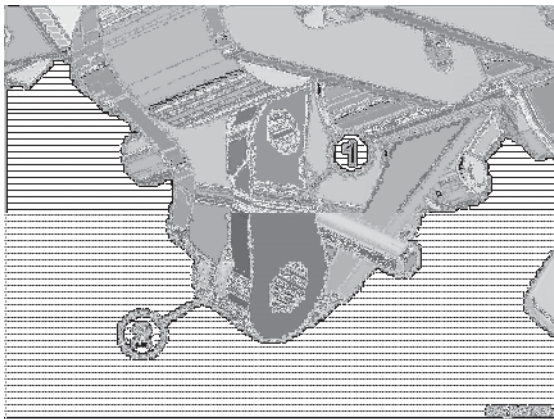
- ◆ Check if bearing support **(1)** can be inserted into bearing bush **(2)** from the inside.

Bearing bush is damaged or deformed.

- ◆ Create a Puma case, do not carry out any repairs.

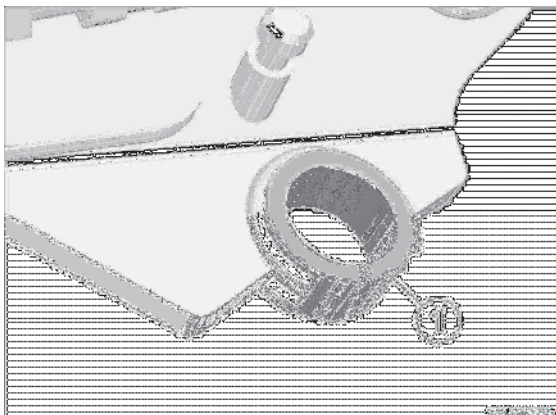
7

- Check the bearing bush (1) for cracks and deformation.

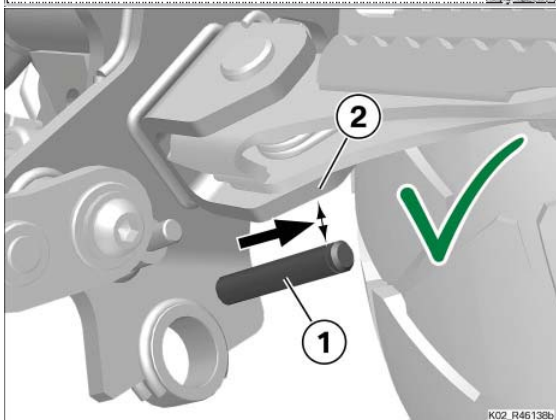
- Check if there is distance between bolts (1) in the footrest bracket (2).

Distance is not there (bolts/footrest bracket have contact) or the bearing bush is damaged/deformed.

- Create a Puma case, do not carry out any repairs.
