# Recall Bulletin 180618REV

Fleetwood Flair and Holiday Rambler Admiral, Model 28 A only, manufactured April 26, 2018 through June 1, 2018

**SUBJECT:**  
Inspection / Correction of Wire Harness Routing for Nightstand 120-Volt Receptacle

**ISSUE DATE:**  
July 2018

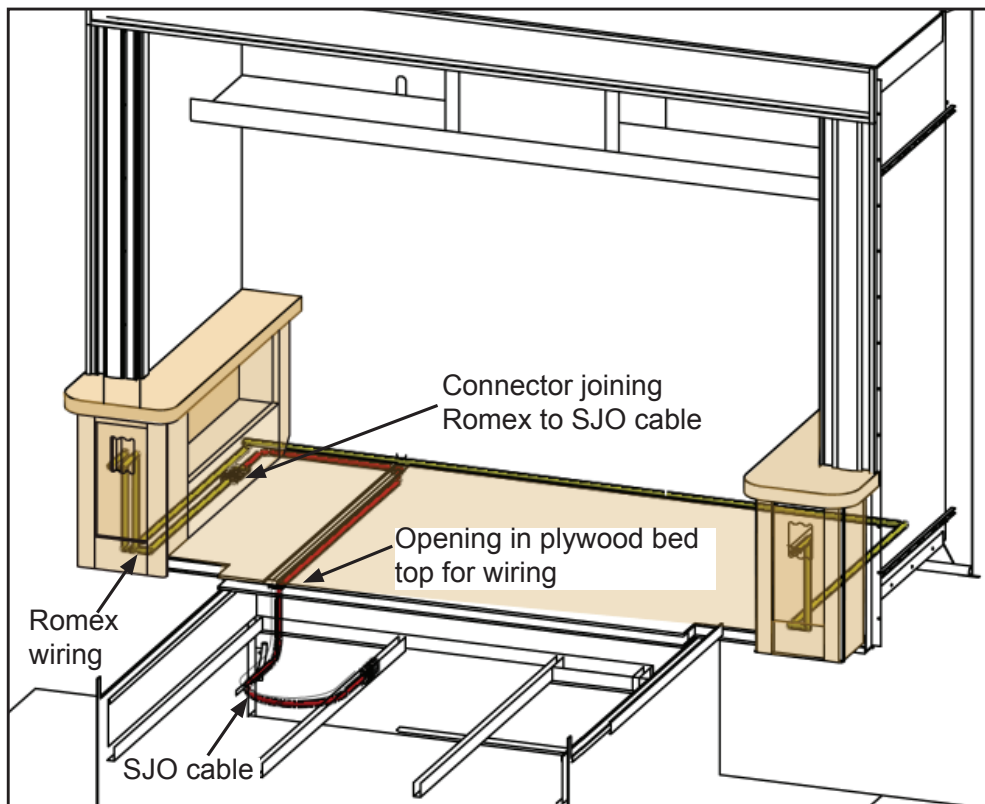
Figure 1

On certain Admiral and Flair model 28 A motorhomes affected by this recall, the 120-Volt wire harness for a nightstand receptacle in the bedroom was not routed properly. Non-flexible Romex wiring was erroneously routed from the stationary bed base to the nightstand receptacle instead of the required flexible-sheathed SJO cable.

The Romex may become damaged as a result of extending and retracting the slide-out. If the Romex wiring is damaged, an electrical short could result, posing the risk of fire which may result in property damage, injury, or death.

6. Carefully loosen and remove the top from the rear bedroom nightstand by pulling it straight out, away from the wall. Set this component aside for reassembly.  
Note: The nightstand top is not fastened with nails, but it may need to be tugged hard in several places to free it from molding and/or caulk.
7. Remove the screws fastening the rear nightstand base to the wall, allowing it to be moved as needed during repairs. Retain screws for reinstallation.
8. Disconnect the Romex from the rear nightstand's 120-Volt receptacle, and then remove the 120-Volt receptacle from the nightstand. Set the receptacle aside for reassembly.

Route the wire harness up and through the nightstand, until the connector between the Romex wiring and the SJO cable comes out through the opening in the plywood bed top. Continue to tug on the wire harness until the connector between the Romex and SJO cable is located inside the false bottom of the nightstand. The excess Romex should extend through the receptacle opening in the nightstand, until it is trimmed in the next step.

11. Use wire cutters to shorten the Romex, removing the slack that was created when performing Steps 8-9. Strip 3/4" of jacket insulation from the Romex wires, and then reconnect the Romex to the receptacle.

12. Use nylon wire ties or insulated loop clamps to secure the Romex and the SJO cable every 12" inside the false bottom of the nightstand. The Romex must be secured within 12" of the 120-Volt receptacle.

13. Reinstall the 120-Volt receptacle and fasten it into position.
14. Ensure the SJO cable exits the false bottom of the nightstand through the notch in the nightstand framing.
