Safety Recall

Code: 69R7

Audi

Subject	Passenger Frontal Airbag (Takata)
Release Date	March 03, 2022
Revision Summary	<u>USA ONLY</u> Updated Rental Car/Loaner claiming labor number
Affected Vehicles	U.S.A. & Canada: Certain 2005-2011 MY Audi vehicles <i>Check Campaigns/Actions screen in Elsa on the day of repair to verify that a VIN qualifies for repair under this action. Elsa is the <u>only</u> valid campaign inquiry & verification source.</i> <ul style="list-style-type: none">✓ Campaign status must show "open."✓ If Elsa shows other open action(s), inform your customer so that the work can also be completed at the same time the vehicle is in the workshop for this campaign.
Problem Description	The passenger frontal airbag may explode in a crash with airbag deployment. Sharp metal fragments can hit people and cause serious injury or death.
Corrective Action	Replace the passenger frontal airbag with a newly manufactured version. This is considered to be the final repair for these vehicles.

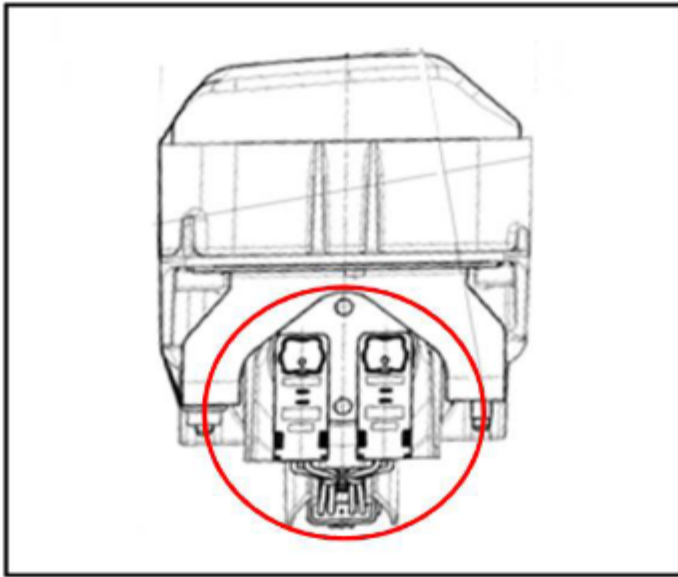
- If the passenger airbag inflator connectors are configured side by side <as shown>, the airbag was not manufactured by Takata and NO further work is required:
 - Reassemble glove box and **Continue to Section E.**

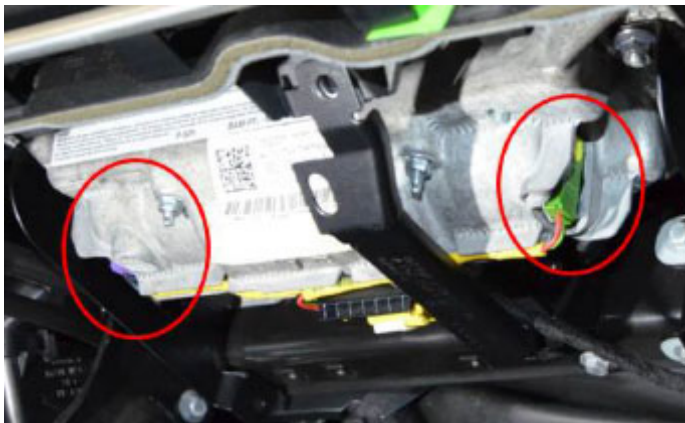
- If the passenger airbag inflator connectors are configured on the ends <as shown>, the airbag was manufactured by Takata and will require replacement.

Continue to Section C.
