# Safety Recall

## Code: 60D1

<b>Subject</b>	<b>Panoramic Sunroof Ambient Light Bar (LED Module)</b>
<b>Release Date</b>	February 16, 2019
<b>IMPORTANT! Revision Summary</b>	<ul style="list-style-type: none"><li>• <b>Work procedure updated to install in-line fuses for panoramic sunroof LED module.</b></li><li>• <b>Claiming instructions updated</b></li><li>• <b>Customer letters revised</b></li></ul>
<b>Affected Vehicles</b>	<b>U.S.A. &amp; CANADA: Certain 2018 MY Volkswagen Tiguan with Panoramic Sunroof &amp; Ambient Lighting</b>  <i>Check Campaigns/Actions screen in Elsa on the day of repair to verify that a VIN qualifies for repair under this action. Elsa is the <u>only</u> valid campaign inquiry &amp; verification source.</i> <ul style="list-style-type: none"><li>✓ <i>Campaign status must show "open."</i></li><li>✓ <i>If Elsa shows other open action(s), inform your customer so that the work can also be completed at the same time the vehicle is in the workshop for this campaign.</i></li></ul>

**Subject: Safety Recall 60D1 - Panoramic Sunroof Ambient Light Bar (LED Module)  
Certain 2018 Model Year Volkswagen Tiguan with Panoramic Sunroof & Ambient Lighting**

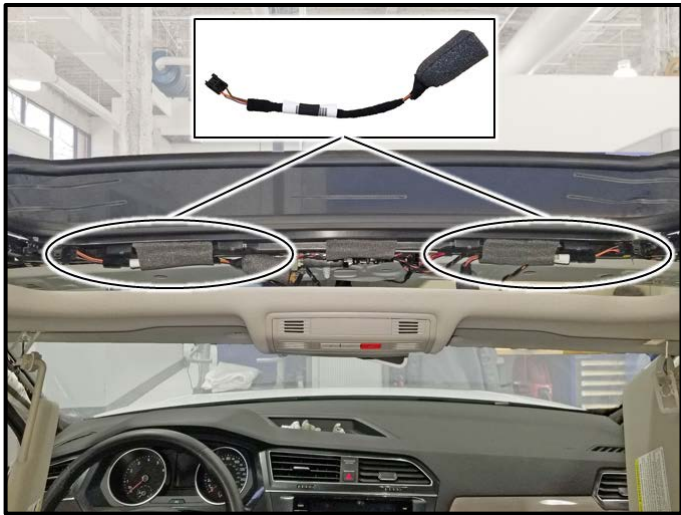
<b>Problem Description</b>	High humidity in the panoramic sunroof ambient lighting bar LED module (caused by environment or by leaving the sunroof open) could lead to a local short circuit. If this happens, there is a risk of a fire.
<b>Corrective Action</b>	Install in-line fuses for the left and right panoramic sunroof ambient light LED modules.  Vehicles that had already been repaired under this action (disconnect power to module) will be included in a future service action under a new campaign code.
<b>Precautions</b>	A burning odor or smoke coming from the front of the sunroof frame indicates that the sunroof LED module may have short circuited.  If this happens, DO NOT continue driving and DO NOT open the sunroof. Doing so will only increase the risk of fire. Get safely away from the vehicle and dial 911 for emergency assistance. DO NOT attempt to extinguish a vehicle fire on your own.

- Install in-line fuses for the left and right panoramic roof ambient light LED modules.
