Safety Recall

Code: 60D1

| Subject | Panoramic Sunroof Ambient Light Bar (LED Module) |
| Release Date | February 14, 2019 |

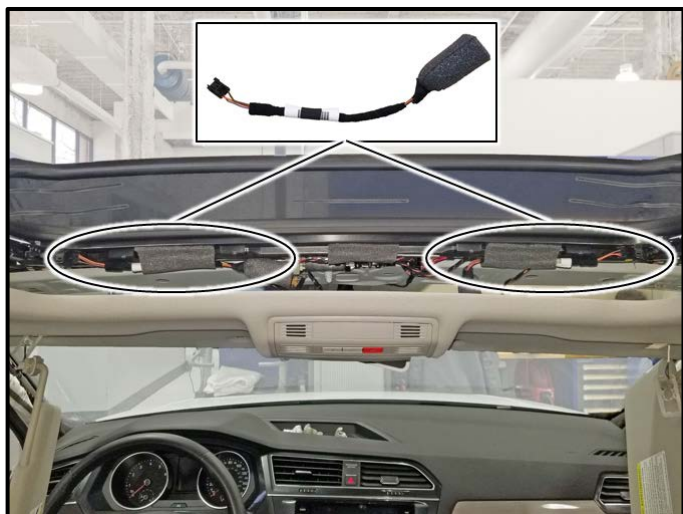
Repair Overview

| Problem Description | High humidity in the panoramic sunroof ambient lighting bar LED module (caused by environment or by leaving the sunroof open) could lead to a local short circuit. If this happens, there is a risk of a fire. |

- Install in-line fuses for the left and right panoramic roof ambient light LED modules.
