TIS Service Bulletin Page 1 of 2

DELIVERY STOP & RECALL 18V-XXX: FUEL LEVEL SENSOR

F90 (M5)

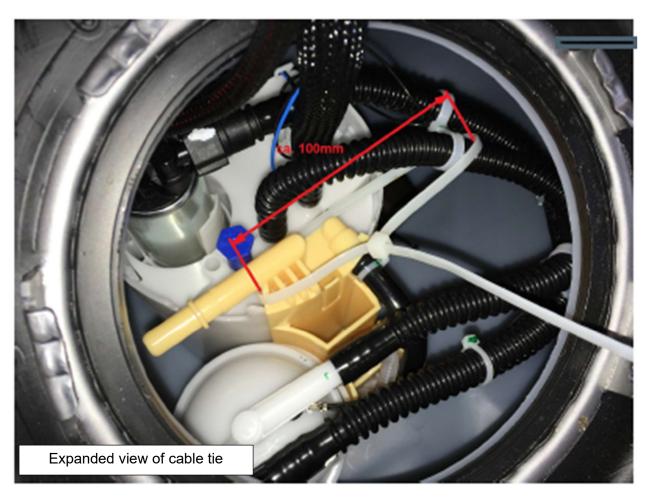
The distance between a fuel line on the fuel delivery unit (in-tank fuel pump) and the fuel level sensor is too short. The line could come into contact with the fuel level sending unit linkage. This could stop the linkage from travelling to the empty position on the sender.

Proper placement of cable tie (fuel pump removed for clarity) Correctly installed cable tie Incorrectly installed cable tie

Install a cable tie to the in-tank fuel line to prevent the fuel line from coming in contact with the fuel level sending unit linkage.

- Install cable tie (1) (PN 61 13 1 382 243) as shown in picture between corrugated hose and pump bracket.
- The cable tie has to be tightened to a distance of 100mm.
- Cut the cable tie end to size
- Check if fuel sending level unit linkage swings free
