August 2018  
FL781A  
NHTSA #18V-487  
Transport Canada #18-386

## Subject: Business Class M2 Steering Shafts

**Models Affected: Specific Freightliner Cascadia Business Class M2 vehicles manufactured December 1, 2017, through May 30, 2018, and built at the Santiago, Mexico, manufacturing plant.**

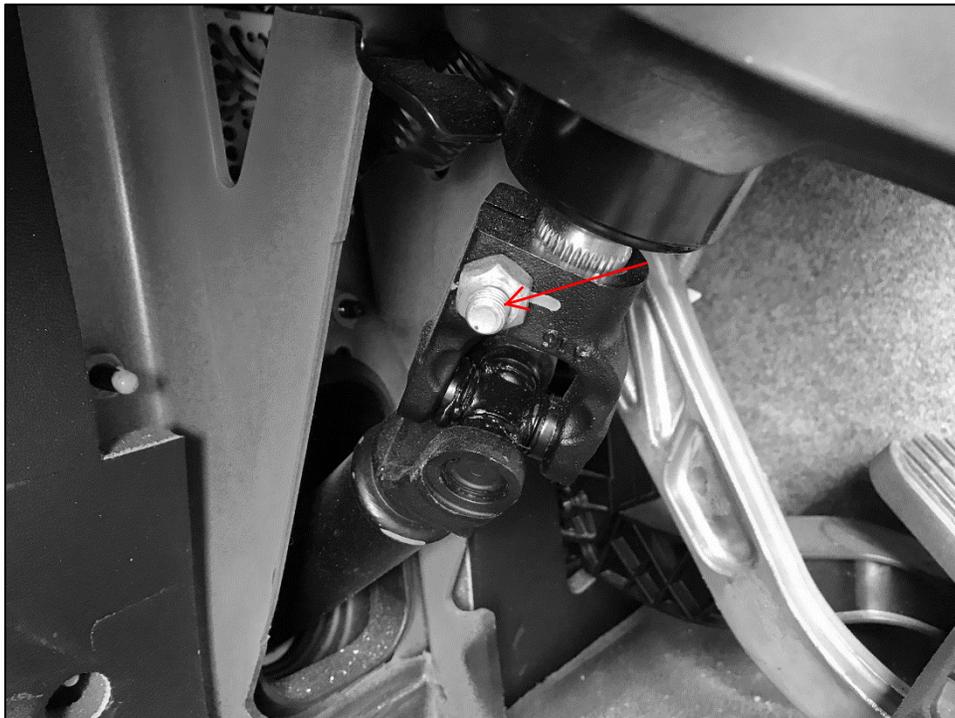
Figure 1, Steering Pinch Bolt

1. Park the vehicle on a level surface, shut down the engine, and set the parking brake. Chock the rear tires.
2. Locate the steering shaft inside the cab, as shown in **Figure 1**.
3. Look at the connections between the steering column and steering shaft, and the nut to pinch bolt connection, as indicated in **Figure 1**. It may be necessary to remove a cover plate to see the bolt.

4. First, inspect the nut to pinch bolt connection. There must be bolt threads exposed beyond the nut as shown in **Figure 1**.

If threads **are not** visible, DO NOT drive the vehicle. Have it immediately towed to the nearest DTNA dealership for repair.

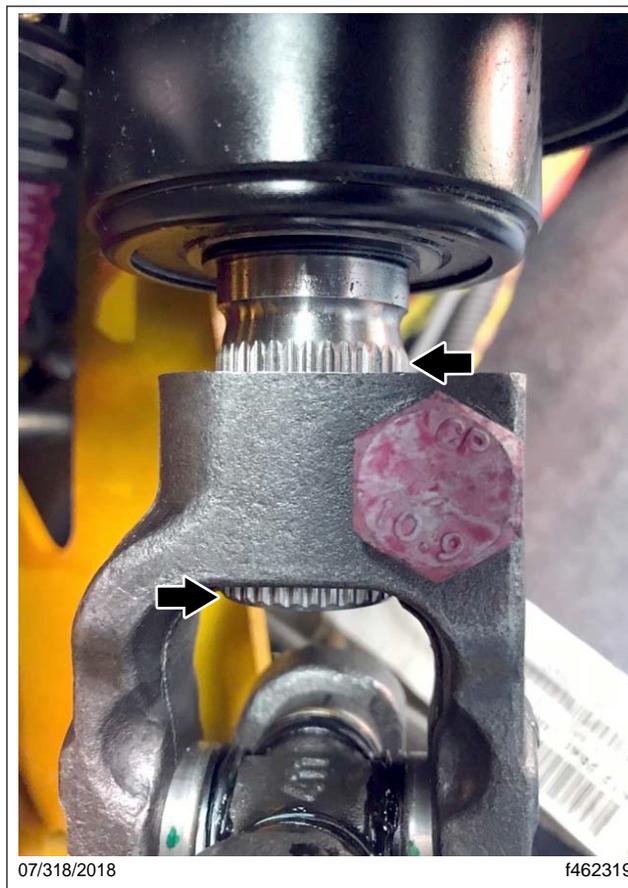
**Fig. 2, Steering Shaft Splines**

5. Second, inspect the exposed splines of the steering shaft connection as shown in **Figure 2**. It may be necessary to turn the steering wheel to gain adequate visibility of the splines.

If the steering shaft splines **are not** visible on both sides of the bolted connection, DO NOT drive the vehicle. Have it immediately towed to the nearest DTNA dealership for repair.

If the steering shaft splines **are** exposed on both sides of the bolted connection, the vehicle may be driven to the nearest DTNA dealer for the formal inspection and to complete the recall.

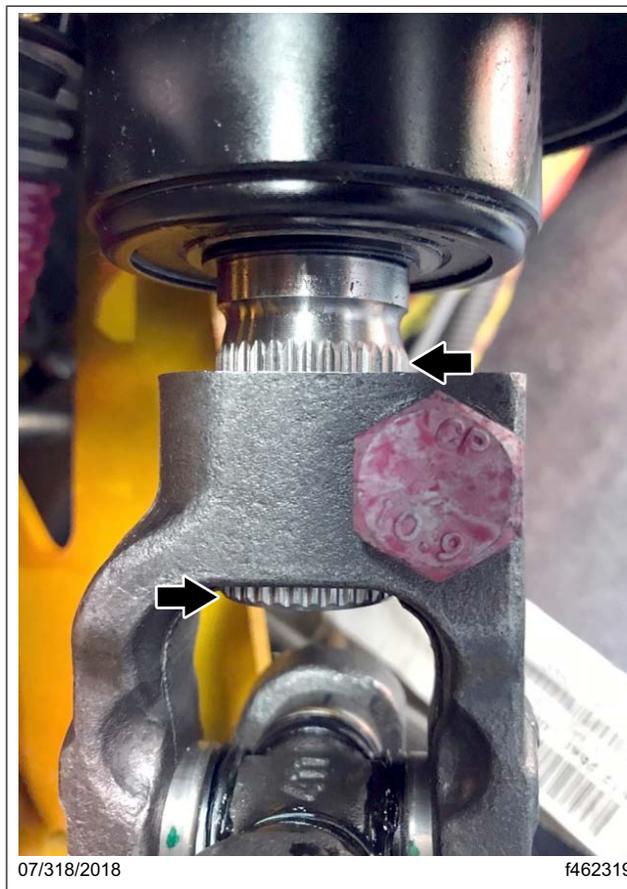
Fig. 1, Steering Shaft Splines

1. Check the base label (Form WAR259) for a completion sticker for FL781 (Form WAR260) indicating this work has been completed. The base label is usually located on the passenger-side door, about 12 inches (30 cm) below the door latch. If a completion sticker is present, no work is needed. If a completion sticker is not present, proceed to the next step.
2. Park the vehicle, shut down the engine, and apply the parking brakes. Chock the tires.
3. Locate the steering shaft inside the cab.
4. Inspect the splines on the bolted steering shaft connection shown in [Fig. 1](#). If splines are exposed on both sides of the connection, go to step 6. If splines are not exposed on both sides of the connection, remove the nut and bolt and discard. Continue with step 5.

5. Position the shaft to align the hole with the groove in the shaft, and install a new bolt and nut.
6. Use a calibrated torque wrench and a backing wrench on the bolt head. Set the torque wrench to 33 lbf-ft (45 N·m) and tighten from the nut side.
7. Apply torque seal to the nut.
8. Clean a spot on the base label (Form WAR259), write the recall number, FL781, on a red completion sticker (Form WAR260), and attach it to the base label to show this work has been completed.
