# Thor Motor Coach Recall Repair Instructions

| Recall # | 18V-498<br>2018-397 | | |
| Description/Title: | <b>ACE 27.2 LP Rubber Hose</b> | | |
| Affected Product Line(s): | <b>Certain 2018 ACE 27.2 motorhomes</b> | | |

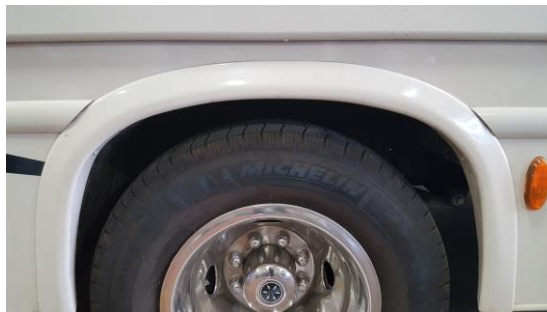
**Figure 1**

Inspect the routing of the rubber LP hose in the right rear wheel well to determine the need for additional p-clamps or relocation of p-clamps for proper securement to eliminate potential for sagging. (Figure 1)

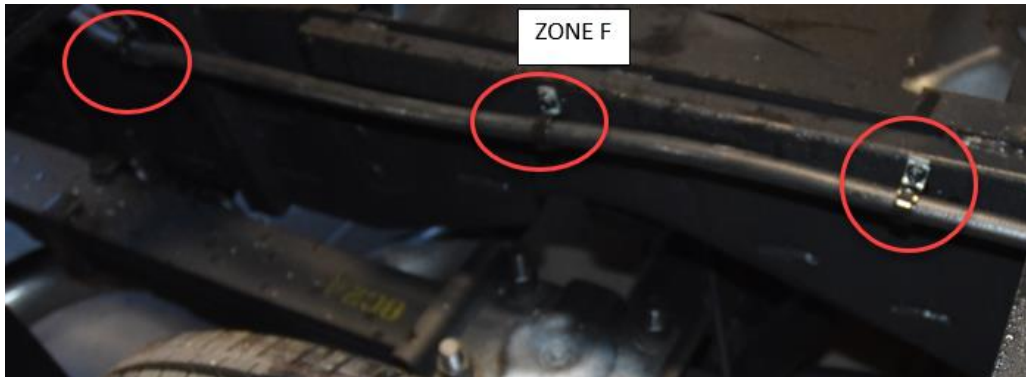
**Figure 2**

There should be a minimum of 3 clamps located in the wheel well for proper securement of the LP hose (left, center, right). (Figure 2)
