September 2018  
INT FL782-01  
NHTSA #18V-503  
Transport Canada #18-395  
**INTERIM RECALL BULLETIN**

**Subject: Detroit Steer Axle Tie Rods**

**Models Affected: Specific Freightliner 114SD, Business Class M2, Cascadia, and Coronado vehicles, and Western Star 4900 vehicles manufactured July 1, 2011, through January 30, 2014.**

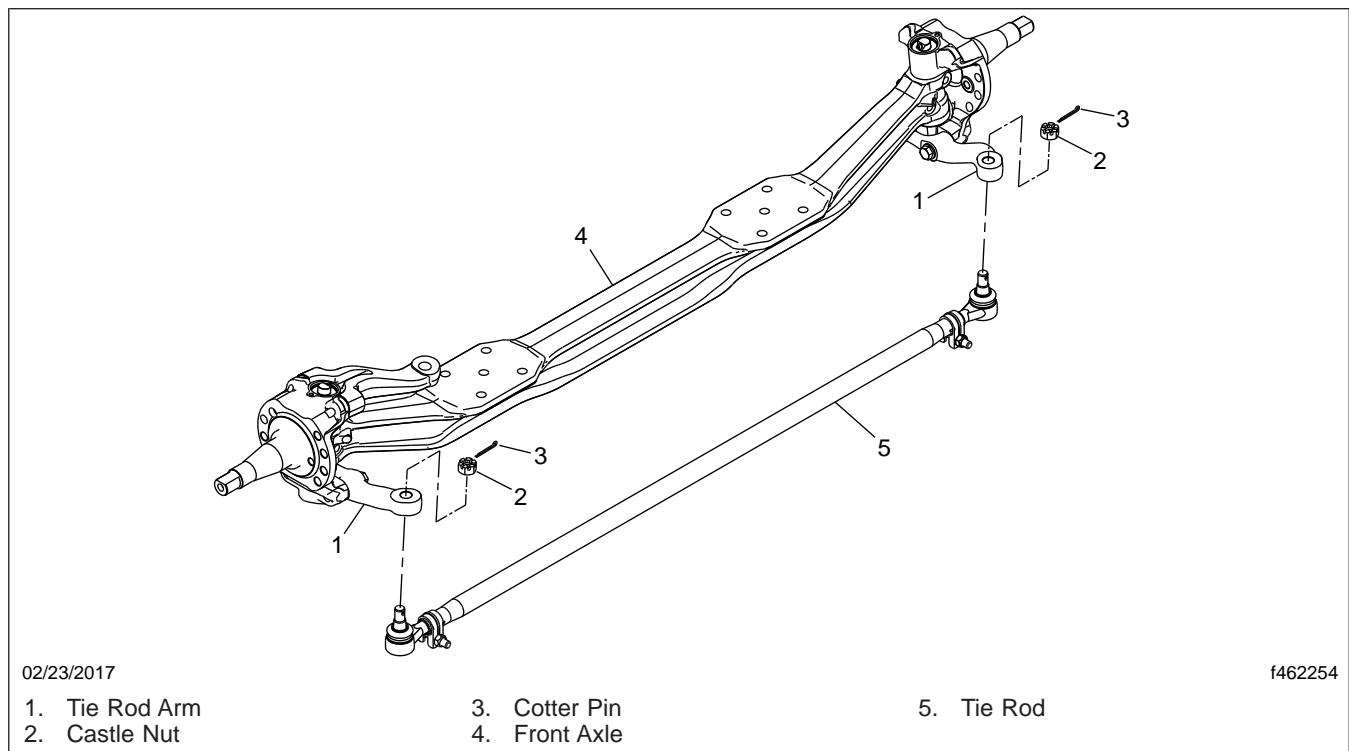
**Fig. 1, Tie Rod Assembly**

Certain vehicles manufactured with Detroit front axles and Meritor brakes may generate transient brake chatter which could lead to a fatigue failure of the tie-rod. Failure of the tie-rod could lead to a loss of vehicle control, which could increase the risk of a crash.

1. Park the vehicle on a level surface, shut down the engine, and set the parking brake. Chock the tires on the rear axle.
2. Raise the front axle and place safety stands under the frame or axle. Be sure the stands will support the weight of the vehicle.
3. Disconnect the tie rod from the tie rod arms; see [Fig. 1](#). Remove the tie rod from the vehicle and discard it.

4. Attach a new tie rod to the tie rod arms. Tighten the castle nut 120 to 170 lbf-ft (163 to 230 N·m) plus a maximum of one-sixth of a turn to align a slot in the castle nut with the cotter pin hole in the tie rod stud. Insert the cotter pin and bend the tangs to secure it.
