SERVICE BULLETIN

Classification: KS18-016a	Reference: NTB18-060a	Date: February 9, 2021
------------------------------	--------------------------	---------------------------

VOLUNTARY SAFETY RECALL CAMPAIGN MECHANICAL KEY IGNITION SYSTEM

CAMPAIGN ID #: PC642 or PM828

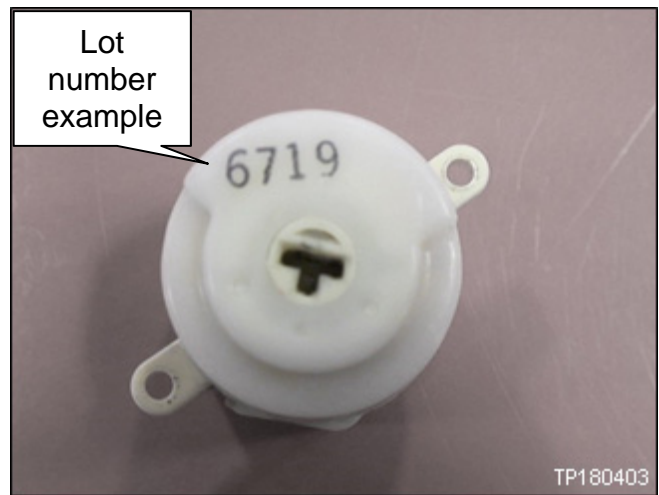
7. Record the lot number located on the back side of the ignition switch.

NOTE: Lot number shown in Figure 6 is an example. Your lot number may be different.

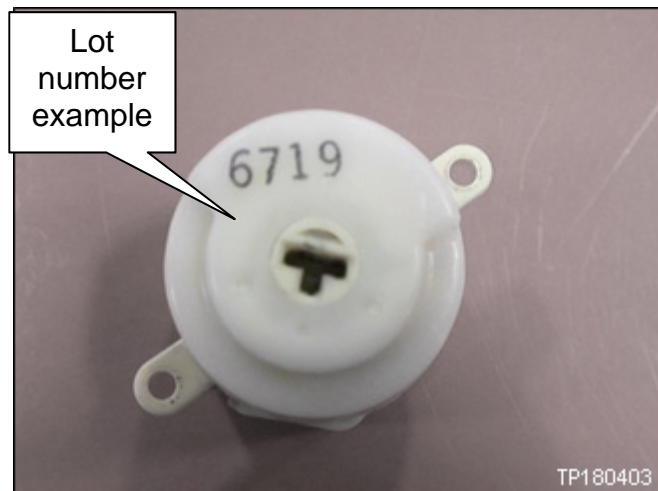
12. Record the lot number located on the back side of the ignition switch.

NOTE: Lot number shown in Figure 19 is an example. Your lot number may be different.

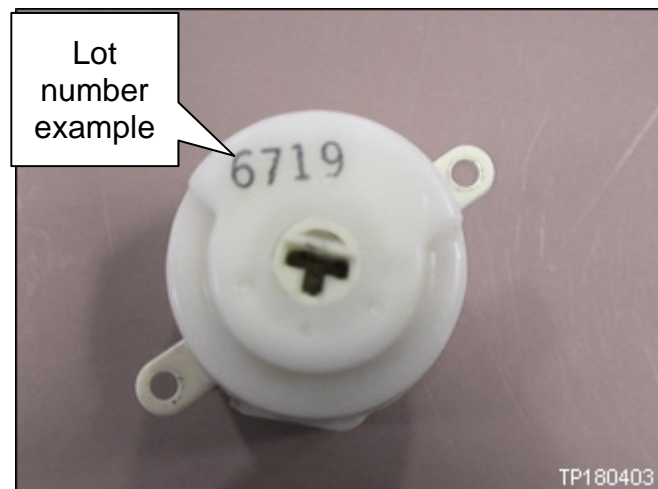
7. Record the lot number located on the back side of the ignition switch.

NOTE: Lot number shown in Figure 25 is an example. Your lot number may be different.

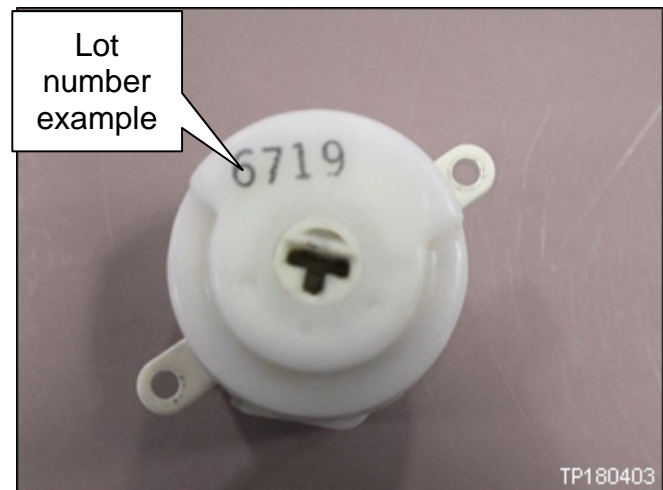
8. Record the lot number located on the back side of the ignition switch.

NOTE: Lot number shown in Figure 33 is an example. Your lot number may be different.

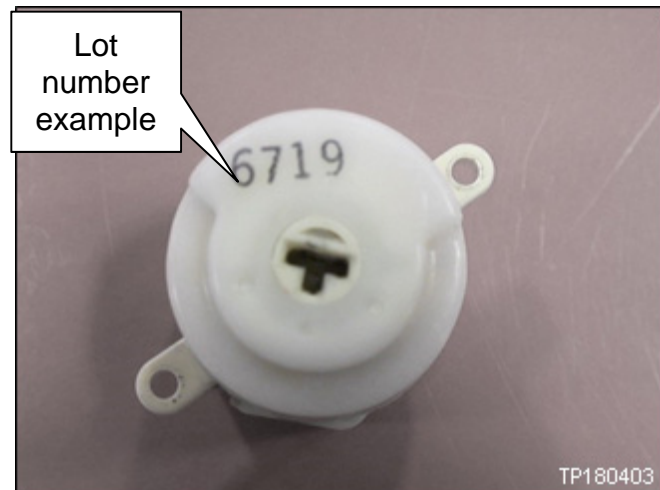
7. Record the lot number located on the back side of the ignition switch.

NOTE: Lot number shown in Figure 40 is an example. Your lot number may be different.

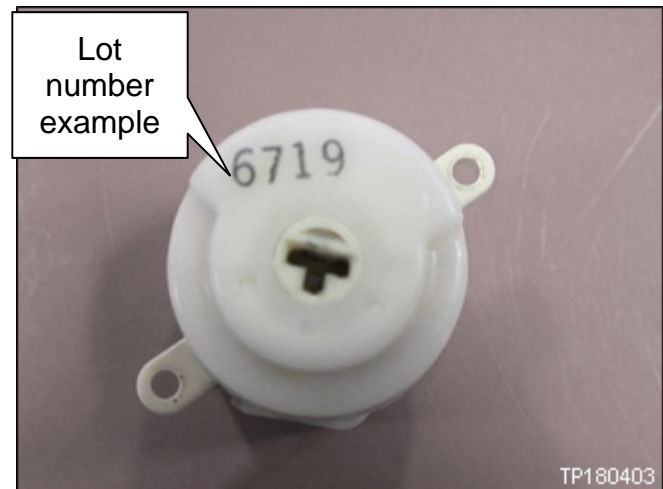
14. Record the lot number located on the back side of the ignition switch.

NOTE: Lot number shown in Figure 54 is an example. Your lot number may be different.
