**October 27, 2018**

Version 4

## Safety Recall: 2018 Accord: Rear Backup Camera

Supersedes 18-092, dated October 16, 2018, to revise the information highlighted in **yellow**

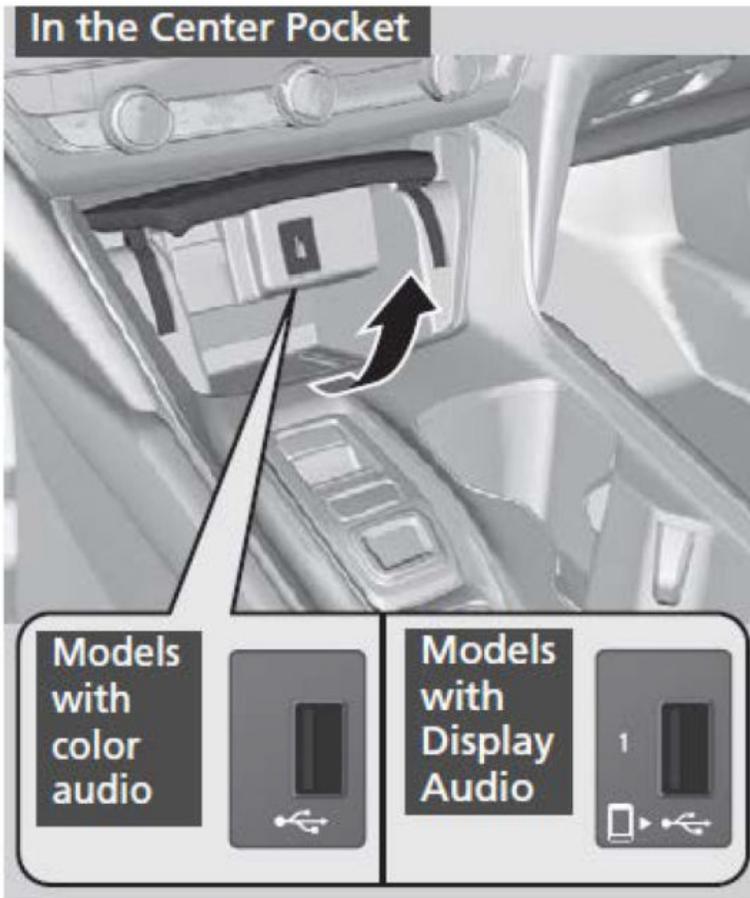
If the battery voltage drops, ignition is cycled, or the USB flash drive is removed during the update, the audio unit will be permanently damaged. If the repair procedure is interrupted at any time, you *may* be able to recover the update by performing the steps in the RECOVERY PROCEDURE section.

7. Insert the USB flash drive into USB Port 1.

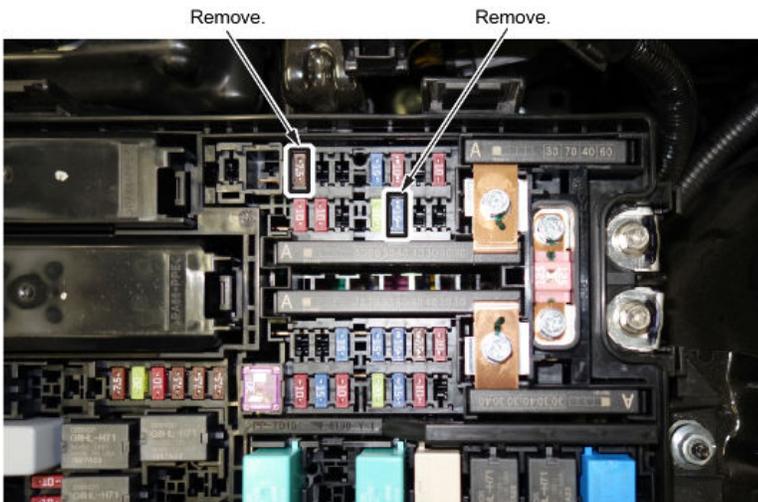
By doing this procedure, the audio unit *may* continue the update. If the audio unit is still inoperable, then the unit will have to be replaced.

1. With the engine running, pull fuses A24 (15 amp) and A35 (7.5 amp), located in the underhood fusebox, for at least 10 seconds.

2. Reinstall the fuses after the 10 seconds.
