## A. VEHICLE INSPECTION PROCEDURE

2009 Mazda6 (HP) and 2010 Mazda6 (HZ) vehicles, which were originally sold in, or currently or previously registered in Salt Belt States listed below.

### B. CROSS MEMBER INSPECTION PROCEDURE 2009-2010 MAZDA6

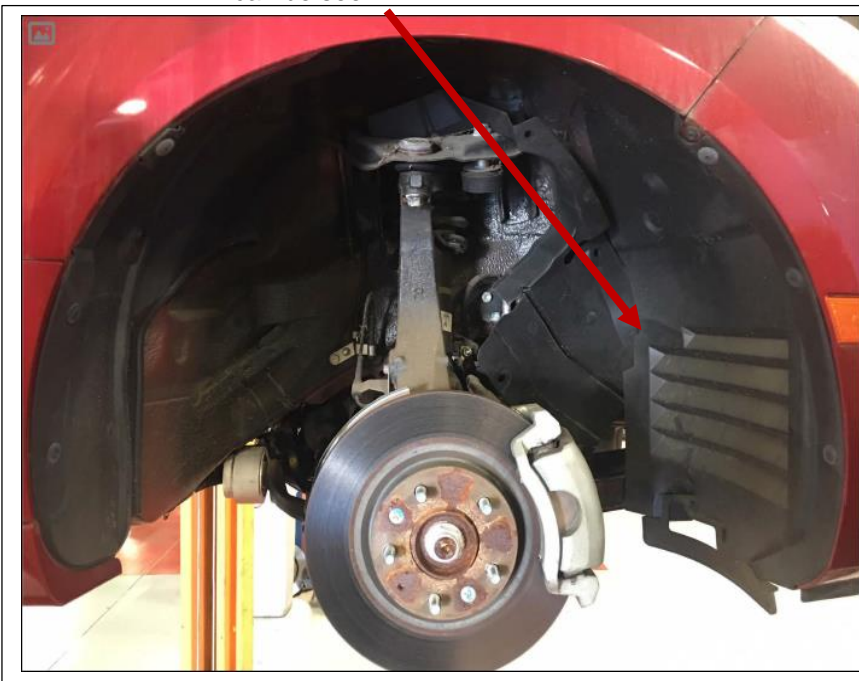
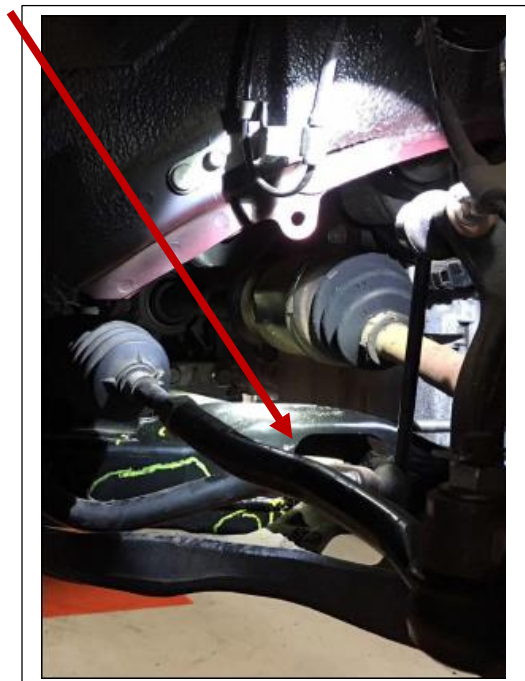
- A. Remove the right front tire.
- B. Remove **visible** clips of side cover of right front tire house.  
Then bend the side cover so that Inspection point Zone No.1: Upper surface of the cross member can be seen

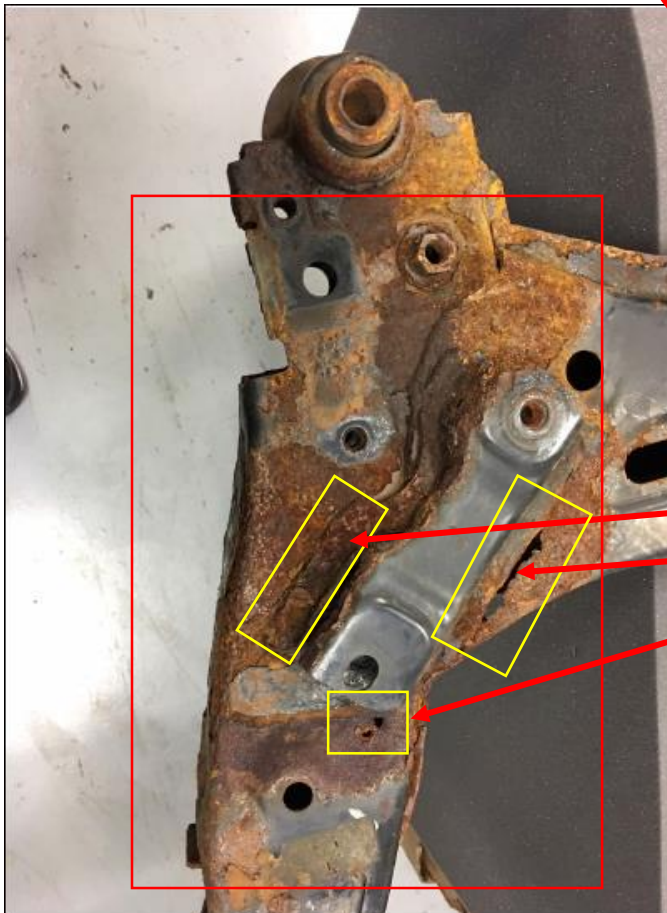
Top View: Used Cross member

Look for holes or cracks along the top surface in these areas. If a hole or crack is present, the cross member needs to be replaced. This cross member fails inspection as there is perforation

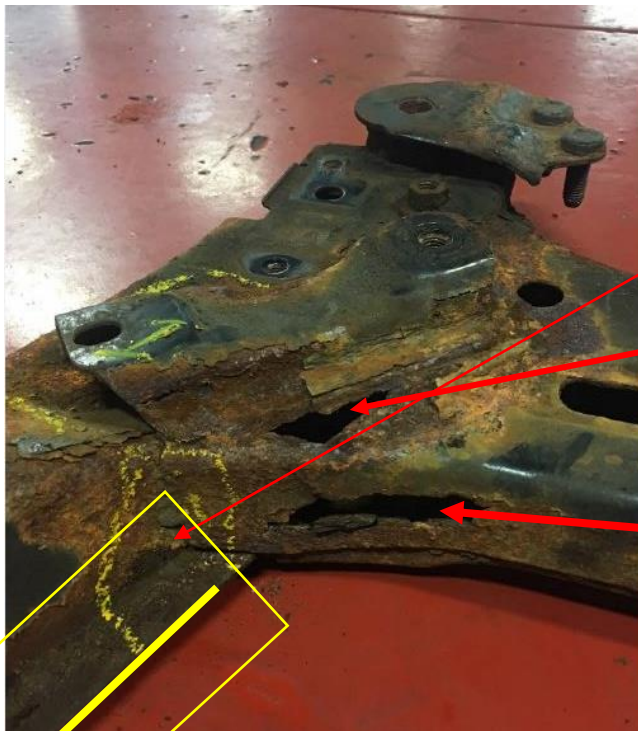
Inside Top View: Damaged Cross member

Top side Zone 1 Failure due to perforation. Replace

Corrosion or a hole in this area does not compromise the structural integrity of the cross member, however this cross member will fail a state safety inspection due to perforation so we need to replace the cross member

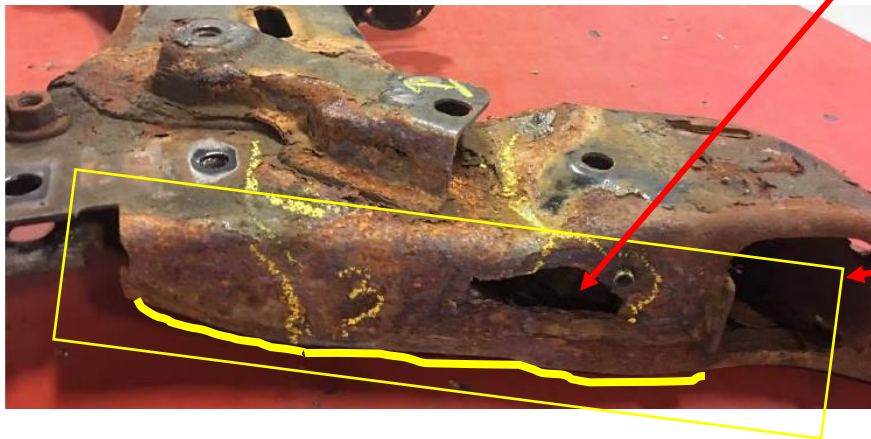
Top Side View: Damaged Cross member

This cross member passes inspection even with the perforation as the bracket supports and covers the hole. If perforation is visible beyond what the bracket covers, the cross member must be replaced as it will fail a state safety inspection for perforation.

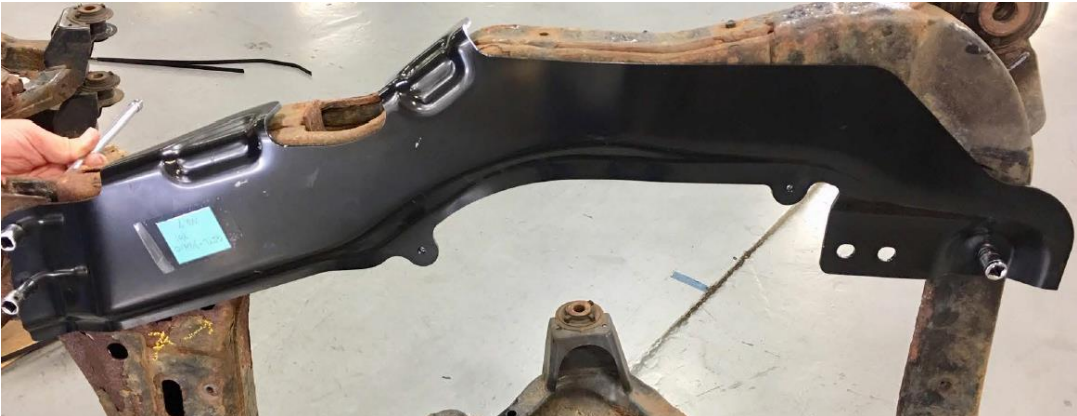
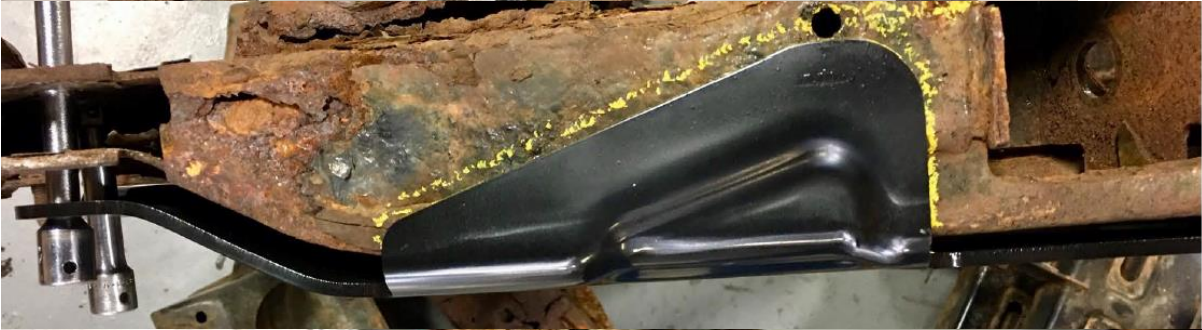
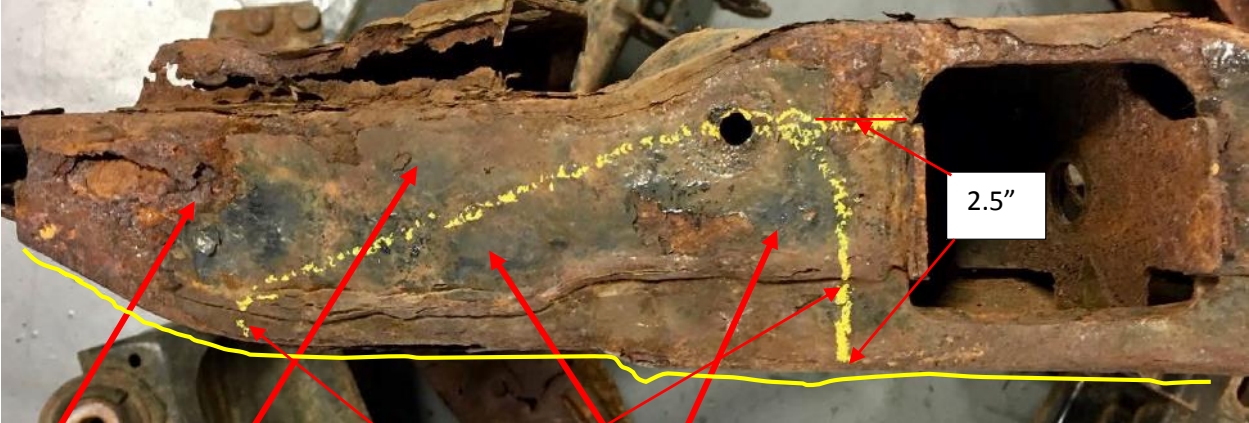
# Photos of the bracket installation

Perforation in this area is not covered by the bracket and will fail State Inspection.

6.5 " Perforation in this area is covered by the bracket and is ok to use the cross member.
