Field campaign

Topic	Infotainment unit software update (RE18/11)
Market area	United States E05 Bentley USA and rest America (6E05)
Brand	Bentley
Transaction No.	2052414/3
Campaign number	RB08
Note	
Type	
US code

Mulsanne

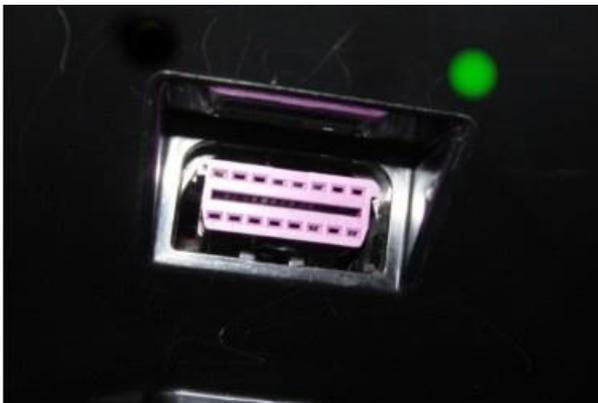
Figure 14

If the vehicle is not already listed as repaired in the "Repair history" (in Elsa pro), check for the presence of a GREEN campaign identification mark next to the OBD port (see Figure 14), should neither be evident carry out the required work in accordance with these instructions

On completion apply a GREEN campaign identification mark next to the OBD port (see Figure 14)
