# D44 Field Inspection Instructions

Date: 8/17/18	Instruction #: FI20180817-1D
Part Number: 008-407-05	Eng. Drawing Description: (D44) Hub-Drum Assembly
	TCM Description: H-D 4.4k 655, Cups & Studs

**Problem:** Possible Missing Inner/Outer Bearing Cup (Race)

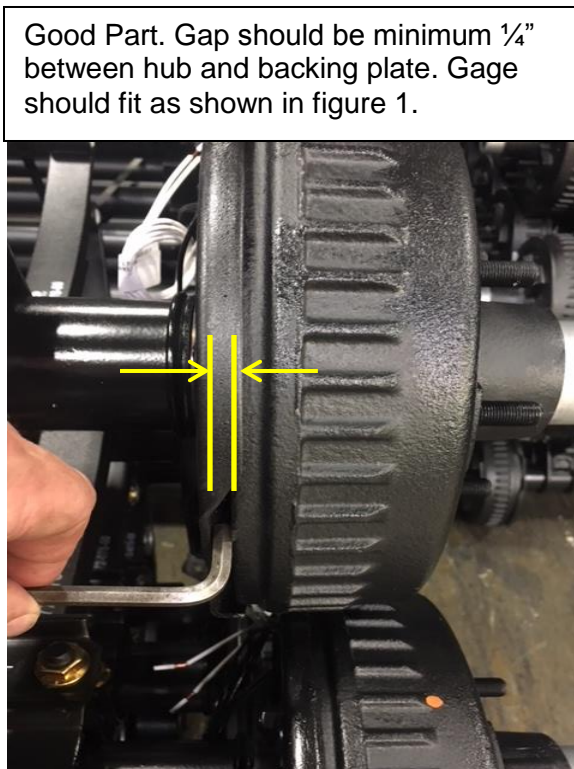
Figure 1

1. While underneath trailer, look at gap between hub-drum and backing plate in scalloped areas of backing plate. Using a  $\frac{1}{4}$ " Allen wrench as a gage, attempt to insert gage between hub –drum and backing plate, in the scalloped area of the backing plate, as shown in figure 1.

2. Determine if the gage fits (figure 1) or does not fit (figure 2) between backing plate and hub-drum.
3. Perform this measurement on both ends of axle.
4. **Note: if gage does not fit between backing plate and hub-drum, the axle will need to be REPLACED.**
