RECALL 18V678 / 2018-531 REMEDY INSTRUCTIONS

FOREST RIVER	Make(s): ROCKWOOD & FLAGSTAFF Model(s): MANY Model Year(s): 2019	Repair Code: N/A Allotted Time: N/A Inspection Code: RC-007-05--002818 Allotted Time: 50 HRS
	Concern: The brake mounting flange is incorrectly oriented (clocked) on the axles in question. The brake (mounted on the flange) is therefore also incorrectly oriented.	Photo(s) Required: YES Prior Authorization Required: YES Part(s) Kit Number: N/A Part(s) Return: NO

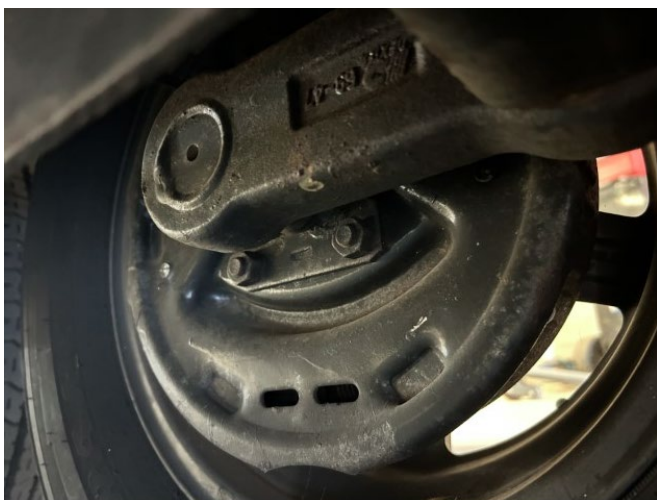
STEP 1: TAKE PHOTOS OF EACH END OF THE AXLE AS REFERENCED IN FIGURE 1 & 2 BELOW.
