Recall Service Bulletin

APPLIES TO: This Recall service bulletin applies to certain 2018 and 2019 model year K2 model motor home chassis, completed as Entegra Anthem, Aspire, and Insignia model motor homes, built between November 16, 2017 and July 27, 2018.

NHTSA/TC Id: 18V-538

CONDITION: The affected motor home chassis fail to conform to the parking brake requirements identified in Federal Motor Vehicle Safety Standard No. 121 – Air Brake Systems

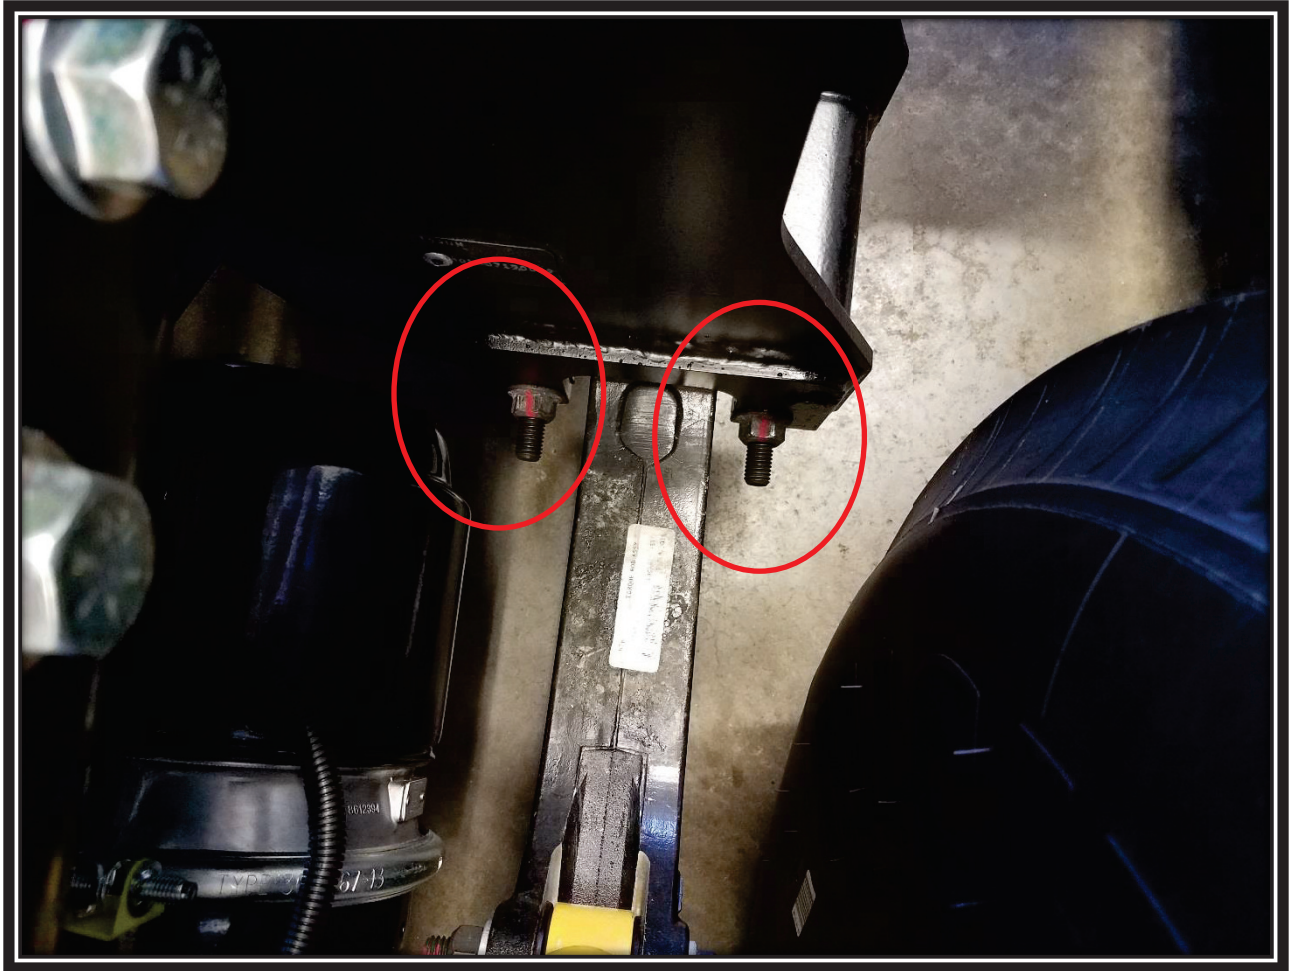
FIG. 6-1

1. Check orientation of torque rod mounting fasteners. Bolts pointing forward are incorrect. Refer to FIG. 6-1. for incorrect orientation. If bolt orientation is incorrect, proceed to step 2.

2. Remove and reinstall fastener pointing rearward. Refer to 2609-DD4. Remove only one fastener at a time, and do not disturb alignment shims. Torque nut to 178 lbf-ft.
3. Repeat for other side.
