September 2019
FL795A
NHTSA #18V-697

Subject: FCCC MT Chassis Ground Cable Studs

Models Affected: Specific Freightliner Custom Chassis MT chassis manufactured September 29, 2017, through June 14, 2018.

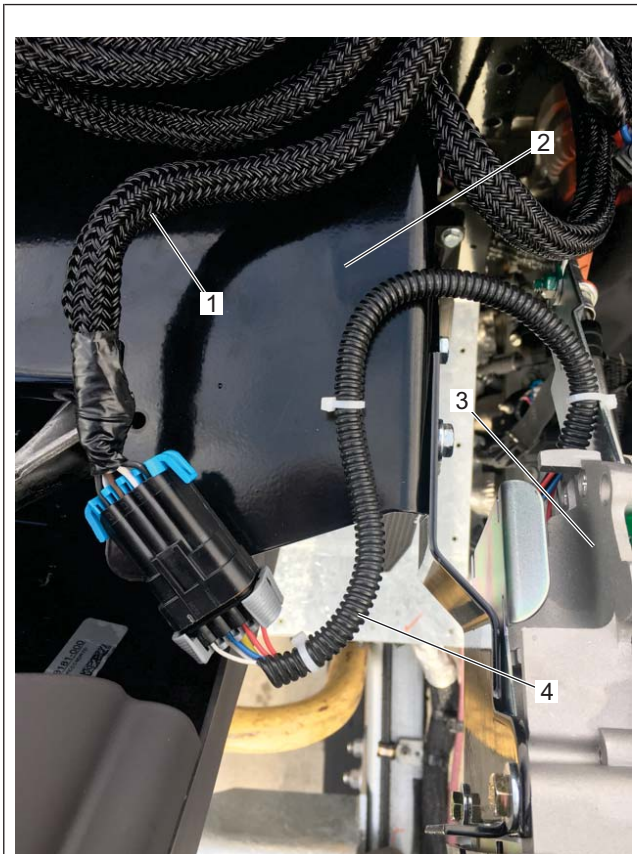
Fig. 1, Transmission Shifter Wiring

7. Turn off the headlights.
8. Disconnect the negative battery cable.
9. Remove the engine cover.
10. Inspect the wiring going to the transmission shifter for any signs of melting. This can be done by looking up between the operators station and the transmission shifter. See [Fig. 1](#).

11. If there is no backlighting on any dash components, follow normal troubleshooting procedures to repair the issue. If backlighting is present on everything except the transmission shifter, or if harness damage is found, repair the damaged wiring. For damaged wiring on the transmission shifter side, replace the transmission shifter assembly.

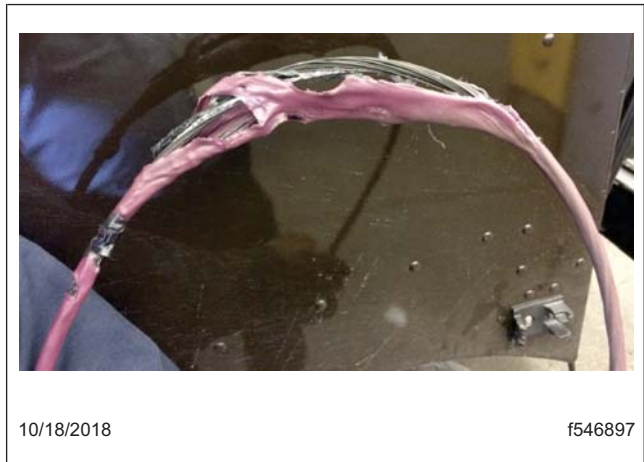
12. Inspect the entire length of the transmission shifter cable for signs of melting or heat damage. See [Fig. 2](#), [Fig. 3](#), and [Fig. 4](#).

Fig. 2, Melted Transmission Shifter Cable

13. If the transmission shifter is tight or has heat damage, replace the cable.
14. Using two wrenches, hold the ground stud and remove the locknut that retains the engine ground cable. Discard the nut and washers. See **Fig. 5**.

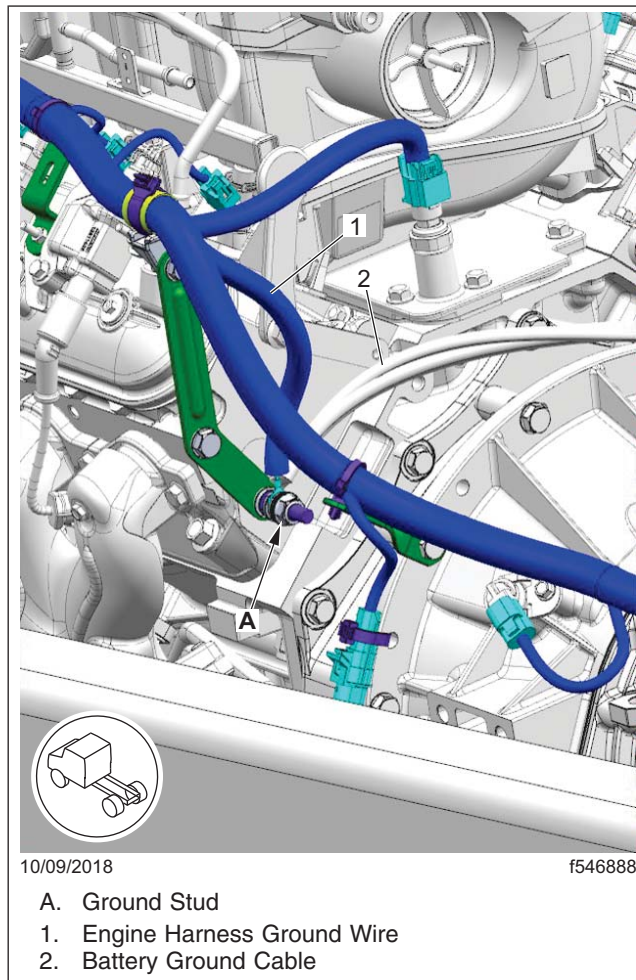
Fig. 5, Ground Cable Stud

On certain vehicles, the engine ground stud may not be properly torqued. Improper grounding of the engine ground stud could overload certain wires. Overloading of electrical wires may lead to melting, and could increase the risk of a fire.

15. Tighten the stud 37 lbf-ft (50 N·m).
16. Remove the hardware that retains the battery cable clamps and set it to the side, then discard the battery cable clamps (green in color). Cut any tie bands on the engine battery ground cable.
17. Remove the locknut on the welded stud of the frame rail that retains the engine battery ground cable and set it to the side. Remove and discard the engine battery ground cable.
