# Keystone RV Company

## SAFETY ADVISORY # 18-334

### Dexter Axle D44 Bearing Cup

# D44 Field Inspection Instructions

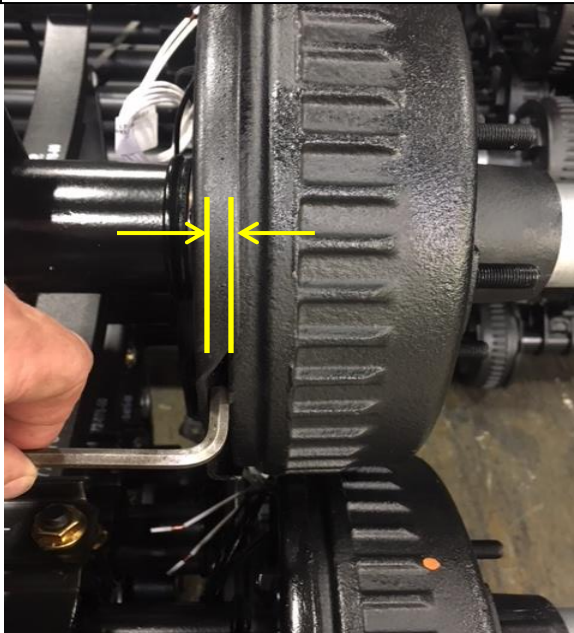
Figure 1

Good Part. Gap should be minimum 1/4" between hub and backing plate. Gage should fit as shown in figure 1.

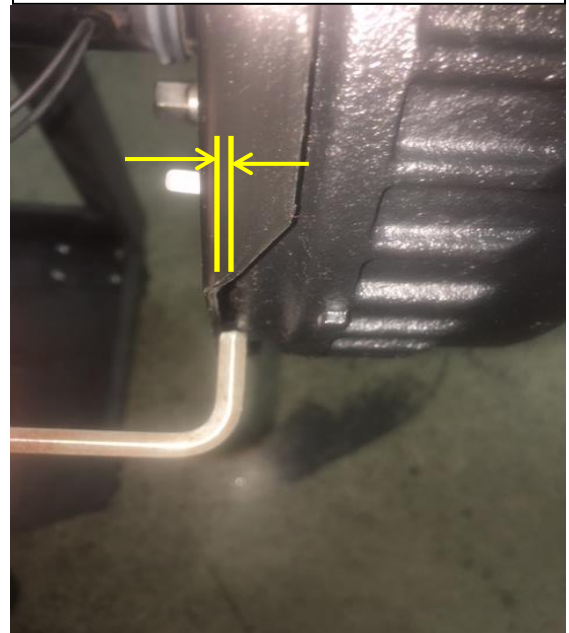
Figure 2

**Problem:** Possible Missing Inner/Outer Bearing Cup (Race)

Bad Part. Gap is too small between hub and backing plate. Gage will not fit as shown in figure 2.

2. Determine if the gage fits (figure 1) or does not fit (figure 2) between backing plate and hub-drum.
3. Perform this measurement on both ends of axle.
4. **Note: if gage does not fit between backing plate and hub-drum, the axle will need to be REPLACED.**
