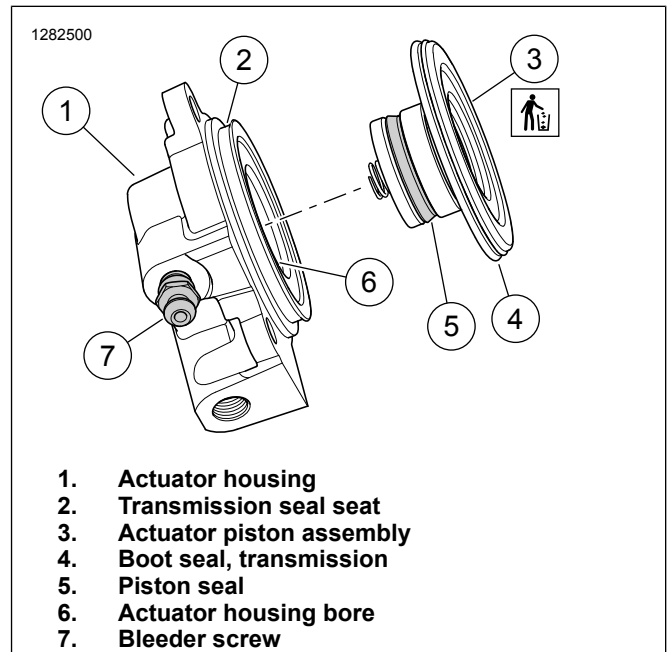
Figure 3. Secondary Actuator Assembly

To avoid scratching the transmission seal seat (2), **do not** use any tools to remove the transmission seal boot (4) from actuator housing (1).

1. See Figure 3. Remove the actuator piston assembly (3).
 - a. See Figure 4. Pinch the actuator transmission seal boot (4).
 - b. See Figure 3. Remove the transmission seal boot from the transmission seal seat (2).
 - c. Remove piston assembly from actuator housing (1).
2. Hold old actuator piston assembly per Return Parts.

2. See Figure 3. Clean actuator.
 - a. Use the provided wipe, thoroughly clean the actuator bore and transmission seal seat area (2, 6).
3. Inspect actuator bore for damage.
 - a. If damage is found, replace actuator assembly.

2. See Figure 3. Remove **new** actuator piston assembly (3) from packaging.
3. Inspect **new** actuator piston assembly for dirt or damage.
 - a. If dirty or damaged, do not use.
4. Install **new** actuator piston assembly.
 - a. Align **new** actuator piston assembly squarely to the actuator housing bore (6).
 - b. See Figure 5. Push down on center of piston until fully seated in bore.
 - c. See Figure 3. Install the transmission boot seal (4) around the transmission seal seat (2).

1. Pull in clutch lever to handlebar grip and hold for 1 min.
2. With clutch lever pulled in, verify the dial indicator reading **does not** change.
3. If reading holds, go to Complete.
4. If reading **does not** hold:
 - a. Repeat bleed procedure, and test again.
 - b. See Figure 3. If hold-in test continues to fail, remove actuator piston assembly (3) and inspect piston seal (5) and actuator housing bore (6). Refer to Clean and Inspect.
