Dealer Service Instructions for:

Safety Recall UA9 / NHTSA 18V-739 Reprogram Powertrain Control Module

2019 (KL) Jeep® Cherokee

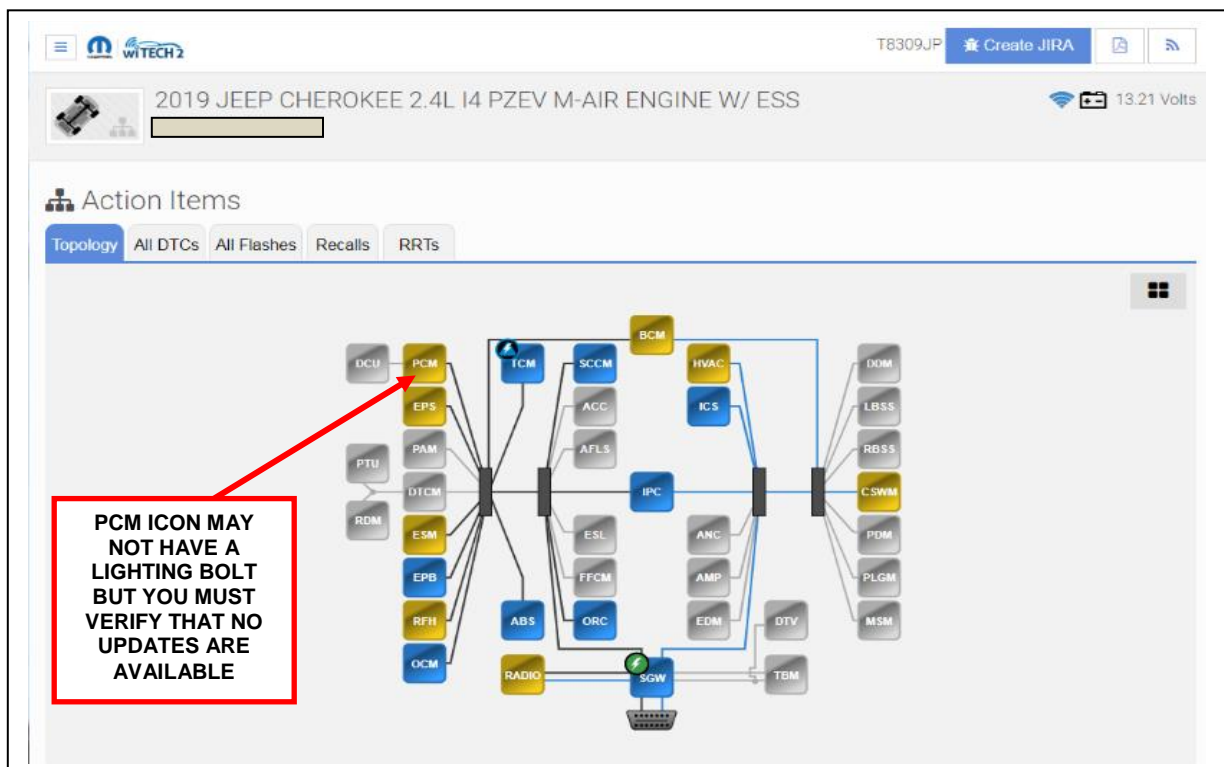
Figure 1 - Topology

SPECIAL NOTE: The “PCM” icon may not have a lightning bolt displayed but must verify that no updates are available (Figure 1).

8. From the “**Topology**” tab, select the “**PCM**” module icon.
9. From the “**Flash**” tab, compare the “**Current Electronic Control Unit (ECU) Part Number**” with the “**New ECU Part Number**” listed.
 - If the “**Current ECU part Number**” is the same as the “**New Part Number**”, proceed to **Step 15**.
 - If the “**Current ECU part Number**” is **NOT the same as one of the “New Part Numbers”**, continue with **Step 10**.
