November 2018

Safety Recall U94 / NHTSA 18V-740 Reprogram Powertrain Control Module

2017-2018 (RU) Chrysler Pacifica PHEV

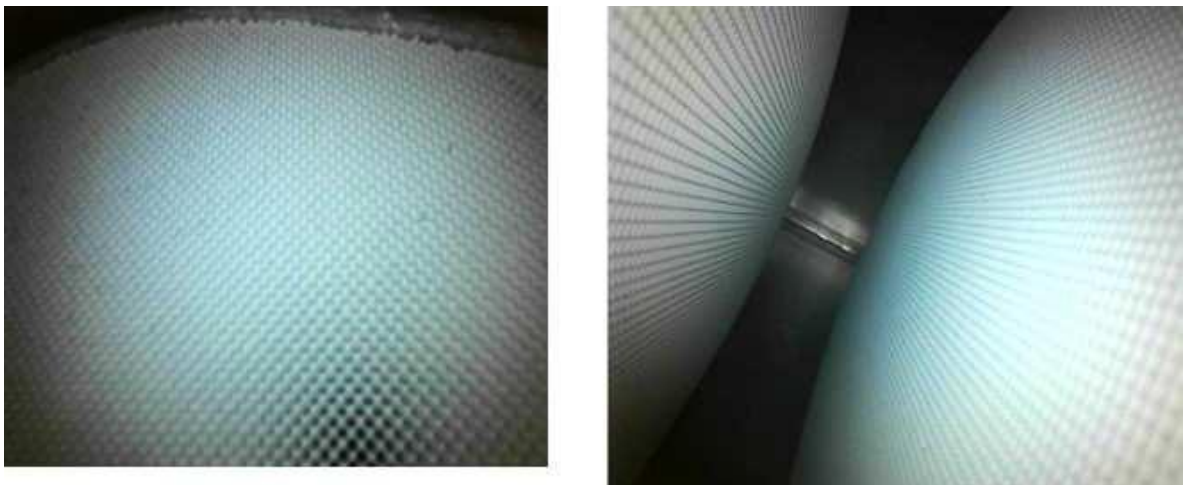
**Figure 4 – Normal Substrate**

- e. Look at the surrounding insulated mat (material at perimeter of substrate along catalyst wall). Mat should be in place between the catalyst brick and catalyst wall. It should not have holes or dropped lower than the catalyst brick material.

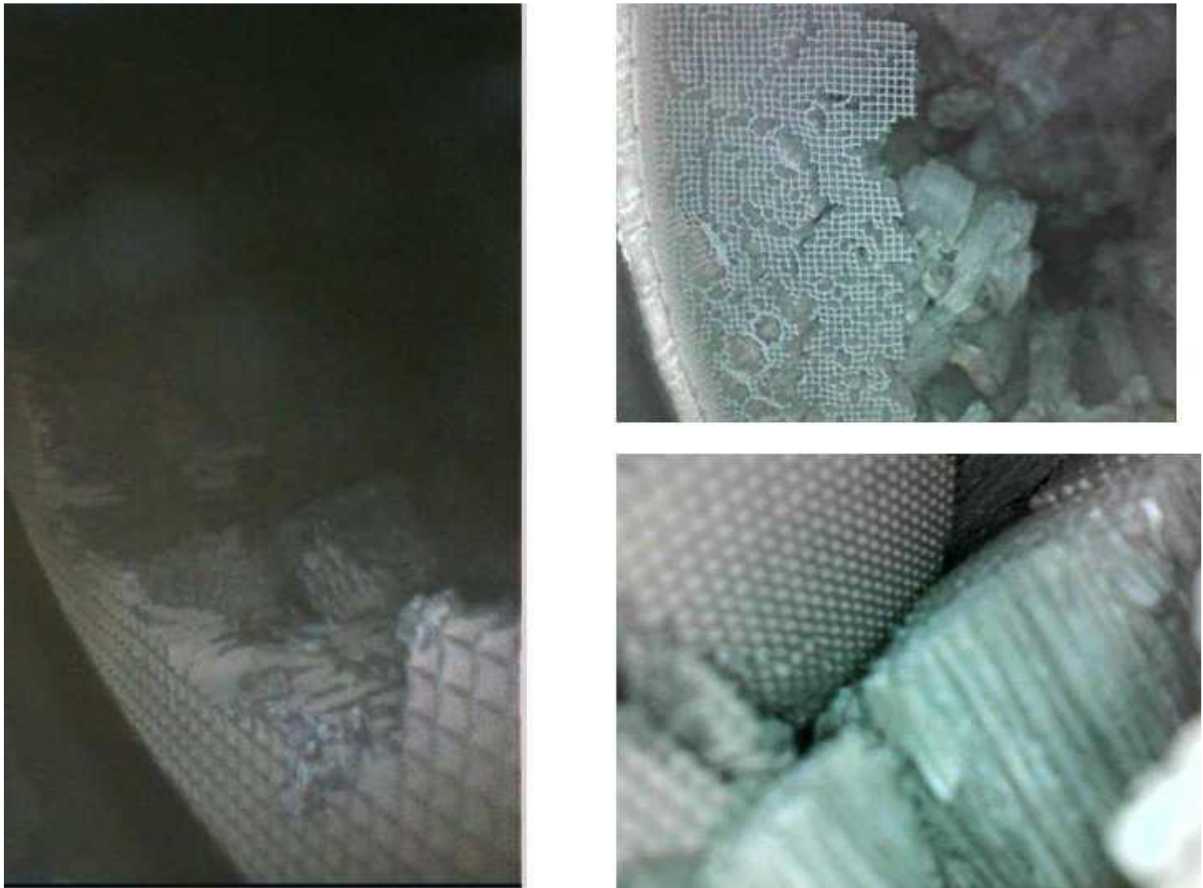
Figure 4 – Extreme Damaged Substrate

- f. Look for signs of degradation, shifting (change of position; under the right conditions, it is possible for the upper catalyst substrate to be pushed down). If there is evidence of overheating, the converters will need to be replaced, proceed to Step 1 of the Repair Procedure.

NOTE: The damaged substrate will show primarily heavy damage (missing material/large holes). Lighter damage to the substrate will consist of broken matrix walls but may not have progressed to large sections of missing material /holes. If “chains” of broken cell walls are found, the catalysts & O2 sensors need to be replaced. This may be present from viewing at either O2 sensor location.

9. If there are signs of the catalytic converters having been overheated then Proceed to **Section C Replace Catalytic Converters.**
