Thor Motor Coach Recall Repair Instructions

Recall #	18V-741 2018-561		
Description/Title:	Norcold Refer LP Hose Routing		
Affected Product Line(s):	Certain MY 2018 & 2019 Chateau, Four Winds, & Freedom Elite motorhomes		
Service Campaign # :	RC000162	Released Date:	12/10/2018
Repair Code:	Inspect: TMCRC80478Y Repair: TMCRC80478V	Document Date:	12/10/2018
Time Allowed:	Inspect: 0.1 Repair: 0.8	Document Revision:	A

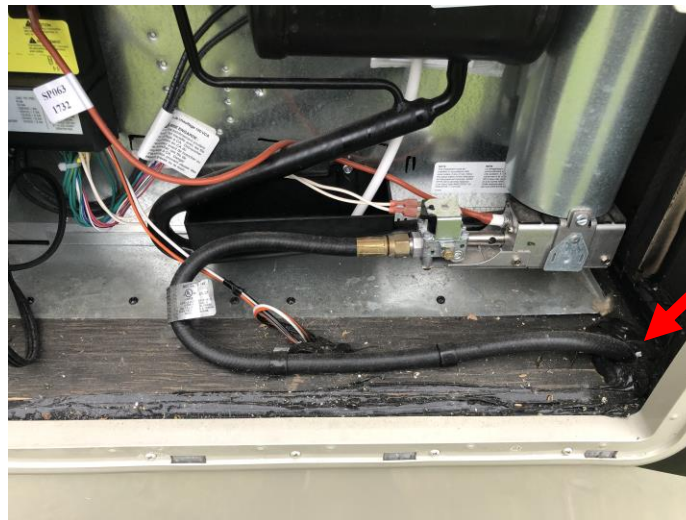
(Figure A)

1. Inspect refrigerator in coach to verify if it is a Norcold model. If yes, continue onto Step 2. If it is a different manufacturer (i.e. Dometic), inspection is complete and no further repair is needed.
(Photo Required of model verification for Claim process)
2. Inspect the routing of LP hose. If LP hose is not pinched or rubbing against bottom metal plate, no repair is needed. *(See Figure A for example)*
(Photo Required of LP hose routing for Claim process)

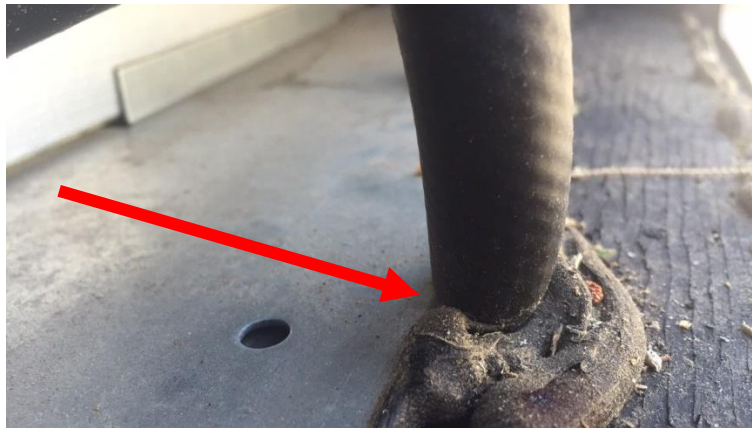
(Figure B)

It has been decided that on certain 2018 & 2019 Chateau, Four Winds, and Freedom Elite motorhomes, there is not enough clearance from the metal plate where the LP hose runs through the refrigerator cabinet floor. The LP hose has the potential to rub on the metal plate and possibly lead to a leak in the LP hose. This could cause a fire, which could result in serious injury or death.

3. If the hose is pinched or rubbing against bottom metal plate, repair will be required.
(See *Figure B* for example)
Continue onto step 4 for repair procedure.
