GROUP
Safety Recall Campaign

MODEL
**2018MY
Stinger (CK)**

NUMBER
SC170 (Rev 2, 05/30/2019)

SUBJECT: **FRONT WIRING HARNESS INSPECTION/REPLACEMENT
AND GROMMET INSTALLATION (SC170)**

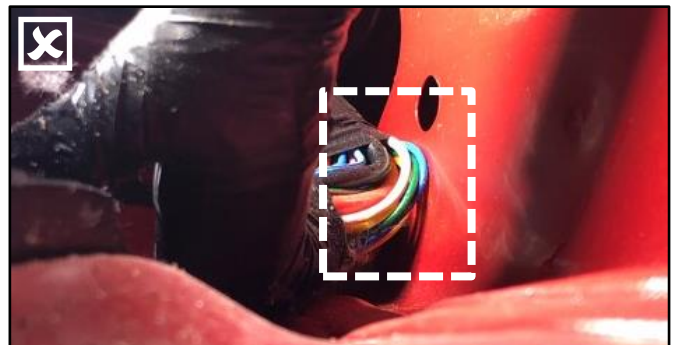
The Front Wiring Harness (“harness”) is located in the engine and passenger compartment of the vehicle. The harness can come in contact with a burr on the edge of a hole in the sheet metal of the left fender apron body panel. Such contact can damage the insulation of one or more wires and cause an electrical short circuit, increasing the risk of a fire.

7. Visually inspect the harness for interference.
- If the harness is touching the left fender apron panel () , proceed to the next step.
 - If the harness is not touching the panel () , proceed to step 13 on page 5.

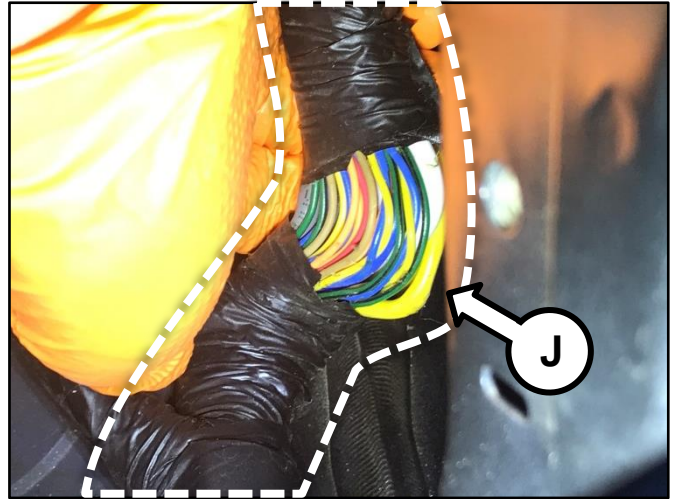
12. Reach behind the hood and into the well area to slightly pull up the harness. Thoroughly inspect the harness for any damage.

- If there is damage to the harness, open a Techline case online and **do not proceed** with claim submission until wire harness replacement approval or denial is determined. See page 6 for the Front Wiring Harness Replacement procedure.
- If there is no damage to the harness, proceed to the next step.
