GROUP  
**Safety Recall Campaign**

MODEL  
**2018MY  
Stinger (CK)**

NUMBER  
**SC170 (Rev 1, 02/04/2019)**

SUBJECT: **FRONT WIRING HARNESS INSPECTION/REPLACEMENT  
AND GROMMET INSTALLATION (SC170)**

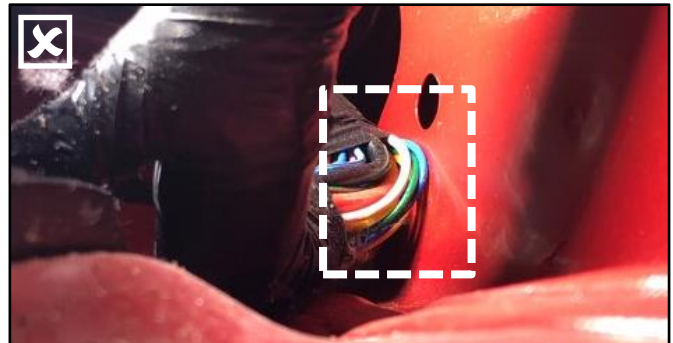
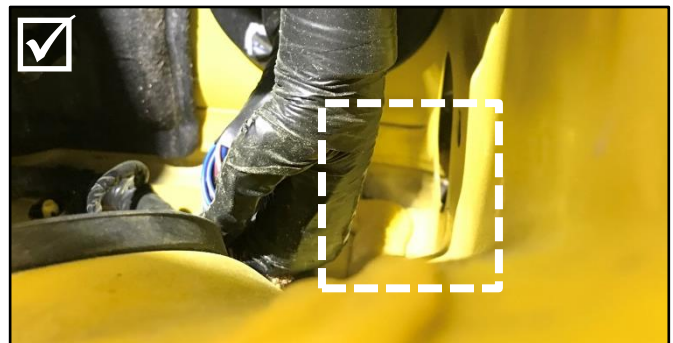
The Front Wiring Harness (“harness”) is located in the engine and passenger compartment of the vehicle. The harness can come in contact with a burr on the edge of a hole in the sheet metal of the left fender apron body panel. Such contact can damage the insulation of one or more wires and cause an electrical short circuit, increasing the risk of a fire.

7. Visually inspect the harness for interference.
- If the harness is touching the left fender apron panel () , proceed to the next step.
  - If the harness is not touching the panel () , proceed to step 13 on page 5.

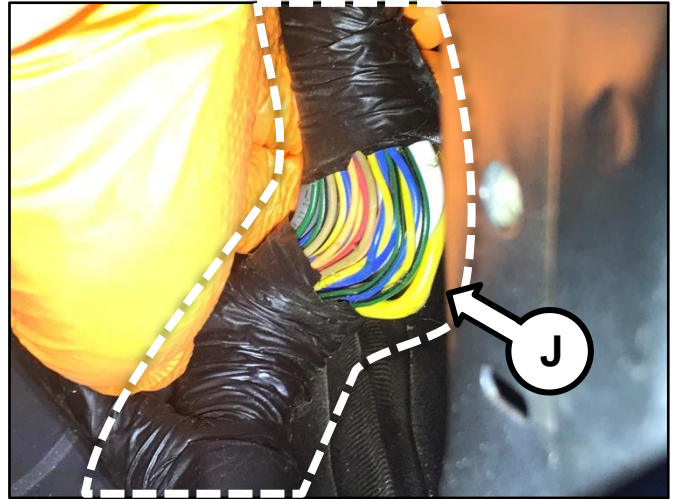
12. Reach behind the hood and into the well area to slightly pull up the harness. Thoroughly inspect the harness for any damage.

- If there is damage to the harness, open a Techline case online and **do not proceed** with claim submission until wire harness replacement approval or denial is determined. See page 6 for the Front Wiring Harness Replacement procedure.
- If there is no damage to the harness, proceed to the next step.
