SIB 11 17 18

## RECALL CAMPAIGN 18V-755: EXHAUST GAS RECIRCULATION (EGR) COOLER INSPECTION (V8)

## Inspecting the EGR Cooler

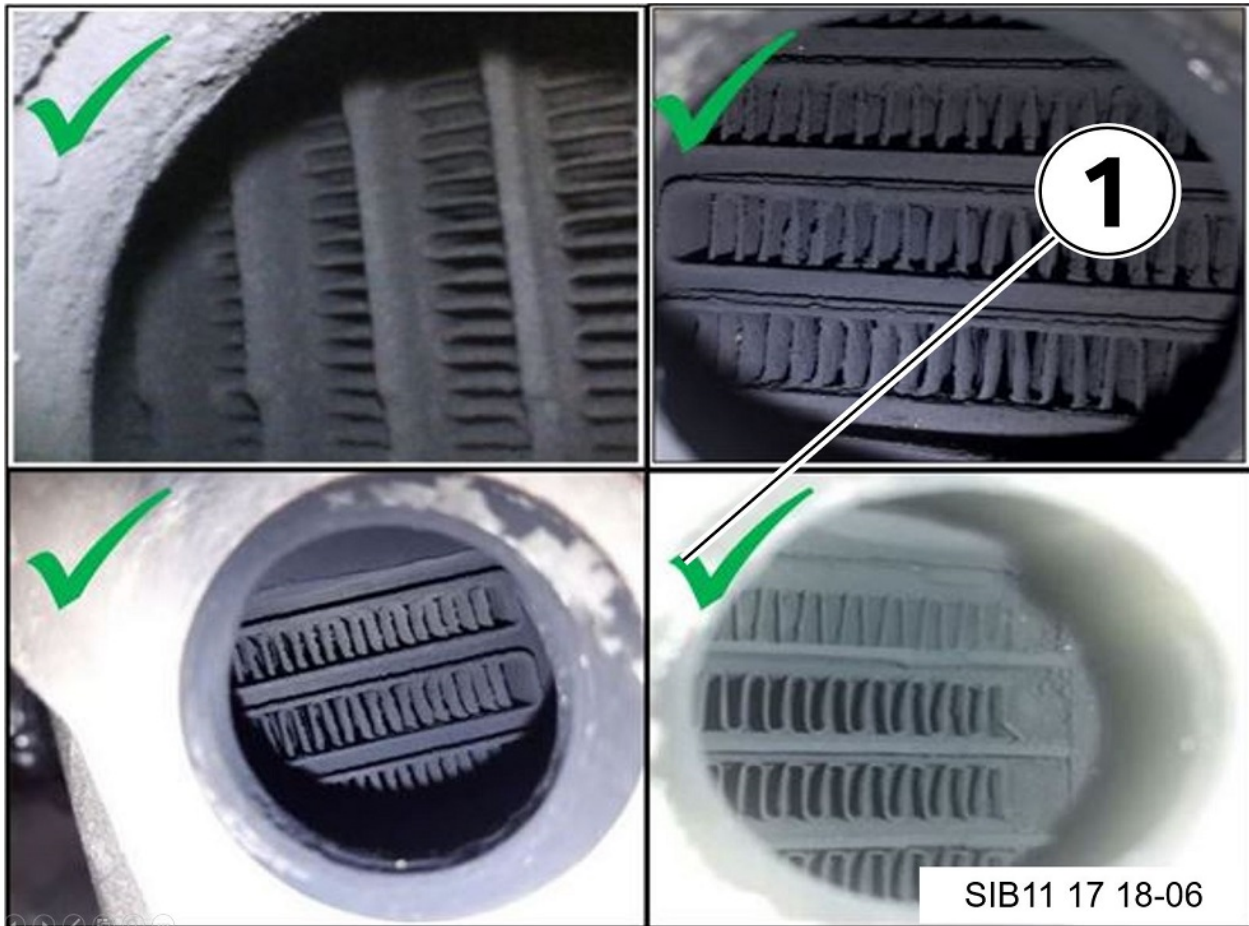
- Inspect the fins on the EGR cooler for any build up or contamination. Black dry soot is a normal byproduct of the EGR system. An internally failed cooler will have a mix of soot and coolant which creates a moist “sludge” build-up.

Clean or normal cooler with dry soot on fins (outlet side).

If the cooler fins are clear (minimal dry soot build-up): Go to **STEP TWO**.

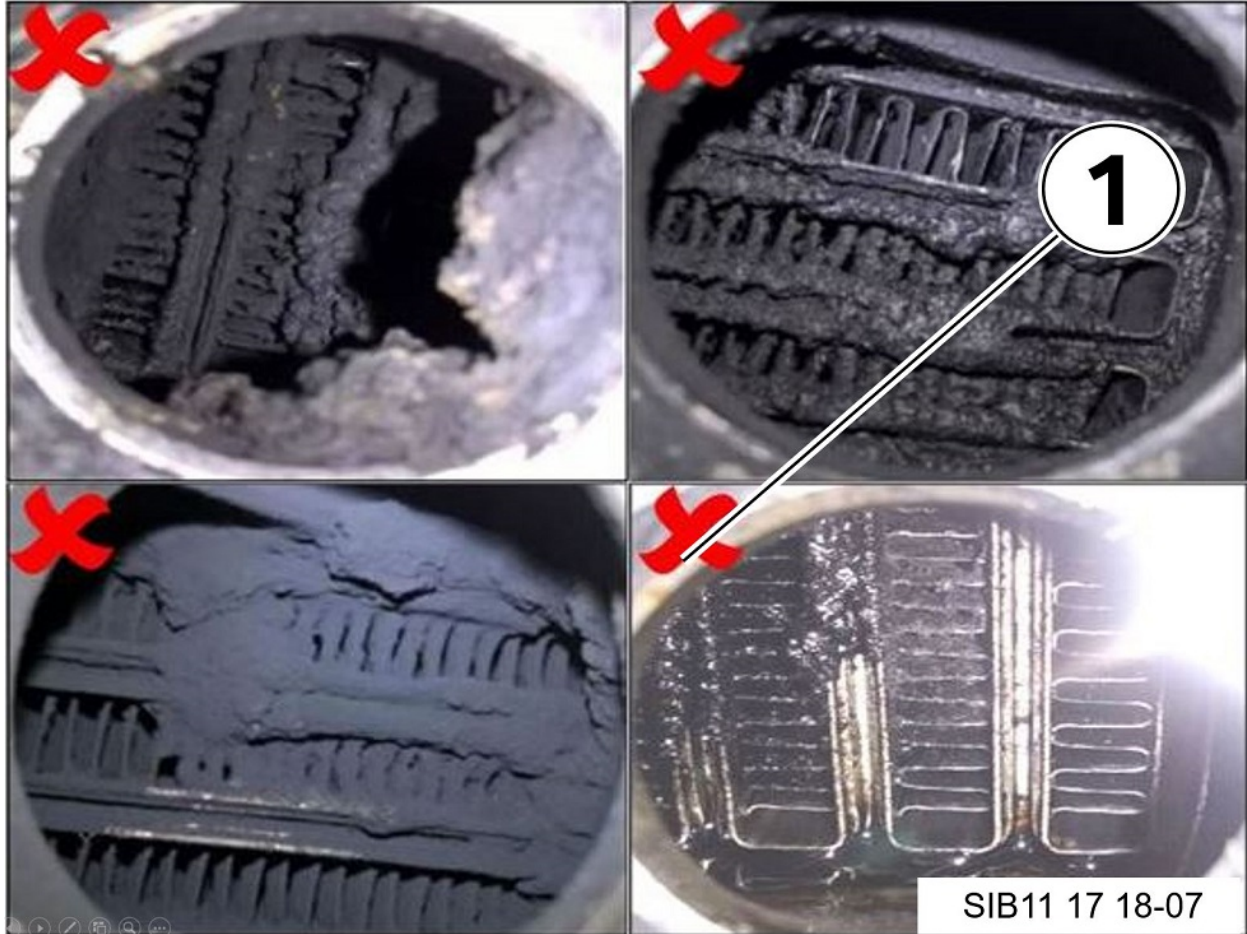
Contaminated or clogged coolers will have extensive soot/sludge build-up (outlet side).

If the cooler is contaminated: Proceed to **STEP FIVE**.

Replace the EGR cooler and intake manifold (Refer to the **PARTS INFORMATION** section of SI B11 17 18). **NOTE:** The EGR valve will need to be **reused**. Recall EGR coolers will be shipped **without** an EGR valve.

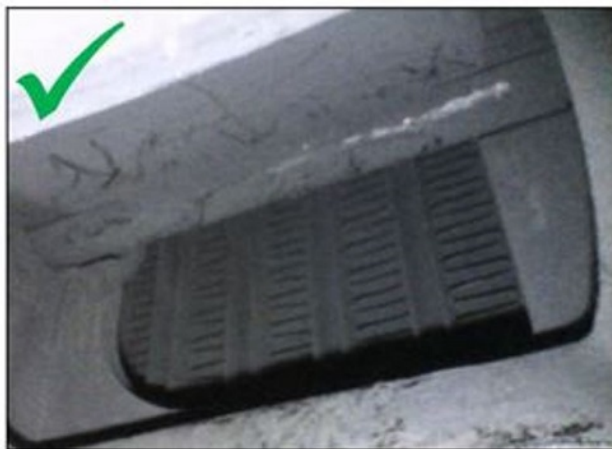
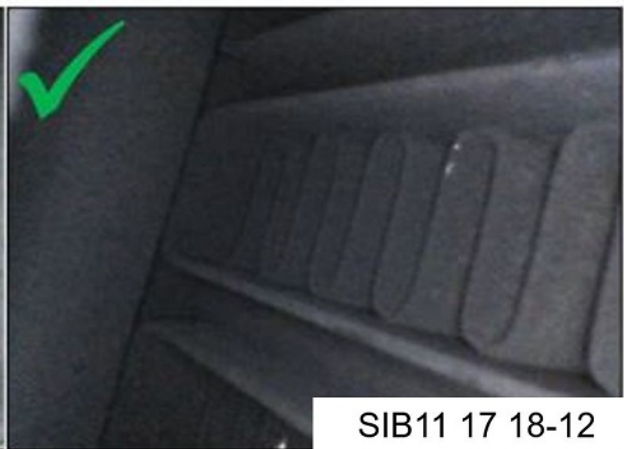
Clean or normal cooler with dry soot on fins (inlet side).

If the fins on the inlet side of the cooler are free from sludge build-up:

- Reinstall the EGR valve (with new seal PN 11 71 7 794 785) and continue to **STEP THREE**.
