SIB 11 17 18

RECALL CAMPAIGN 18V-755: EXHAUST GAS RECIRCULATION (EGR) COOLER INSPECTION (VS4)This Service Information bulletin (Revision 5) replaces SI B11 17 18 **dated April 2019****What's New** (Specific text highlighted):

RECALL CAMPAIGN 18V-755: EXHAUST GAS RECIRCULATION (EGR) COOLER INSPECTION (VERSION 5)

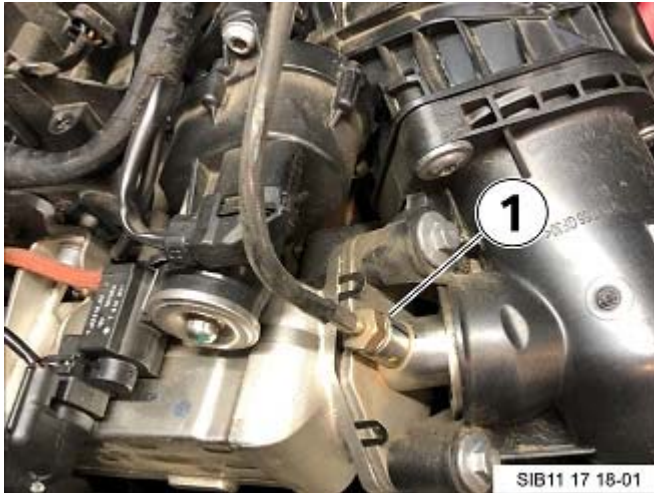
- Measure the temperature at the EGR cooler outlet pipe (1).

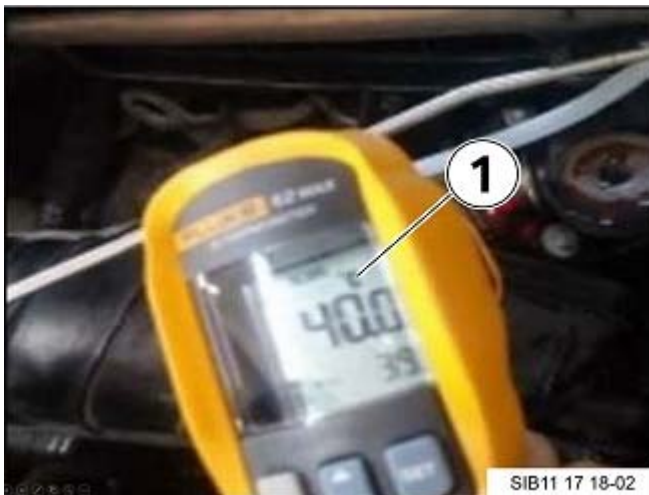
- The temperature of the cooler needs to be below 50°C (1) before the probe of the digital video scope can be safely inserted to inspect the cooler.

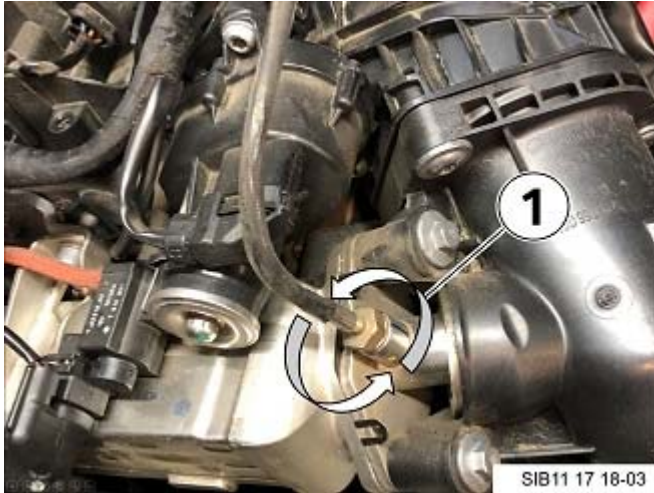
- Remove the EGR temperature sensor (1). **NOTE:** Count the number of revolutions (turns) required to remove the temperature sensor.
- **NOTE:** During installation, Pre-wind the temp sensor counterclockwise the number of turns it took to remove the sensor. This will keep the wires from twisting when reinstalled. Tightening torque 21Nm.

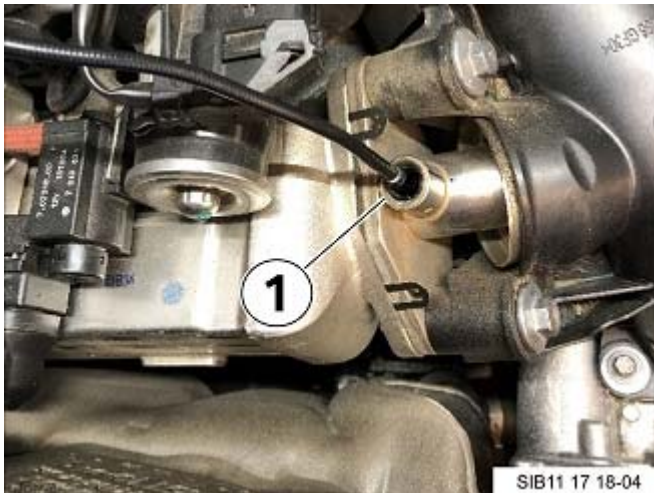
- Set the borescope to the 90° setting and install in the port temperature sensor (1).

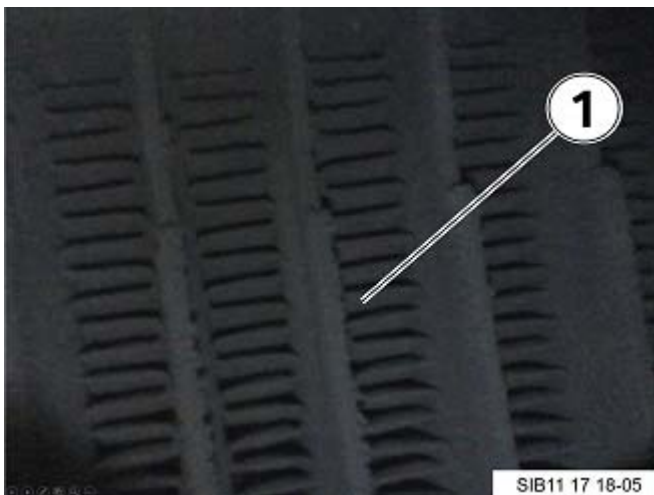
- Inspect the fins on the EGR cooler for any build up or contamination. Black dry soot is a normal byproduct of the EGR system. An internally failed cooler will have a mix of soot and coolant which creates a moist “sludge” build-up.

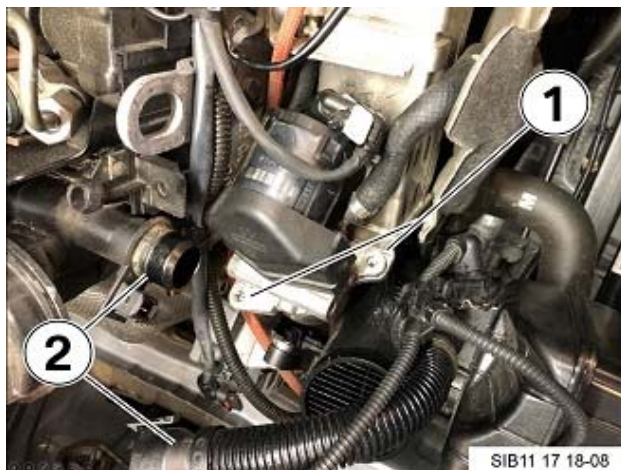
- Loosen the tamperproof T30 screws (1) on the EGR valve and remove the valve from the EGR cooler. **NOTE:** The valve only needs to be removed from the cooler far enough to inspect the inside of the cooler. Do not disconnect the cooling lines from the EGR valve.

NOTE: (F25 is pictured) It is necessary to disconnect the crankcase breather line to access the EGR valve (2).

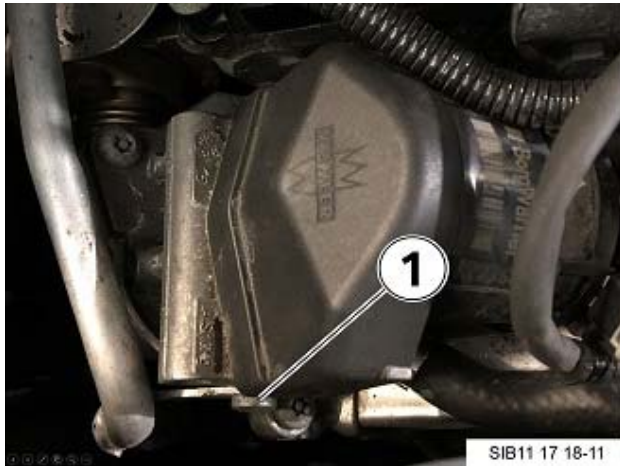
- **NOTE:** (F15 is pictured) Remove the T30 screw (1) before removing EGR valve.

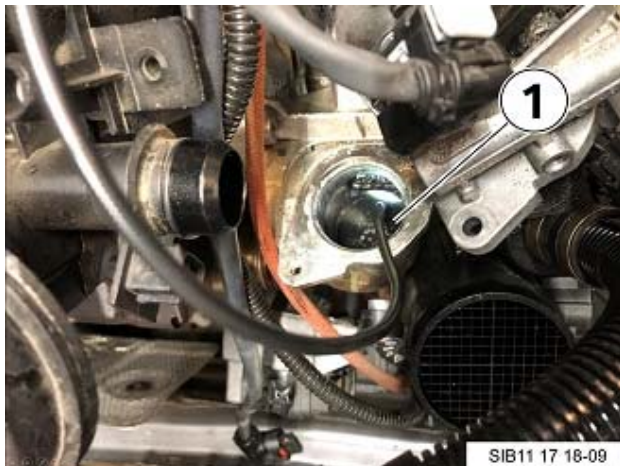
- Insert the probe for the borescope and inspect the fins on the inlet side of the EGR cooler for any build up or contamination (1).
