SI B11 17 18  
Engine

## RECALL CAMPAIGN 18V-755: EXHAUST GAS RECIRCULATION (EGR) COOLER INSPECTION (VERSION 2)

This Service Information bulletin replaces SI B11 17 18 **dated October 2018**

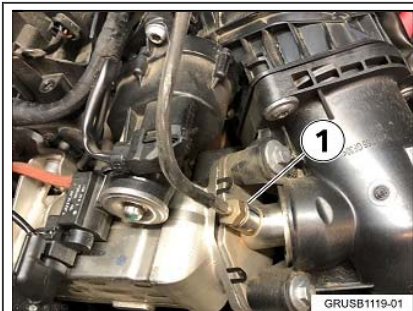
- Measure the temperature at the EGR cooler outlet pipe (1).

- The temperature of the cooler needs to be below 50°C (1) before the probe of the digital video scope can be safely inserted to inspect the cooler.

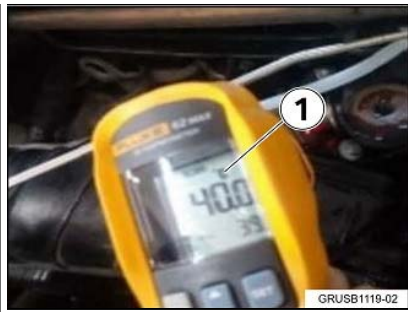
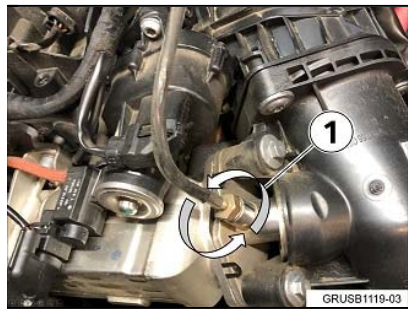
- Remove the EGR temperature sensor (1). **NOTE:** Count the number of revolutions (turns) required to remove the temperature sensor.
- **NOTE:** During installation, Pre-wind the temp sensor counterclockwise the number of turns it took to remove the sensor. This will keep the wires from twisting when reinstalled. Tightening torque 21Nm.

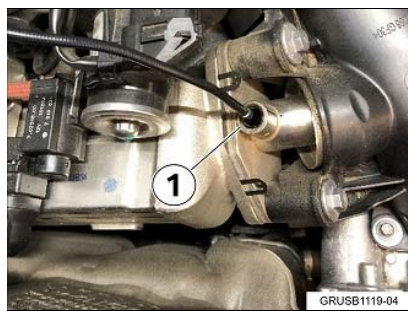
- Set the borescope to the 90° setting and install in the port temperature sensor (1).

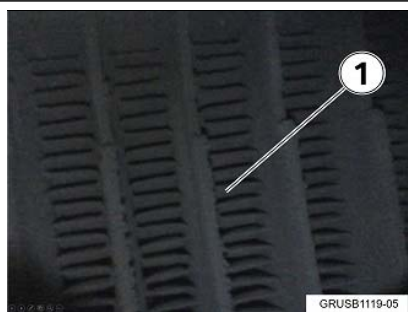
- Inspect the fins on the EGR cooler for any build up or contamination. Black dry soot is a normal byproduct of the EGR system. An internally failed cooler will have a mix of soot and coolant which creates a moist “sludge” build-up.

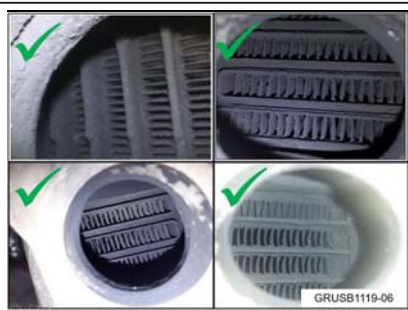
Clean or normal cooler with dry soot on fins (outlet side).

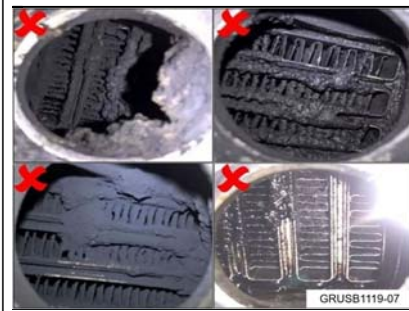
Contaminated or clogged coolers will have extensive soot/sludge build-up (outlet side).

If the cooler is contaminated: Proceed to **STEP FIVE**.

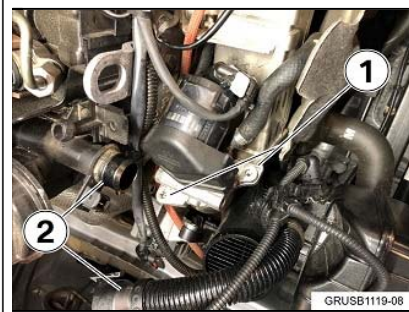
- Loosen the tamperproof T30 screws (1) on the EGR valve and remove the valve from the EGR cooler. **NOTE:** The valve only needs to be removed from the cooler far enough to inspect the inside of the cooler. Do not disconnect the cooling lines from the EGR valve.
- **NOTE:** (F25 is pictured) It is necessary to disconnect the crankcase breather line to access the EGR valve (2).

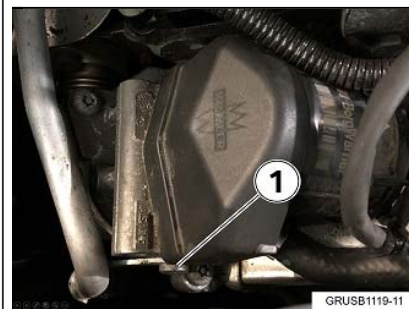
- **NOTE:** (F15 is pictured) Remove the T30 screw (1) before removing EGR valve.

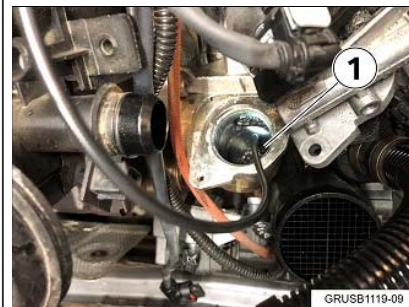
- Insert the probe for the borescope and inspect the fins on the inlet side of the EGR cooler for any build up or contamination (1).

Contaminated or clogged coolers will have extensive build-up (inlet side).

If the fins on the inlet side of the cooler are free from sludge build-up: Reinstall the EGR valve (with new seal PN 11 71 7 794 785) and continue to **STEP THREE**.

If the cooler is clogged or contaminated: Continue to **STEP FIVE**.

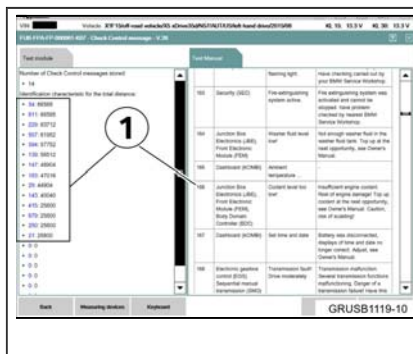
Check the CCM history for message 166 "Coolant level to low" (1).
