## SIB 11 17 18

### RECALL CAMPAIGN 18V-755: EXHAUST GAS RECIRCULATION (EGR) COOLER INSPECTION (VS4)

F30 (328d Sedan)	F31 (328d Sports Wagon)	F10 (535d Sedan)	F02 (740Ld Sedan)
F25 (X3 xDrive28d Sports Activity Vehicle)	F15 (X5 xDrive35d SAV)

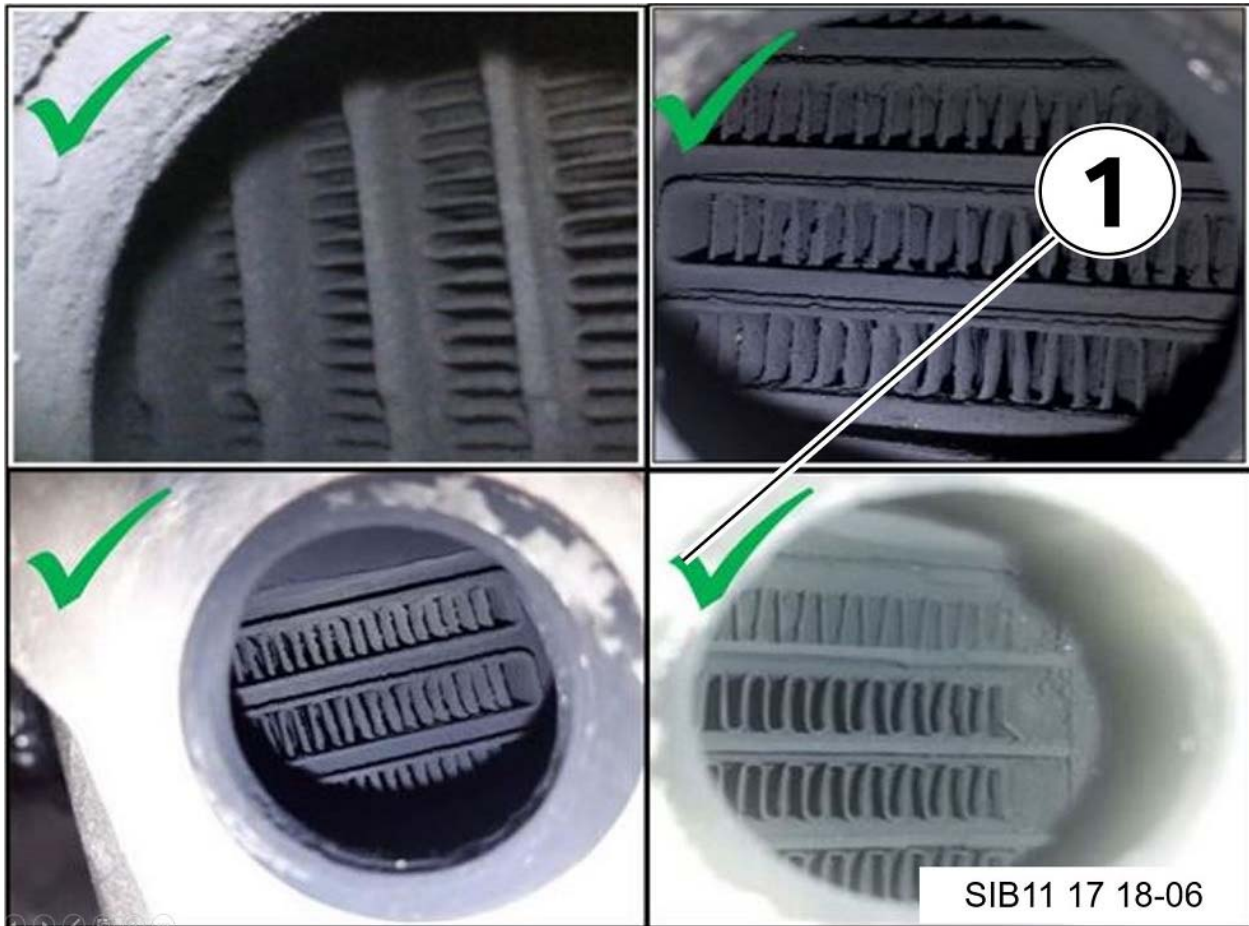
Clean or normal cooler with dry soot on fins (outlet side).

If the cooler fins are clear (minimal dry soot build-up): Go to **STEP TWO**.

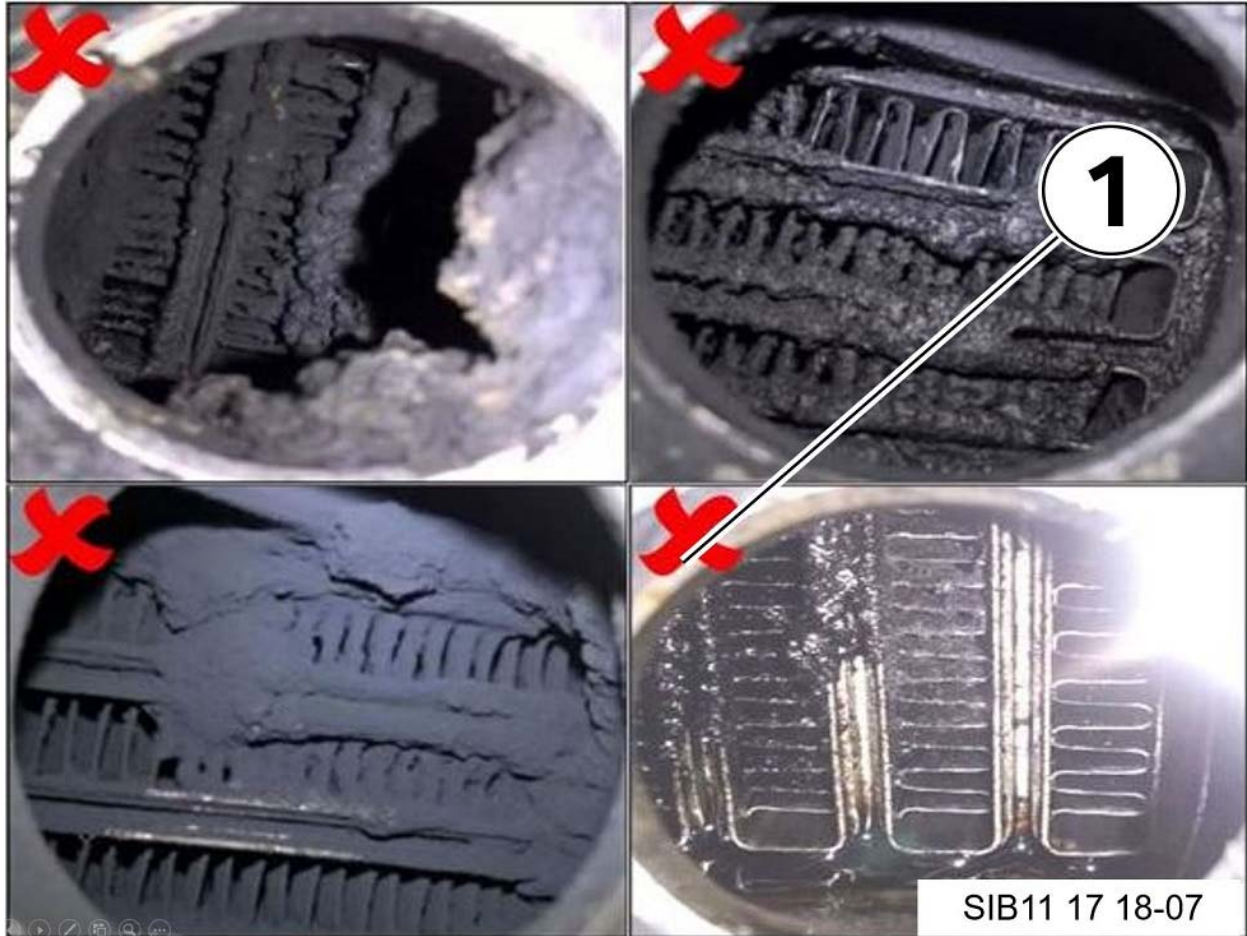
Contaminated or clogged coolers will have extensive soot/sludge build-up (outlet side).

If the cooler is contaminated: Proceed to **STEP FIVE**.

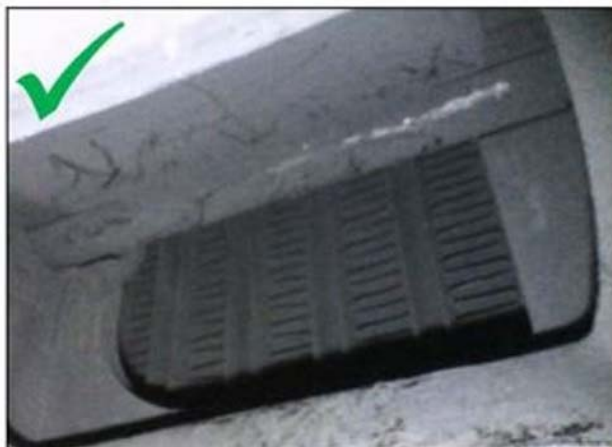
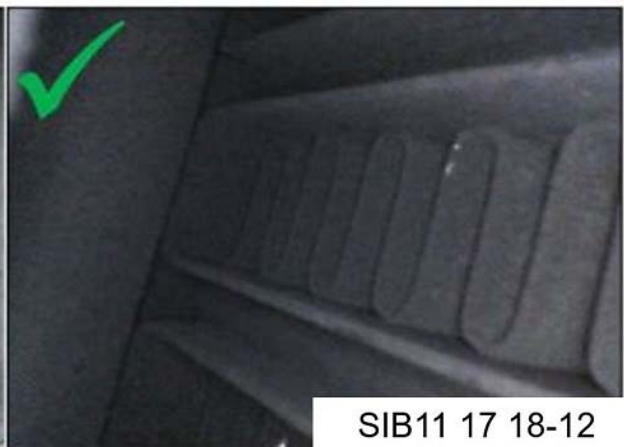
Clean or normal cooler with dry soot on fins (inlet side).

- Reinstall the EGR valve (with new seal PN 11 71 7 794 785) and continue to **STEP THREE**.

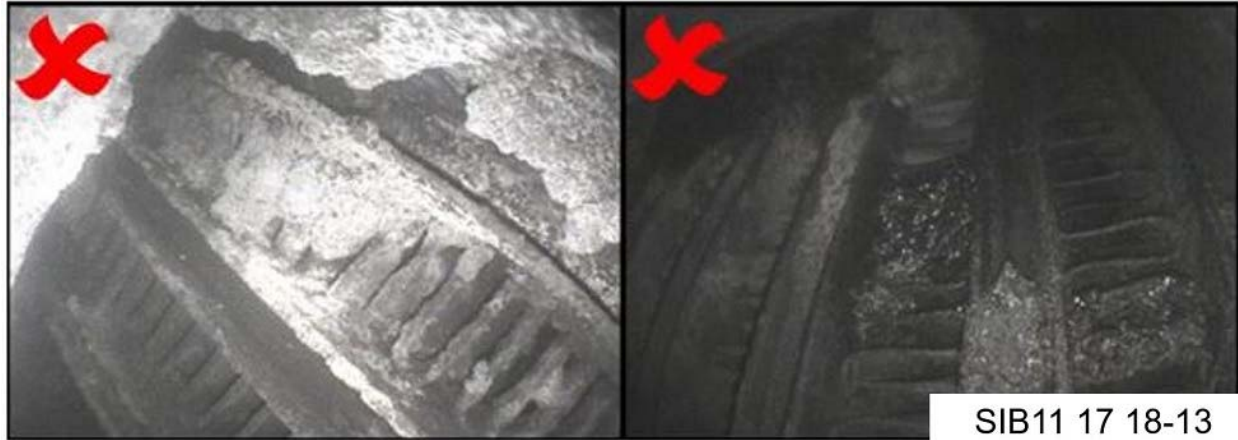
Contaminated or clogged coolers will have extensive build-up (inlet side).

- Continue to **STEP FIVE**.
