**SIB 11 17 18**

## RECALL CAMPAIGN 18V-755: EXHAUST GAS RECIRCULATION (EGR) COOLER INSPECTION

This Service Information Bulletin (Revision #9) replaces SI B11 17 18 **dated January 2020**.

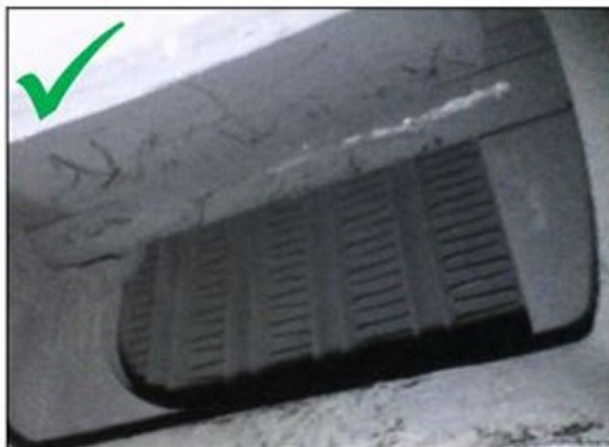
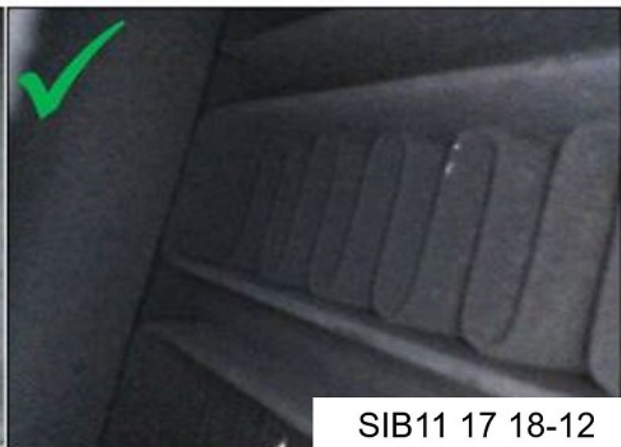
Clean or normal cooler with dry soot on fins (inlet side).
