SIB 11 17 18

## RECALL CAMPAIGN 18V-755: EXHAUST GAS RECIRCULATION (EGR) COOLER INSPECTION: VER6

2019-10-08

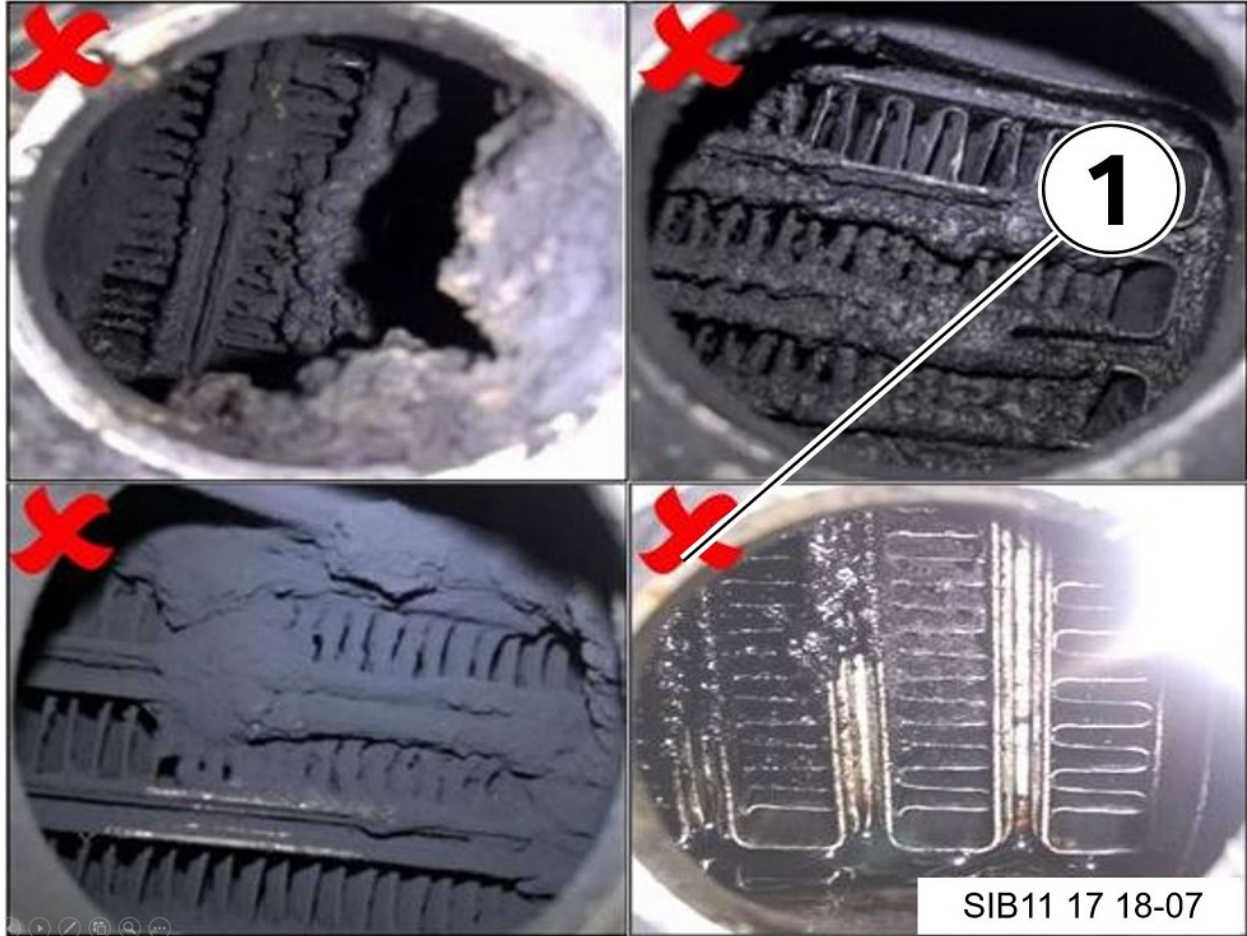
- Inspect the fins on the EGR cooler for any build up or contamination. Black dry soot is a normal byproduct of the EGR system. An internally failed cooler will have a mix of soot and coolant which creates a moist “sludge” build-up.

Contaminated or clogged coolers will have extensive soot/sludge build-up (outlet side).

If the cooler is contaminated: Proceed to **STEP FIVE**.

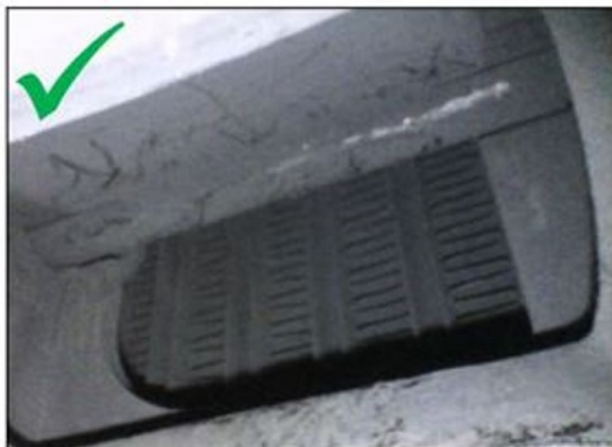
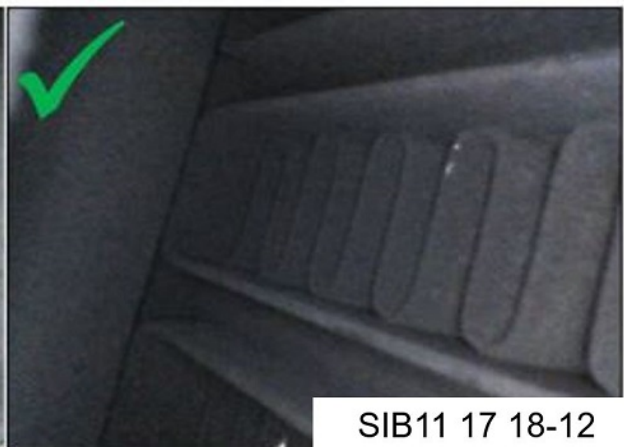
Clean or normal cooler with dry soot on fins (inlet side).

- Reinstall the EGR valve (with new seal PN 11 71 7 794 785) and continue to **STEP THREE**.

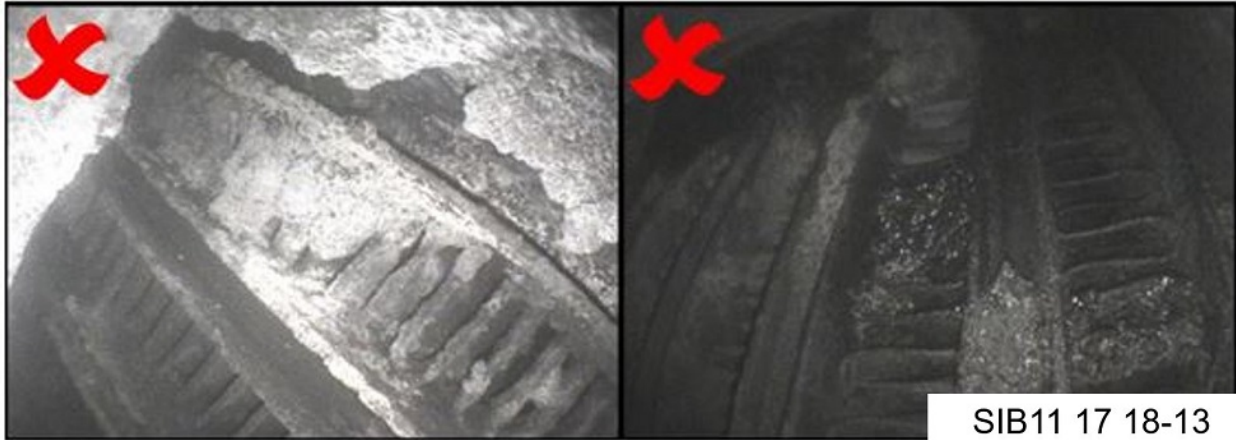
Contaminated or clogged coolers will have extensive build-up (inlet side).

- Continue to **STEP FIVE**.
