SIB 11 17 18

2019-10-29

RECALL CAMPAIGN 18V-755: EXHAUST GAS RECIRCULATION (EGR) COOLER INSPECTION (VS7)

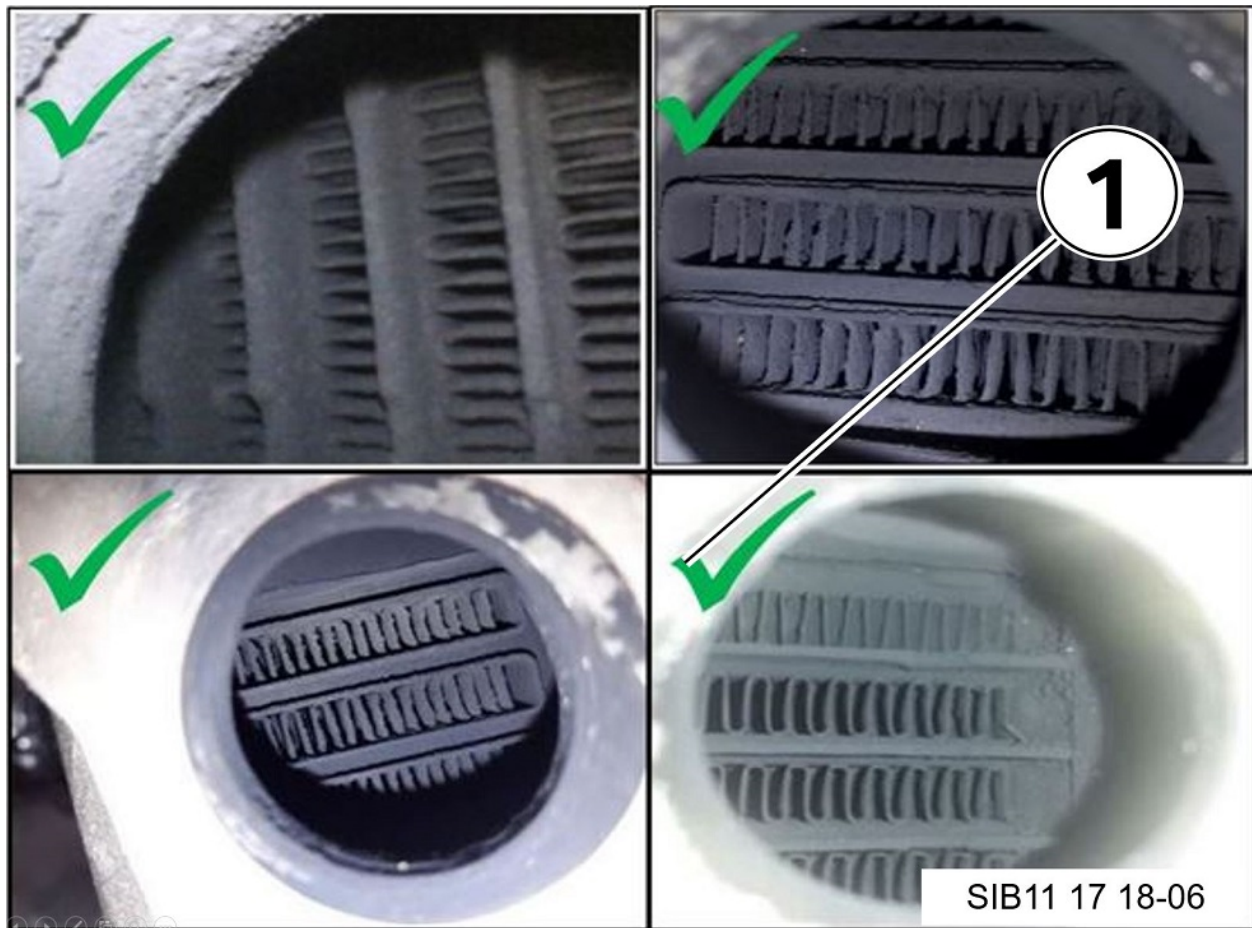
- Inspect the fins on the EGR cooler for any build up or contamination. Black dry soot is a normal byproduct of the EGR system. An internally failed cooler will have a mix of soot and coolant which creates a moist “sludge” build-up.

Clean or normal cooler with dry soot on fins (outlet side).

If the cooler fins are clear (minimal dry soot build-up): Go to **STEP TWO**.

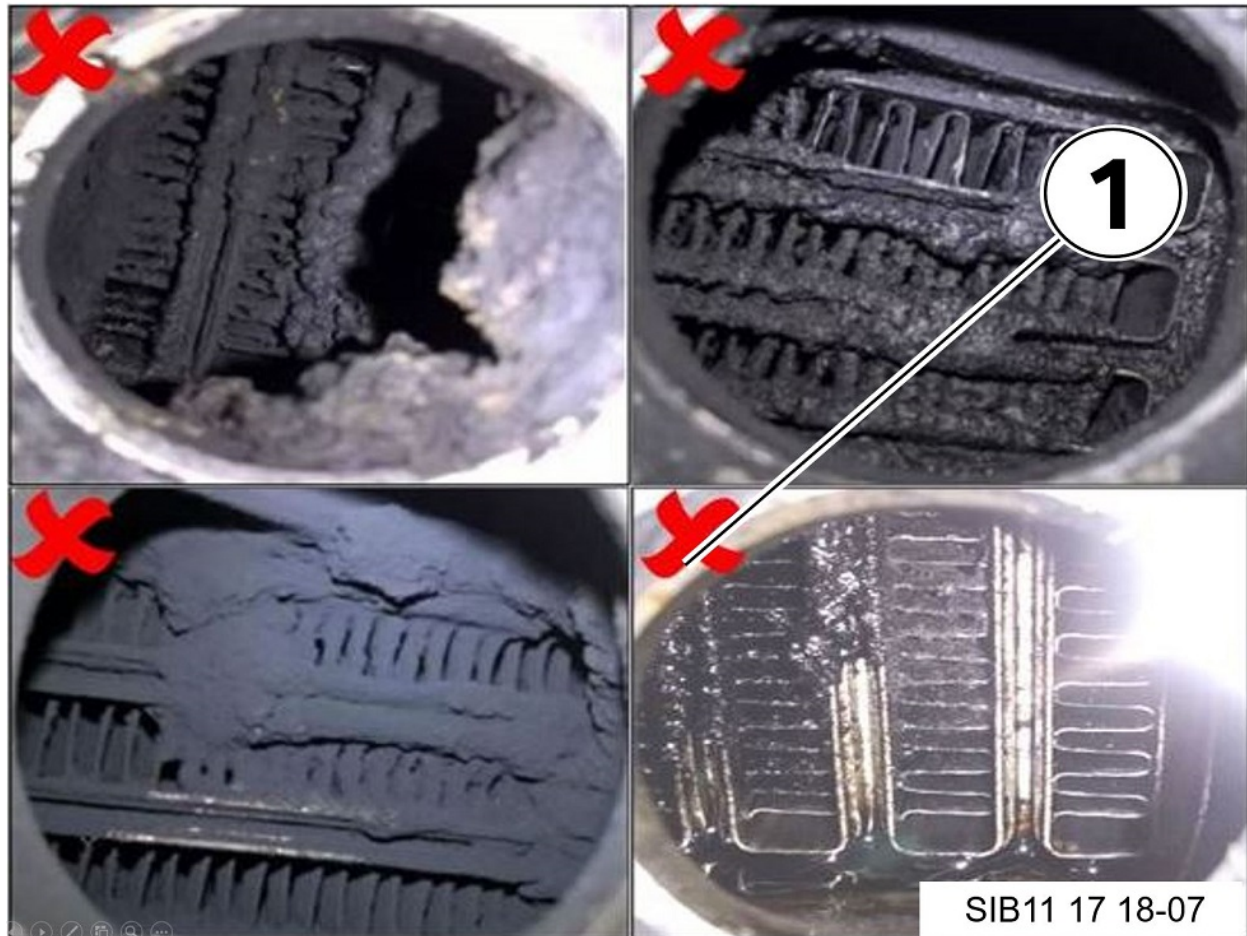
Over time, the Exhaust Gas Recirculation Cooler (EGR cooler) could develop an internal coolant leak. The coolant could mix with normal soot / sediment and, in combination with high temperatures normally present in the EGR module, could create flammable deposits. This may lead to-

Contaminated or clogged coolers will have extensive soot/sludge build-up (outlet side).

If the cooler is contaminated: Proceed to **STEP FIVE**.

Replace the EGR cooler and intake manifold (Refer to the **PARTS INFORMATION** section of SI B11 17 18). **NOTE:** The EGR valve will need to be **reused**. Recall EGR coolers will be shipped **without** an EGR valve.

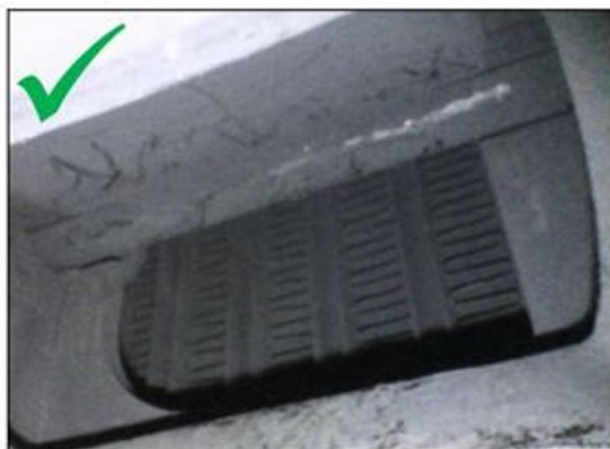
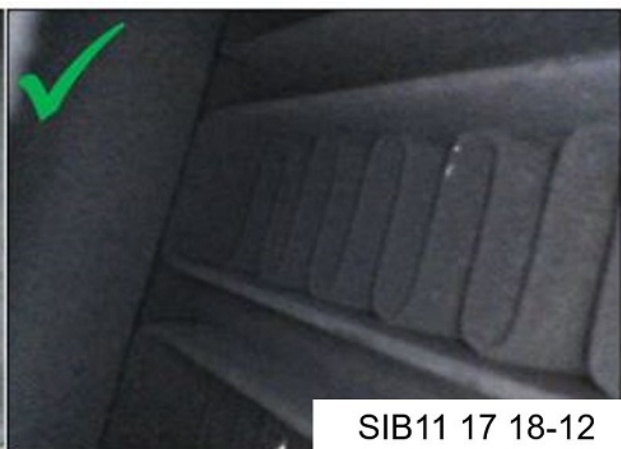
Clean or normal cooler with dry soot on fins (inlet side).

- Reinstall the EGR valve (with new seal PN 11 71 7 794 785) and continue to **STEP THREE**.

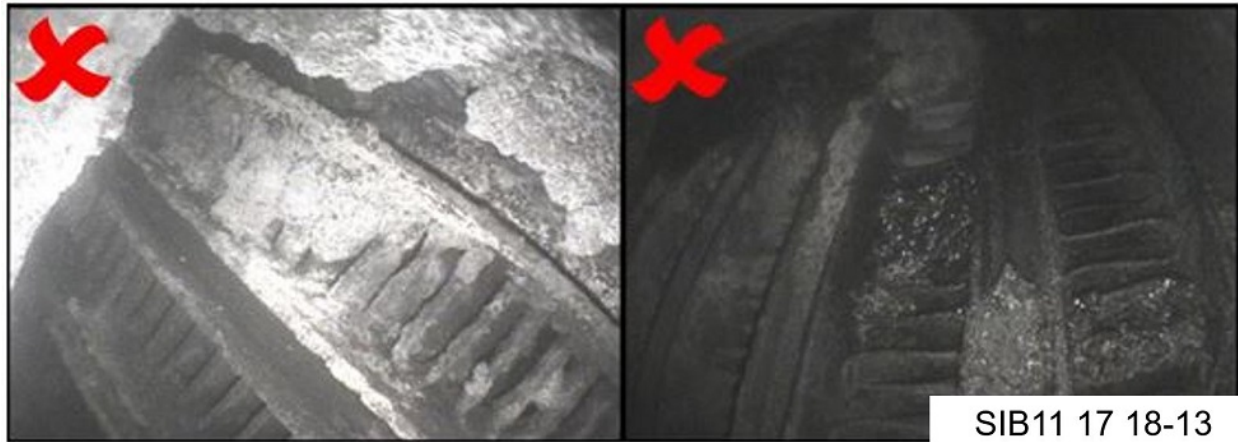
Contaminated or clogged coolers will have extensive build-up (inlet side).

- Continue to **STEP FIVE**.
