TECHNICAL INSTRUCTIONS
FOR
SAFETY RECALL J0W
AIRBAG(S) AND SEAT BELT PRETENSIONER(S) INADVERTENTLY DEPLOY
OR MAY BECOME DEACTIVATED
CERTAIN 2004 – 2006 MODEL YEAR SCION xA

V. CENTER AIRBAG SENSOR ASSEMBLY REPLACEMENT COMPONENTS

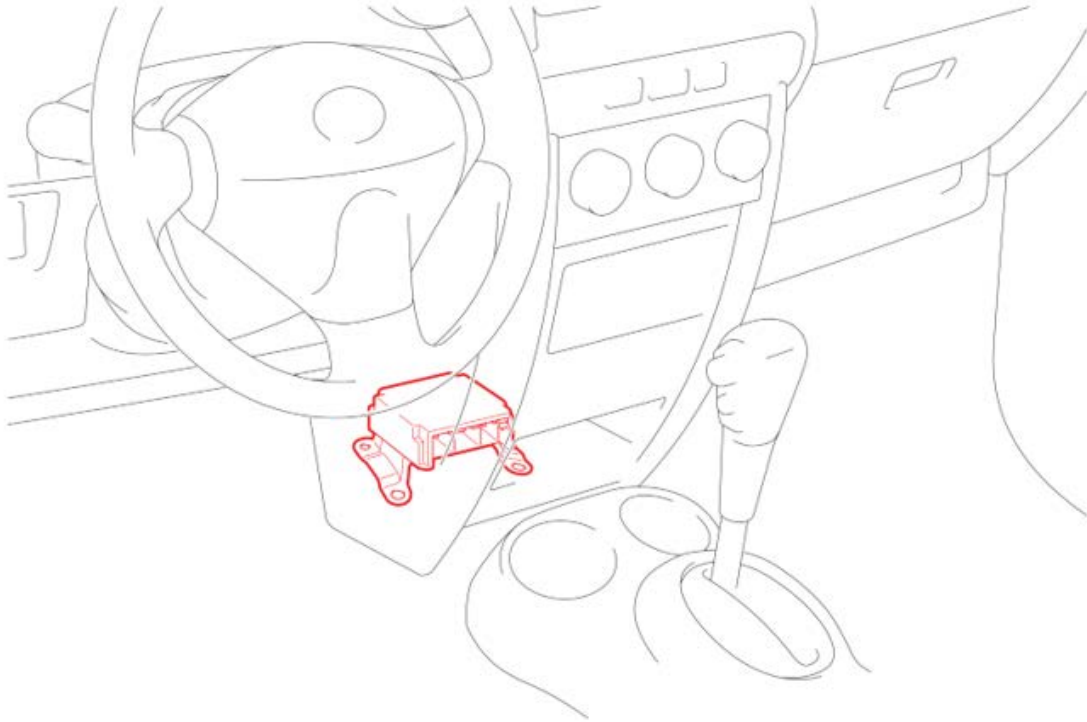
R1810030011

The airbag system in the subject vehicles could experience electrical shorting that could damage the circuits in the system. This could cause the airbag warning lights to illuminate and the airbag(s) and seat belt pretensioner(s) to become deactivated, or it could cause those systems to inadvertently deploy. These conditions can increase the risk of injury or crash.

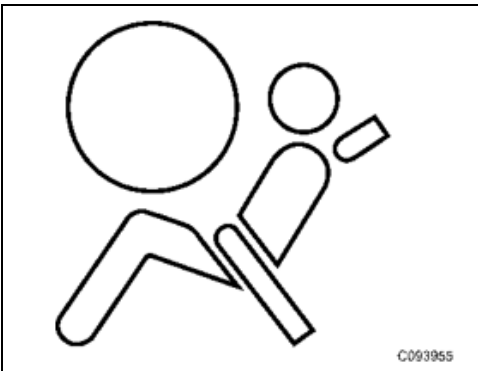
If the airbag warning lamp remains on, it is likely caused by a connection failure of the airbag connector to airbag ECU

5. INSPECT SRS WARNING LIGHT

- a. Check that the airbag warning lamp lights when the power switch is turned on.
- b. Check that the airbag warning lamp goes off approximately 6 seconds after turning on of the ignition switch.
