# SAFETY RECALL

Mack Trucks Inc.  
Greensboro, NC USA

Date	Number	Release	Page
11.2018	<b>SC0413</b>	<b>01</b>	1 (7)

## Steering Shaft Pinch Bolt, Inspection

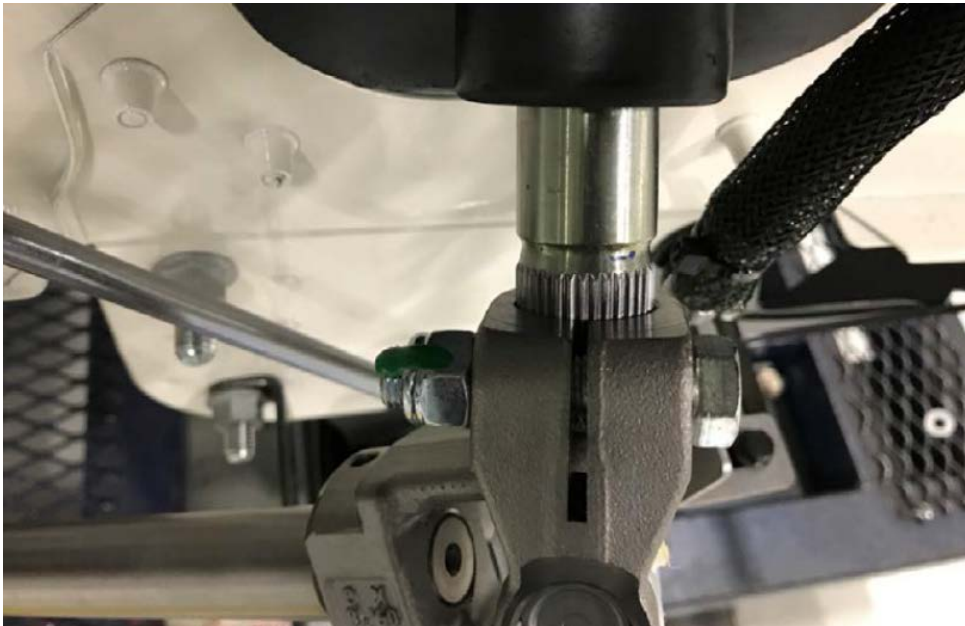
Figure 1 (**OK** Condition)

NOTE
Figures 1 and 2 below shows the yoke to shaft joint in <b>OK</b> condition.

**OK** Condition: Return vehicle to service after documenting inspection results.

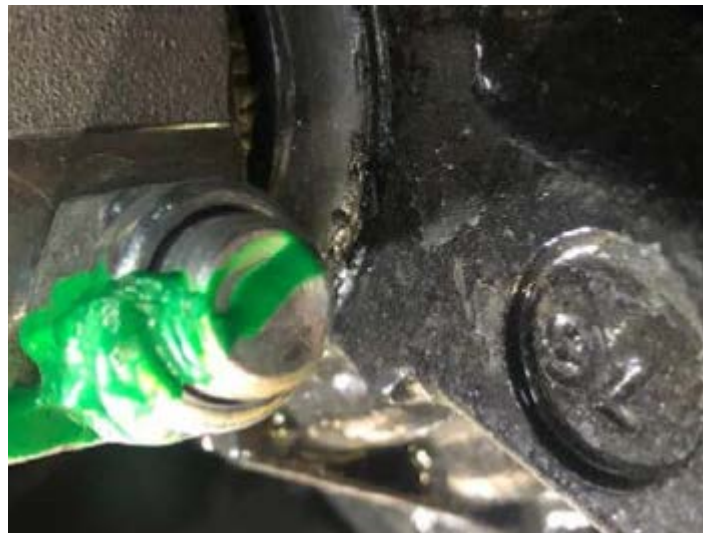
Figure 2 (**OK** Condition)

More Detailed view of protruding threads and tamper proof marking on the nut/bolt

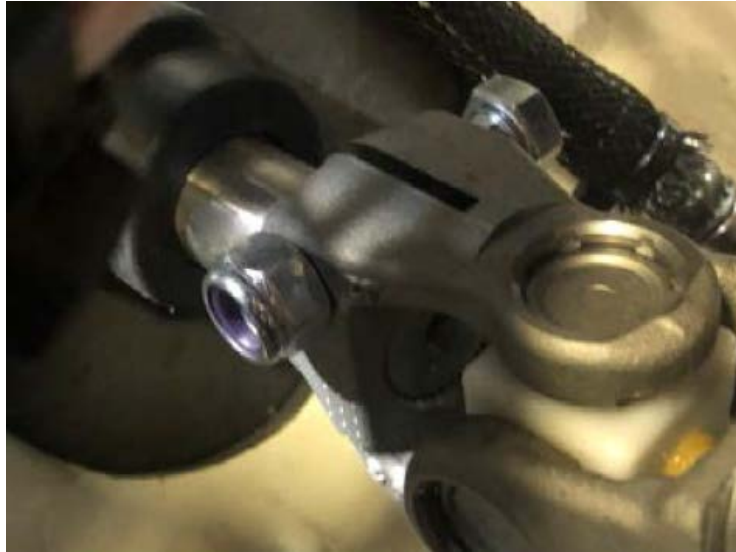
Figure 3 (**NOT OK** Condition)

2. If the tamper proof marking is missing or less than 2 threads protrude from outside the lock nut, then it is a **NOT OK** condition.

Figures 3 below shows the yoke to shaft joint in <b>NOT OK</b> condition.
---

**NOT OK** Condition: Use one of the following applicable repair options.

1. Replace pinch bolt and lock nut
2. Torque to  $30 \pm 3$  Nm ( $22 \pm 2$  lb-ft) + 90° Turn (This torque **MUST** be used for this safety Recall).

1. **NOT OK** Condition **and** truck has 1000 or more miles on odometer.
2. Replace Output Shaft per service procedure 6412-03-02-08 in IMPACT.
3. Replace Steering Shaft per service procedure 6412-03-02-02 in IMPACT.
4. Replace pinch bolt and lock nut.
5. Torque all pinch bolts to  $30 \pm 3$  Nm ( $22 \pm 2$  lb-ft) + 90° Turn. (This torque **MUST** be used for this safety Recall)
