Date: 30.11.2018

Model: Evora Model Range
from '18 Model Year VIN JHB20905 to
JHA11273

Number: 2018/01R
Federal & Canadian
Markets

Re-torque of the steering column cartridge screw.

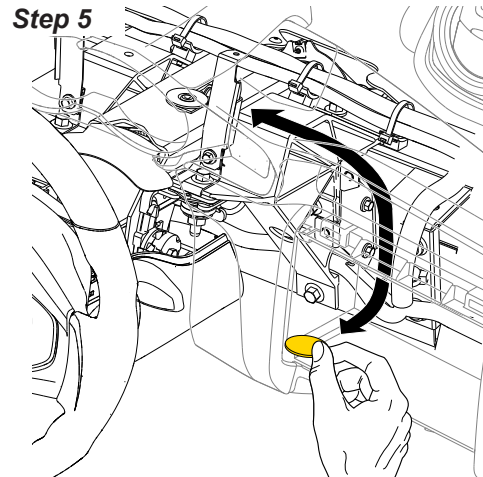
Note: it is possible that the patch is obscured by harness wiring, take care not to use excessive force when moving the wiring, as this may cause damage to harness and connector plugs.

5. Place a hand through the unit aperture and route it towards the top of the steering column, feel for the self adhesive protective patch, remove and retain for refitment.

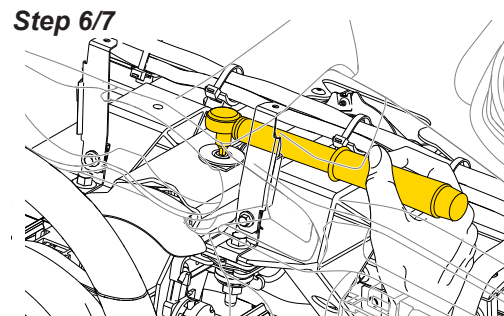
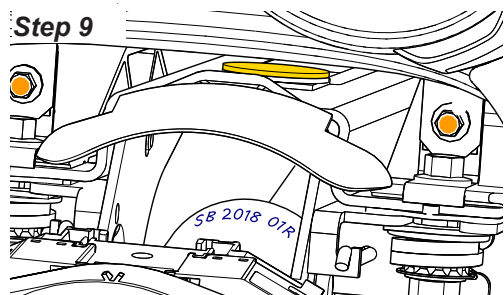
A misbuild issue of the steering column assembly fitted to the Evora model range has been identified in a small number of vehicles manufactured between 17/04/2018 to 02/10/2018. As a result the steering column cartridge screw may not have been tightened to its specified torque of 5 Nm.

6. Using the 5mm Allen socket provided and a suitable ¼ inch drive torque wrench, pass it through the audio unit aperture, guiding the Allen socket onto the head of the column cartridge screw.
7. Tighten the screw to 5 Nm, (if the screw was loose, then up to ½ turn will be required to achieve the required torque figure).
8. Remove the torque wrench and refit the self adhesive protective patch onto the steering column over the top of the column cartridge screw.
9. Using a suitable marker pen, write the recall campaign number (2018/01R) on the top of the ignition barrel/lock housing.
10. Refit all ancillary components previously removed.
