# Alternator Cable Routing Vision With Ford Engine

# RECALL

Models Affected: Certain 2017-2019 Visions with Ford 6.8L Engines

RECALL CAMPAIGN R18Z0

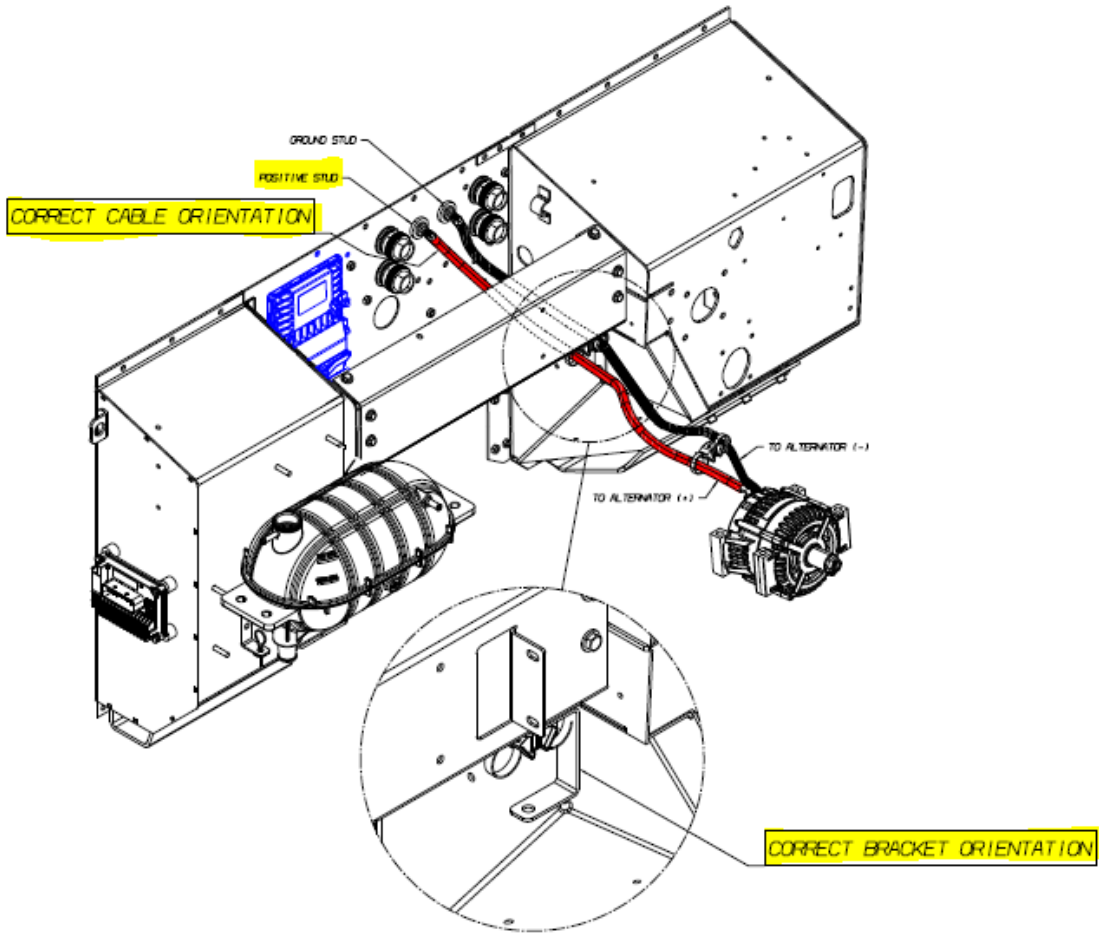
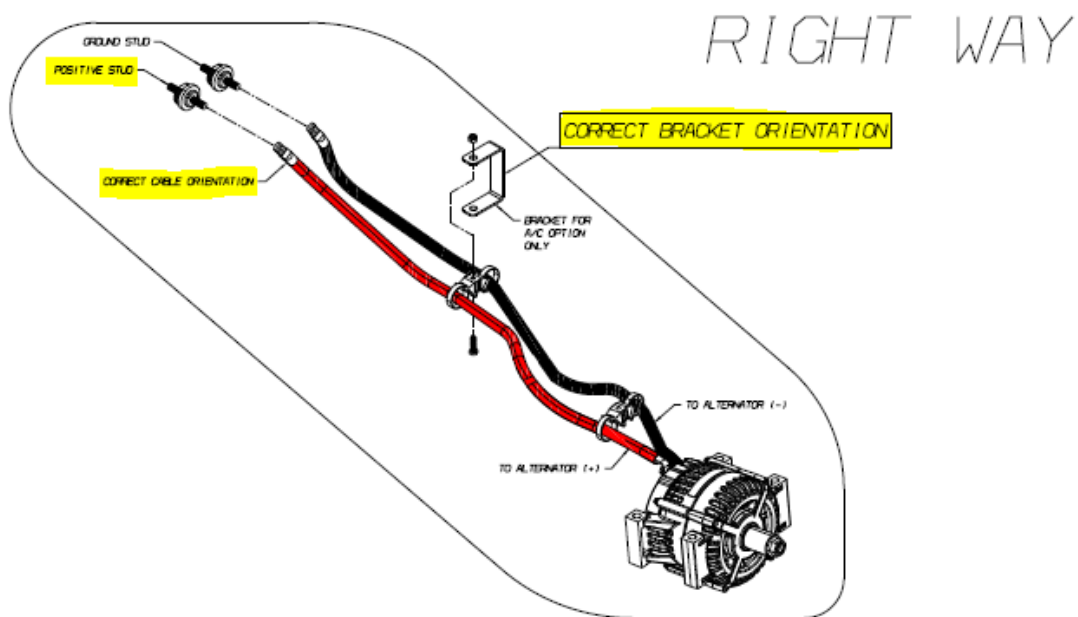
ISSUE	CORRECTIVE ACTION
<p>On certain 2017-2019 Visions with Ford 6.8L engines the alternator cables may not be routed correctly. The alternator cables may contact and potentially chafe against the air conditioning support bracket “if equipped”, and the DCM-to-Toe Box reinforcement channel.</p>	<p>Inspect for proper clearance between the alternator cables and the air conditioning support bracket “if equipped”, and the DCM-to-Toe Box reinforcement channel. If required correct routing, per instructions provided below.</p>

1. Park bus on a level surface, apply parking brake, remove ignition key, and chock wheels.
2. Disconnect Batteries: Note when disconnecting the batteries, remove negative cable first.
3. Inspect alternator cable routing per the illustrations on Pages 2 and 3. Insure that alternator cable and bracket for A/C option “if equipped” is oriented as shown on Page 2. Insure no contact with the alternator cables.
4. As a general guide maintain approximately ½ inch clearance gap between alternator cable and bracket for A/C option “if equipped”, and the DCM-to-Toe Box reinforcement channel.

5. If alternator cable orientation on positive stud requires correction, loosen the stud nut, reorient cable per “RIGHT WAY” illustration Page 2, and torque stud nut to 11-15 ft. lbs.

6. If bracket for A/C option orientation requires correction, loosen the attaching nut, reorient bracket per “RIGHT WAY” illustration Page 2, and torque attaching nut to 5-7 ft. lbs.
7. If reorientation in either step 5 or step 6 was required, inspect for any possible damage to the alternator cable. **If any damage is present, contact your local Blue Bird Dealer for replacement alternator cable.**
8. Reconnect batteries by connecting the negative cable last. Return bus to service.
