November 2018

Dealer Service Instructions for:

Safety Recall UB6 / NHTSA 18V-786 Right Rear Door Latch

2018 (JL) Jeep® Wrangler

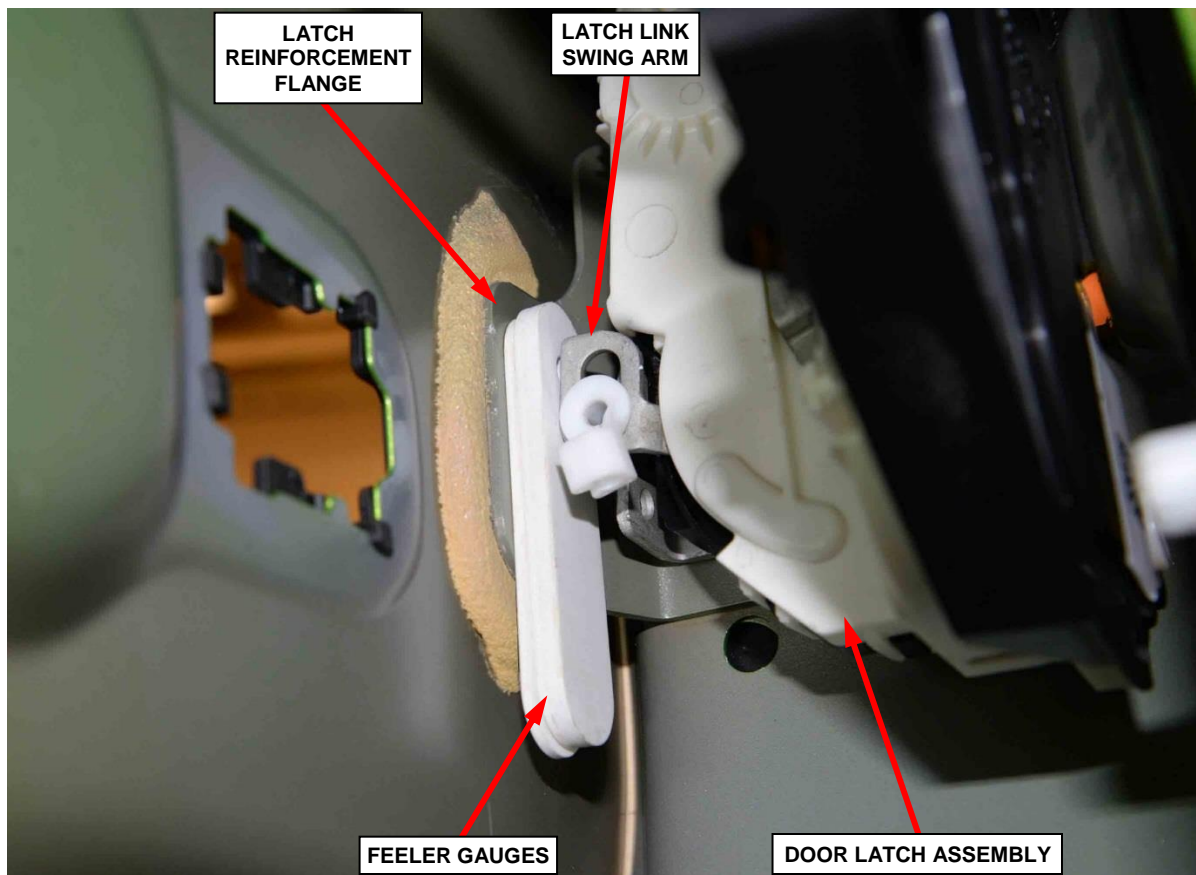
Figure 22 – Measure Between the Latch Link Swing Arm and Latch Reinforcement Flange

36. Temporally install the latch assembly in the door and secure with the three mounting bolts (Figure 21).
37. Using feeler gauges inside the door, measure the distance between the latch link swing arm and latch reinforcement flange (Figure 22).

38. Remove the three mounting bolts and the latch assembly from the door.
- If the measurement from **Step 37** was less than 4.5mm, proceed with the next steps to remove flocking and bend the latch reinforcement flange in order to achieve a minimum measurement of 4.5mm between the latch link swing arm and the latch reinforcement flange.
 - If the measurement from **Step 37** was 4.5mm or greater, no bending of the latch reinforcement flange is required. The door may be reassembled. Proceed to **Step 53** of door reassembly.
39. Using a saw blade or putty knife or other equivalent tool, remove ALL of the flocking material from between the outer door panel skin and latch reinforcement flange, ensuring to not dent the outer door skin (Figure 23). Remove any loose remaining pieces of flocking material from the door cavity.

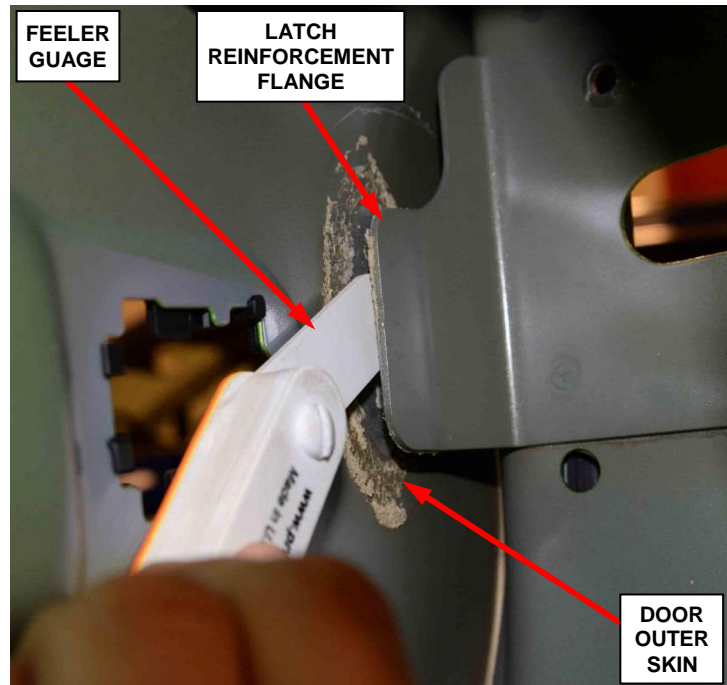
Figure 24 – Measure Between Latch Reinforcement Flange and Door Skin

40. Using feeler gauges, measure the gap between the latch reinforcement flange and door skin. (Figure 24).

Use this measurement as a guide for how much the latch reinforcement flange moves toward the door skin (away from the latch link swing arm) during the following steps to bend the latch reinforcement flange.

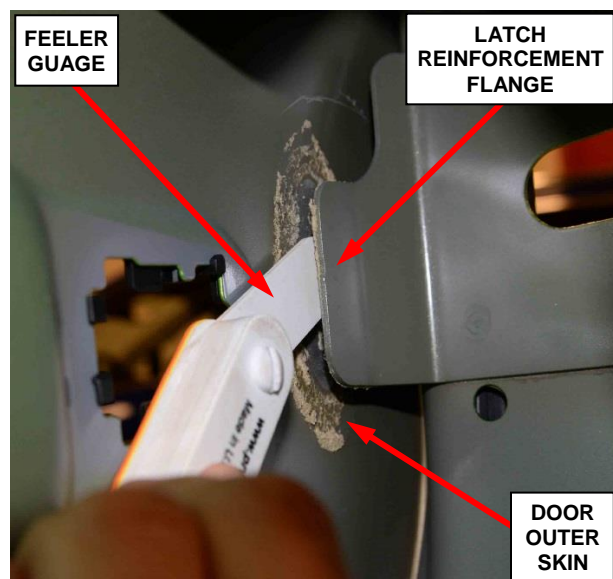
Figure 27 – Measure Between Latch Reinforcement Flange and Door Skin

44. Remove the Steering Wheel Puller L4407B from the door.
45. Using feeler gauges, measure the gap between the latch reinforcement flange and door skin. Measurement target is between 1.5mm and 2.5mm (Figure 27).

Repeat **Steps 42-44** if necessary until no more movement of latch reinforcement flange can be achieved using the Steering Wheel Puller.

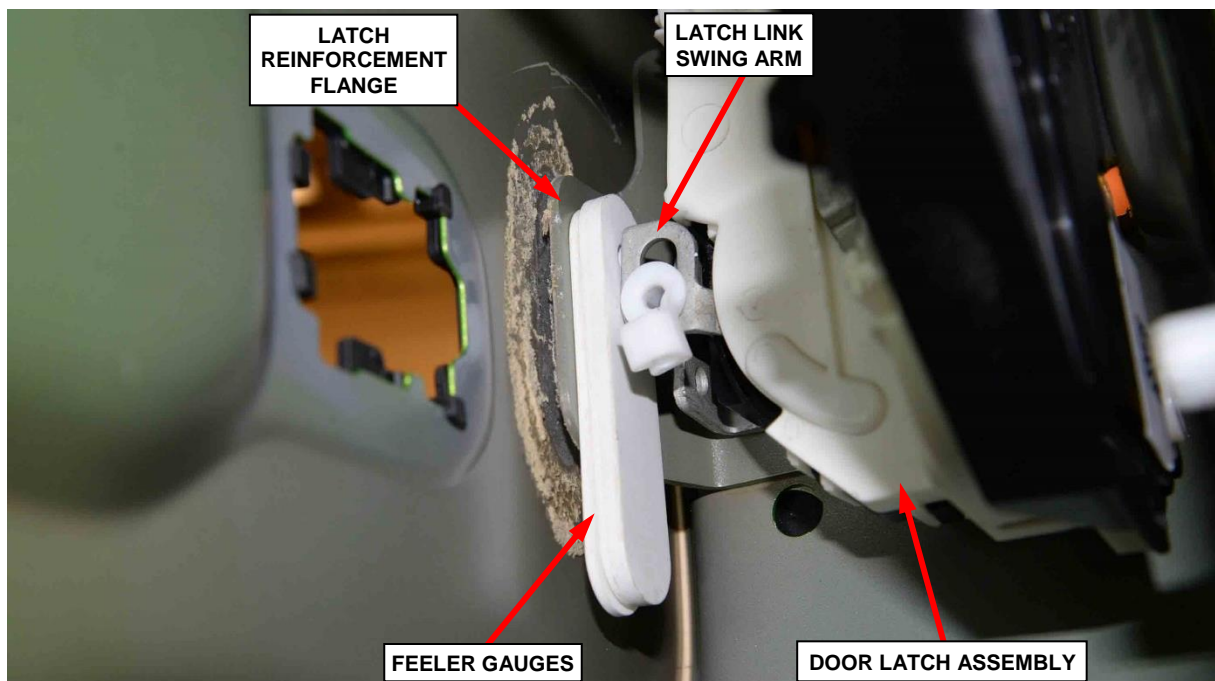
Figure 28 – Measure Between the Latch Link Swing Arm and Latch Reinforcement Flange

46. Temporally install the latch assembly in the door as described in **Step 36** (Figure 21) then measure the distance between the latch link swing arm and latch reinforcement flange (Figure 28). Remove the three mounting bolts and the latch assembly from the door after taking measurement.

- If the latch reinforcement flange moved enough that proper clearance of 4.5mm or more was achieved between the latch link swing arm and latch reinforcement flange, proceed to **Step 51** apply an air-dry urethane.

- If a clearance of 4.5mm or more was NOT achieved between the latch link swing arm and latch reinforcement flange, also if the gap between the latch reinforcement flange and door skin is still greater than 2.5mm, proceed to **Step 47**.

- If a clearance of 4.5mm or more was NOT achieved between the latch link swing arm and latch reinforcement flange and if the gap between the latch reinforcement flange and door skin is 1.5mm or less, the door will require replacement.
