Thor Motor Coach Recall Repair Instructions

Recall #	18V-812 2018-630		
Description/Title:	Irvine Windshield Motor Shade		
Affected Product Line(s):	Certain MY 2017-2019 Challenger, Miramar, & Outlaw Motorhomes		
Service Campaign # :	RC000165	Released Date:	MM/DD/YYYY
Repair Code:	TMCRC80477V	Document Date:	MM/DD/YYYY
Time Allowed:	0.3	Document Revision:	A

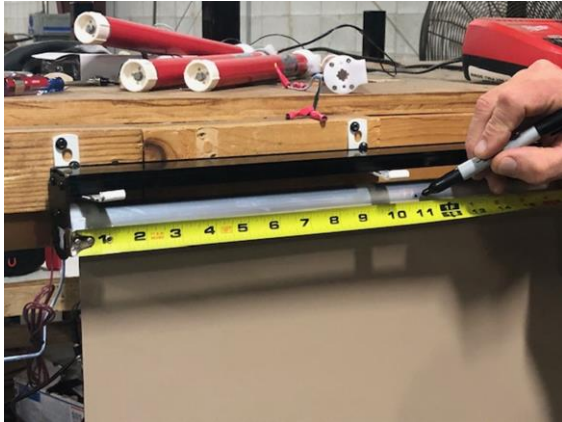
1. Put motor shade into program mode by depressing push button switch for approximately 2 seconds until audible beep is heard. Roll shade down using switch until the aluminum roller tube is exposed.
2. Measure 11" from the end of the motor shade bracket.
