NHTSA RECALL 18V-815, TRANSPORT CANADA RECALL 2018-663

AUTOCAR, LLC SAFETY RECALL ACX-1803

December, 2018

Autocar has determined that a defect that may present an unreasonable risk to safety exists due to potentially improperly swaged steering assist cylinder hardware on certain model year 2019 Xpeditor vehicles.

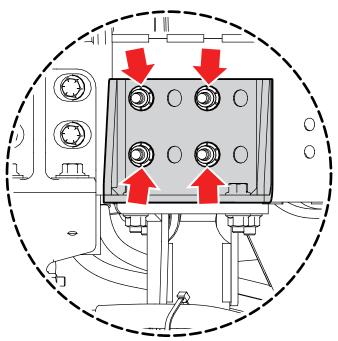
Figure 2, Inspect 4 Huck Fasteners

3. Inspect the power steering assist cylinder bracket hardware for looseness, if all hardware is found to be secure, proceed to step 5. If any hardware is found to be loose, proceed to step 4 (see Figure 2).

4. Using the appropriate Huck tooling, secure the fasteners as required. If the appropriate tooling is not available, please contact Autocar technical support for direction regarding the repair (see Figure 3).

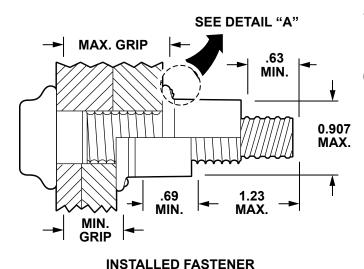
Figure 3

BUMP CREASES ON COLLAR FLANGE INDICATE FULL SWAGE

NOTE: Only .69 Min swage length required to meet minimum values.
