SERVICE PROCEDURE

18517

DECEMBER 2018

SUBJECT: SAFETY RECALL
Brake Air Line Tubing on certain IC BUS® CE Series school bus models built 25 January 2018 thru 10 October 2018 with feature code 04AZS (4-channel Antilock Brakes [ABS], 4-channel Electronic Stability, and Automatic Traction Control)

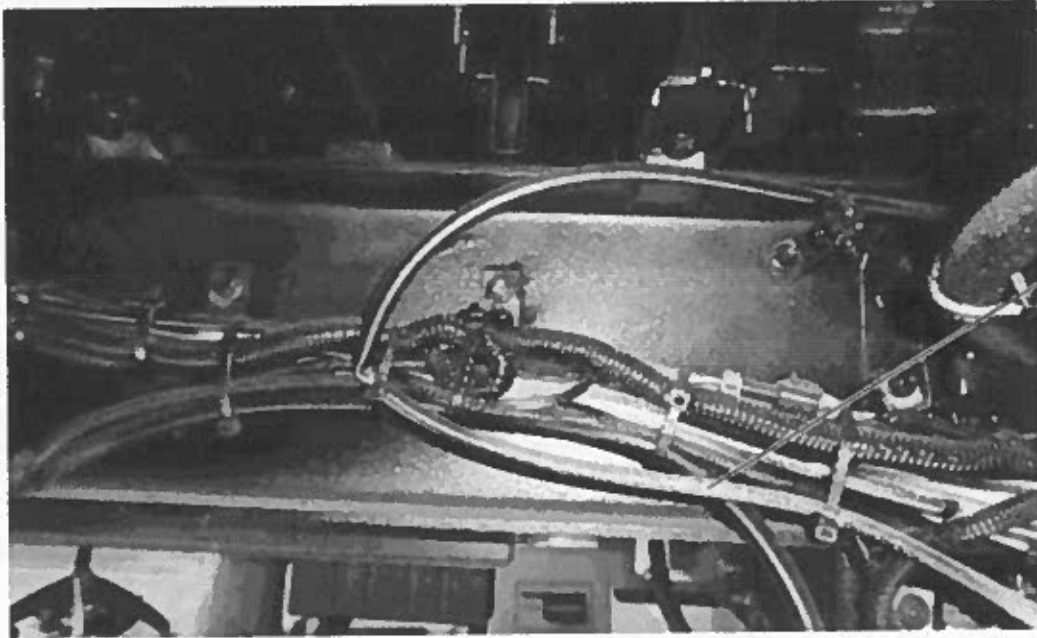
Figure 1. Incorrect Routing
1. Synflex tube

The brake air line tube from the relay valve port to the left brake modulator valve may be improperly routed, resulting in a kinked air line. A kinked air line may result in the vehicle pulling to the right during braking or improper operating of the modulating valve during an ABS event. A vehicle pulling to the right during braking or improper ABS modulation could make it more difficult for the driver to maintain their line, which could result in loss of control or a vehicle crash.

4. Locate and visually inspect Synflex tube. The tube is on the frame rail, near the driver seat area.
 - a. If Synflex tube is routed as shown in Figure 2, proceed to Step 27.
 - b. If Synflex tube is routed as shown in Figure 1, but is free of kinks or damage, proceed to Step 5.
 - c. If Synflex tube is routed as shown in Figure 1 and tube is kinked or damaged, proceed to Step 11.

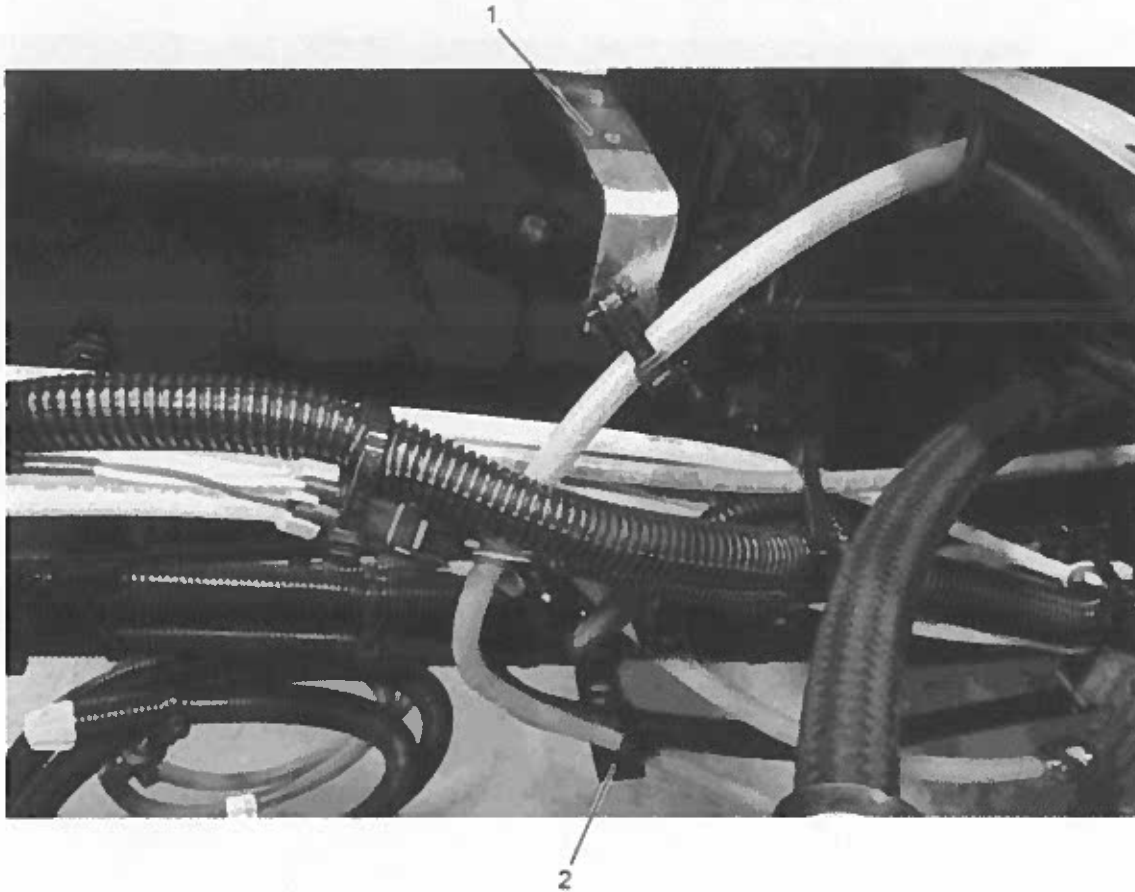
Figure 2. Correct Routing

1. Z style extension clip
2. Battery cable ladder bracket

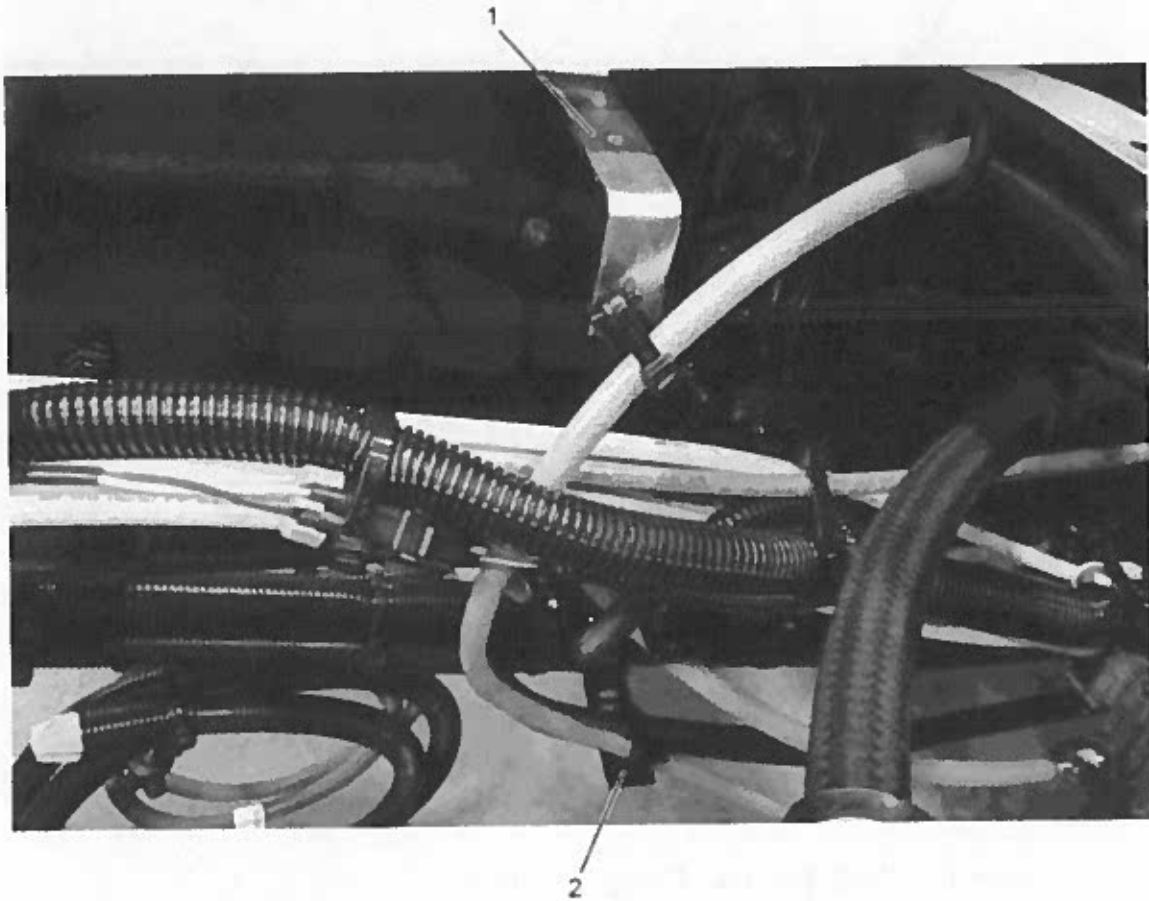
Figure 7. New Tube Routing

NOTE: It is important to route the airline as shown in Figure 7 and Figure 8. Do not reroute the airline to reduce its length. Shortening the airline will cause the vehicle to pull in one direction when the breaks are applied.

20. Route Synflex tube to Z style extension clip (Item 1) and secure with tie strap.
21. Install new saddle clamp on battery cable ladder bracket (Item 2).
22. Route Synflex tube to battery cable ladder bracket and secure with tie strap.
23. Torque saddle bolt to 90 - 110 lb-in (10 - 12 N•m).
