Compliance Recalls Codes: 90L3/90L4

Instrument Cluster Coding

February 26, 2019

Certain vehicles may not comply with Federal Motor Vehicle Safety Standard (FMVSS) & Canadian Motor Vehicle Safety Standard (CMVSS) No.114. *Theft Protection and Rollaway Prevention*.

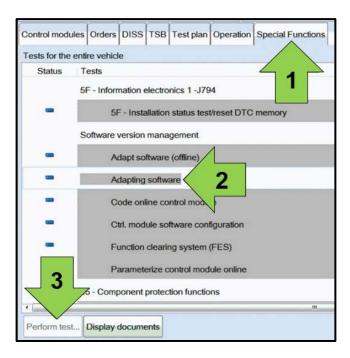
- Confirm that scan tool is communicating with the diagnostic head by USB <Green Arrow>.
 - If the Bluetooth symbol is shown <Red Arrow> then disconnect the diagnostic head from the vehicle and reconnect the USB cable to the diagnostic head and then reattach to the vehicle.
- Upon ODIS startup, verify the "Diagnosis" operating mode is selected <as shown>.
- Once the GFF scan is complete, select "Special functions" <arrow 1>, then "Adapting software" <arrow 2>, then select "Perform test" <arrow 3>.

Select option 2 to "Update software via action code".
