Dealer Service Instructions for:

Safety Recall UB9 / NHTSA 18V-828

Brake Fluid Tube

2017 - 2018 (GA) Alfa Romeo Giulia

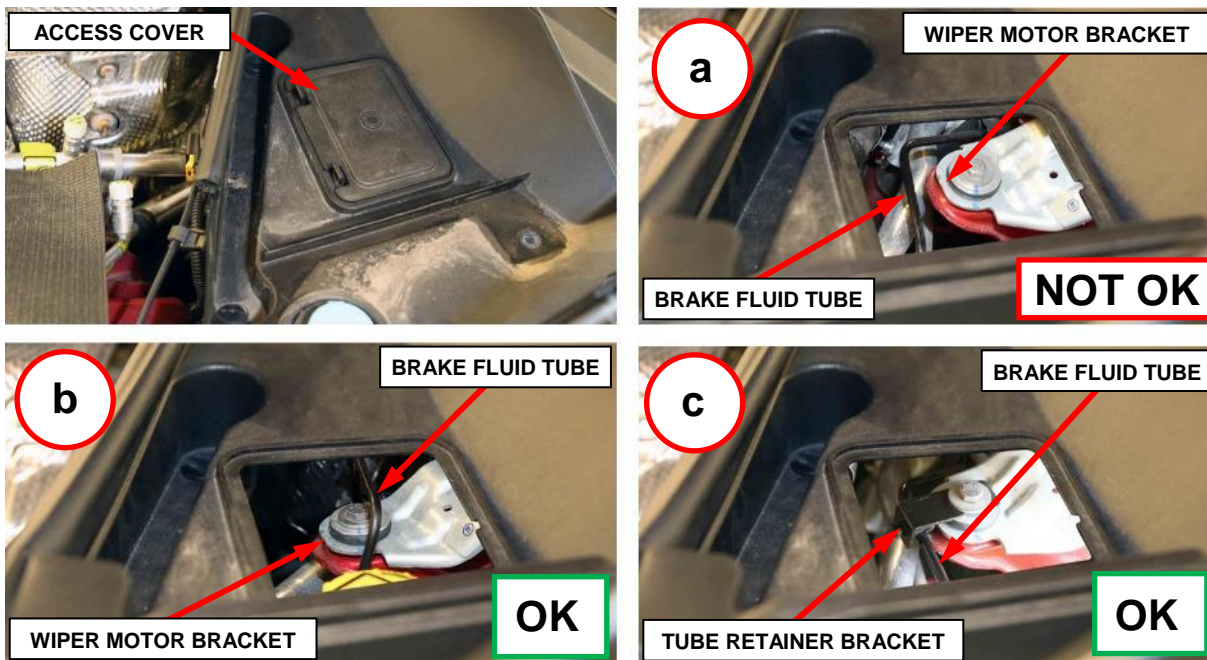
Figure 1 – Brake Fluid Tube Routing Inspection.

1. Open the hood.
2. Remove the brake fluid reservoir access cover (Figure 1).
3. Inspect the brake fluid tube routing (Figure 1):
 - a. Brake fluid tube is routed in front of the windshield wiper motor bracket. Continue with the **Step 4**.
 - b. Brake fluid tube is routed over the windshield wiper motor bracket. Vehicle has been previously remedied; no further action is required. Install the brake fluid reservoir access cover. Return the vehicle to customer or inventory, and claim the inspection LOP.
 - c. Brake fluid tube is retained by a bracket to the windshield wiper motor bracket. Vehicle has been previously remedied; no further action is required. Install the brake fluid reservoir access cover. Return the vehicle to customer or inventory, and claim the inspection LOP.

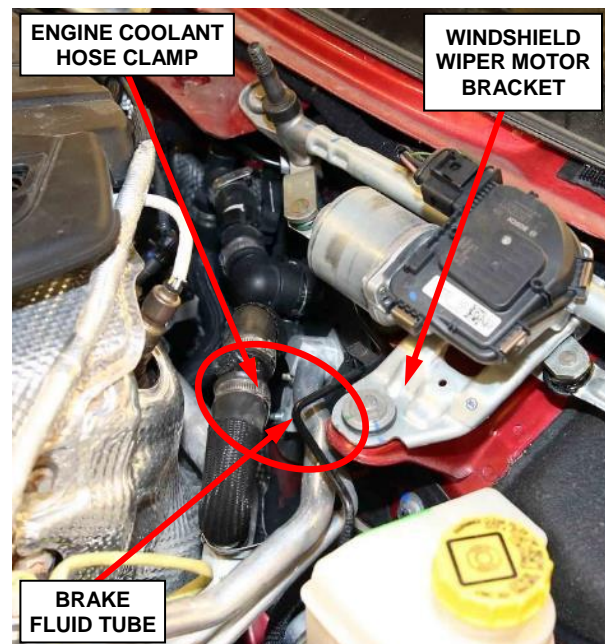
Figure 12 – Potential Contact Area

17. Locate the area where the brake fluid tube and engine coolant hose clamp could potentially contact each other during engine movement (Figure 12).

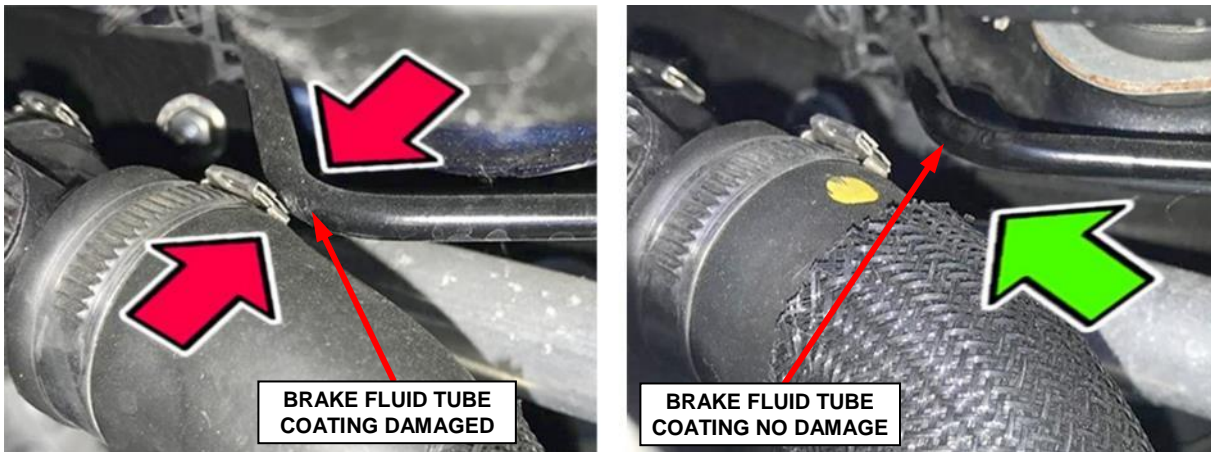
Figure 13 – Inspect for Brake Tube Damage

18. Carefully inspect the right front brake fluid tube in relation to the engine coolant hose clamp (Figure 13).
 - Brake fluid tube surface coating shows **no signs of damage** due to contact with the engine coolant hose clamp. Proceed to **Section B Retaining Bracket Installation**. Brake fluid tube does NOT require replacement.
 - Brake fluid tube surface coating **has been damaged** due to contact with the engine coolant hose clamp. Proceed to **Section C Brake Fluid Tube Replacement**.

Contact Damage

No Contact Damage
