IMPORTANT SAFETY RECALL

Bulletin Number: NHTSA Recall 18V-832
Product Line: 2019 Airstream Interstate 19
Subject: Incorrect Battery Fuse

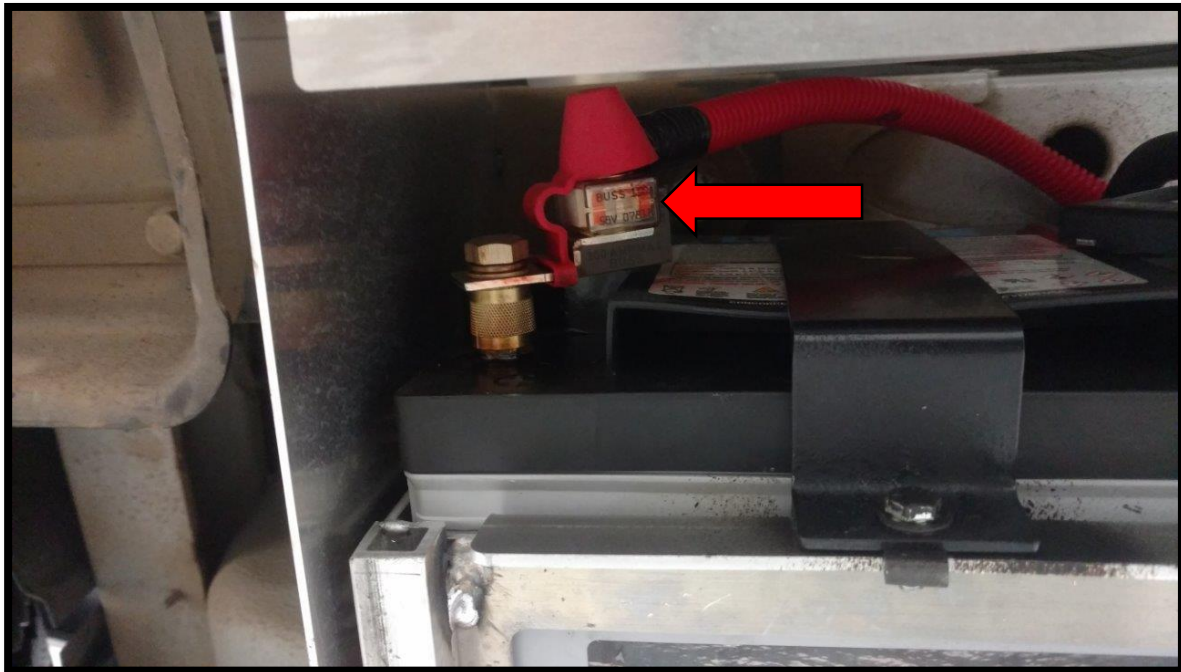
Incorrect coach battery fuses were installed on the initial Interstate 19 production units which may cause an overloaded battery cable condition. The initial units have a 150 Amp fuse installed on both the coach batteries instead of the correct 100 Amp fuse that was required.

Step 5: Disengage the red rubber cap and, using the 13mm wrench, remove the containment nut on the positive fuse. Remove lock washer, flat washer and positive cable from the fuse side stud.

Then remove the 150Amp fuse and replace with 100Amp fuse.

Reconnect the positive cable, flat washer, lock washer and nut on the 100 Amp fuse. Using the inch lb. torque wrench, torque nut to 70 inch lbs.
