L614-
R.01.18

To: **Official After Sales Network**
Subject: **Engine Software Update Coupè**
Date: **21 December 2018**
Pages: **18**

Engine SW Update Coupè

Gallardo Coupè

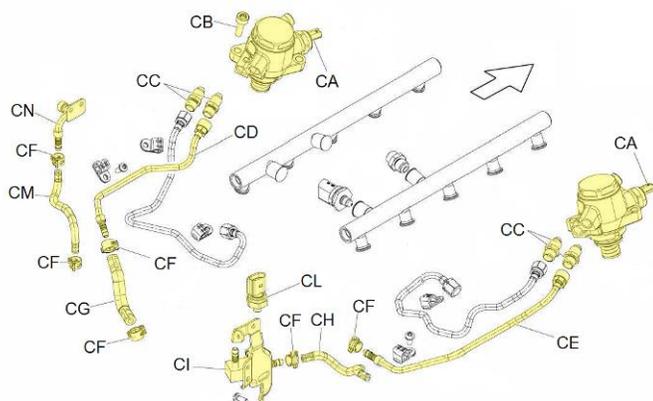
55. Disassemble the feeding pipes and the high pressure pumps following scrupulously the instructions reported in the Workshop Manual.

Ref.	Des.
CA	High pressure pump
CB	M8X30 Screw
CC	Union pipe
CD	Pipe
CE	Pipe
CF	Clamp
CG	Pipe
CH	pipe
CI	Union
CL	pressure sensor
CM	Pipe
CN	Union
